Tuscaloosa

Greater Downtown Study
Historic Resource Survey - 2006

Survey Number: _____ 1 _____
Historic name(s): House, Not Named
Common name: Southeast Appraisers
Location: University Blvd., 2720

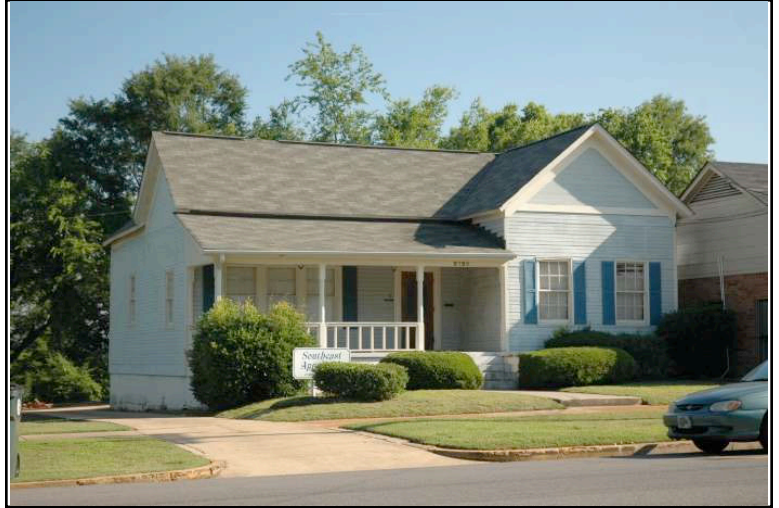
T-shaped 1-story frame dwelling with a cross gable composition shingle roof; faces south, 4x2 bay core with front and rear facing gable wings at east; less than full facade shed porch with turned posts; central entrance at facade flanked to the west by a triple 6/6 double hung sash window, paired similar single windows to east, similar windows at side elevations; plain weatherboard siding; brick foundation.

Condition: good _____ Integrity: good _____ Ownership: private _____ Category: Building _____
Historic Use: Single Dwelling - Non Farm Current Use: Commerce/Trade
Function: Residence Function: Business/Professional Office

Construction and design details suggest that this house was built circa 1900 and remodeled circa 1950. This house appears on the 1923/1950 Sanborn Map.

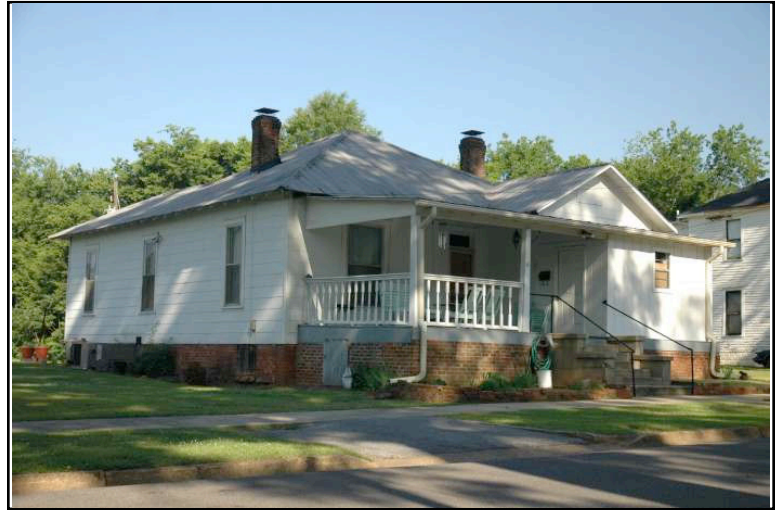
Rectangular 1-story frame dwelling with a hipped V-crimped metal roof with exposed rafter ends, 2 interior brick chimneys; faces east, 3x2 bay core; full facade shed porch with tapered wood posts and turned balustrade, north bay now enclosed; central entrance at facade with transom flanked to the south by a single 1/1 double hung sash window, similar single windows at side elevations; replacement asbestos shingle siding; brick foundation.

Condition: fair _____ Integrity: fair _____ Ownership: private _____ Category: Building _____
 Historic Use: Single Dwelling - Non Farm _____ Current Use: Single Dwelling - Non Farm _____
 Function: Residence _____ Function: Residence _____

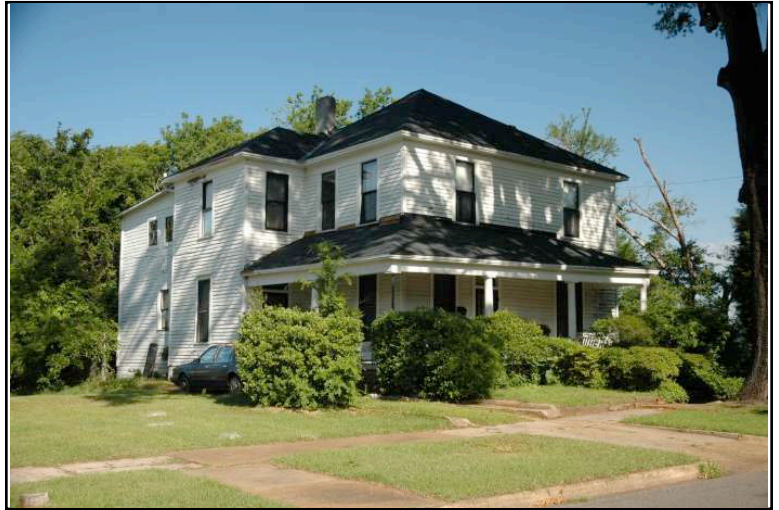
Irregular-shaped 2-story frame dwelling with a hipped composition shingle roof with 2 interior stuccoed chimneys; faces east, 3x2 bay core with side projection to south and rear extension; full facade hipped porch with columns wraps to south elevation; off-center entrance at facade with transom flanked by a single 1/1 double hung sash window, similar single windows at side elevations; plain weatherboard siding; brick foundation.

Condition: good _____ Integrity: good _____ Ownership: private _____ Category: Building _____
Historic Use: Single Dwelling - Non Farm _____ Current Use: Single Dwelling - Non Farm _____
Function: Residence _____ Function: Residence _____

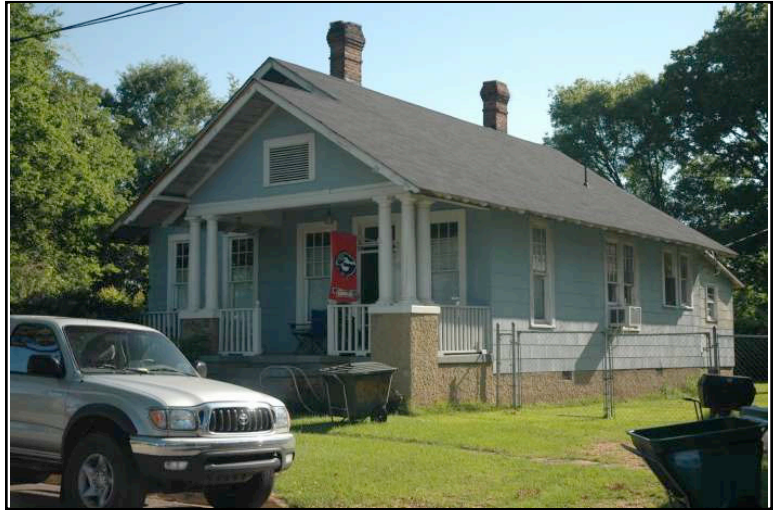
Rectangular 1-story frame dwelling with a front-facing gable composition shingle roof with 2 interior brick chimneys; faces west, 5x3 bay core with rear shed extension; less than full facade gable porch with paired columns on stucco pedestals; off-center entrance at facade with transom flanked by single 9/1 double hung sash windows, similar single windows at side elevations; replacement asbestos shingle siding; stucco foundation.

Condition: good _____ Integrity: fair _____ Ownership: private _____ Category: Building _____
 Historic Use: Single Dwelling - Non Farm _____ Current Use: Single Dwelling - Non Farm _____
 Function: Residence _____ Function: Residence _____

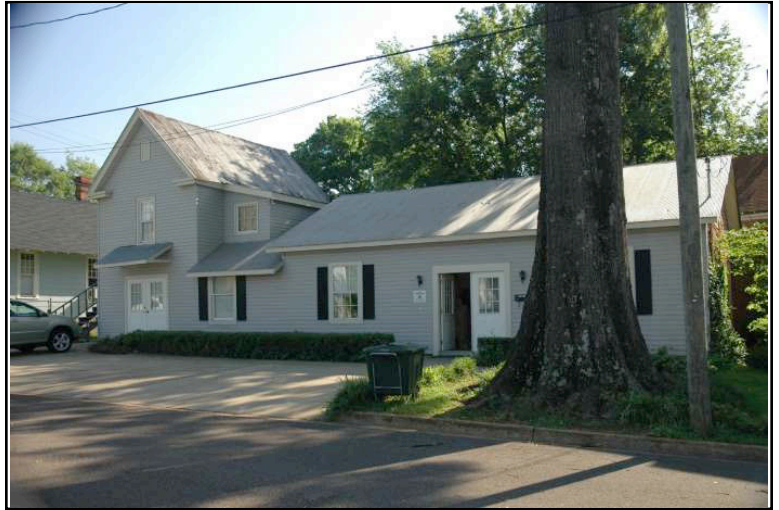
Original building at north represented by a rectangular 2-story frame section with a front-facing gable metal roof with boxed cornice with returns; faces west, 1x2 bay core with 1-story 4x1 bay addition to the south; no porch; central entrance at facade of core with double leaf doors, single wood 6/6 window at upper level, similar single windows at north elevation; replacement vinyl siding; foundation not visible.

Condition: good _____ Integrity: fair _____ Ownership: private _____ Category: Building _____
Historic Use: Secondary Structure _____ Current Use: Education _____
Function: Residence _____ Function: School _____

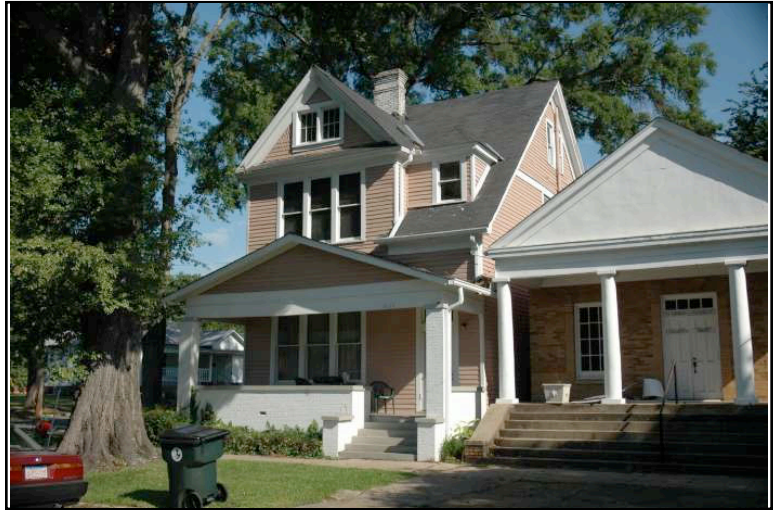
Rectangular 2.5-story frame dwelling with a cross gable composition shingle roof with 1 interior brick chimney; faces south, 2x3 bay core with a secondary rear wing to the east flanked to the west by a now enclosed former porch; full facade gable porch with brick piers appears to be a later alteration; entrance at east bay of facade with transom flanked by triple 1/1 double hung sash window, similar triple window at 2nd level flanked by a hipped dormer, similar single windows at side elevations; plain weatherboard siding; brick foundation.

Condition: good _____ Integrity: good _____ Ownership: private _____ Category: Building _____
Historic Use: Single Dwelling - Non Farm _____ Current Use: Single Dwelling - Non Farm _____
Function: Residence _____ Function: Residence _____

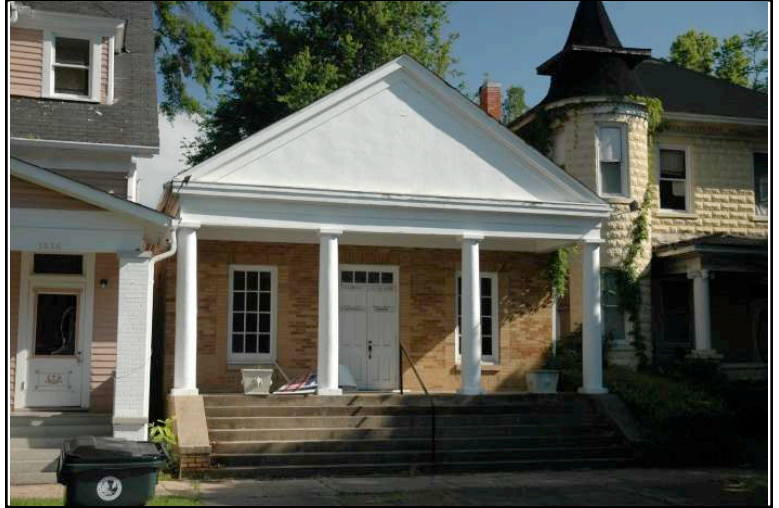
Rectangular 1-story brick church building with a front-facing gable composition shingle roof; faces south, 3x3 bay core; full facade pedimented gable porch with columns; central entrance at facade with multi-light transom flanked by fixed 12-light wood windows, similar triple windows at side elevations; exposed brick exterior walls; brick foundation.

Condition: good _____ Integrity: good _____ Ownership: private _____ Category: Building _____
Historic Use: Religion _____ Current Use: Commerce/Trade _____
Function: Religious Facility _____ Function: Business/Professional Office _____

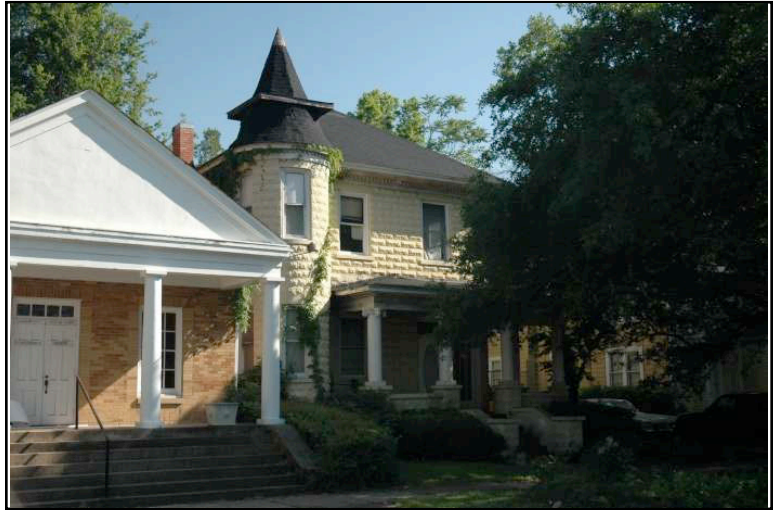
Rectangular 2-story patterned concrete block dwelling with a hipped composition shingle roof with 1 interior brick chimney; faces south, 4x3 bay core with an engaged tower at its southwest corner, projecting bay at the rear bay of its east elevation, real ell wing; less than full facade hipped porch columns on concrete block pedestals; entrances at east bays of facade with transoms flanked by single 1/1 double hung sash window, similar windows at upper level and side elevations; painted patterned concrete block walls, cornice with dentils; siding; brick foundation.

Condition: good _____ Integrity: good _____ Ownership: private _____ Category: Building _____
Historic Use: Single Dwelling - Non Farm _____ Current Use: Multiple Dwelling _____
Function: Residence _____ Function: Duplex _____

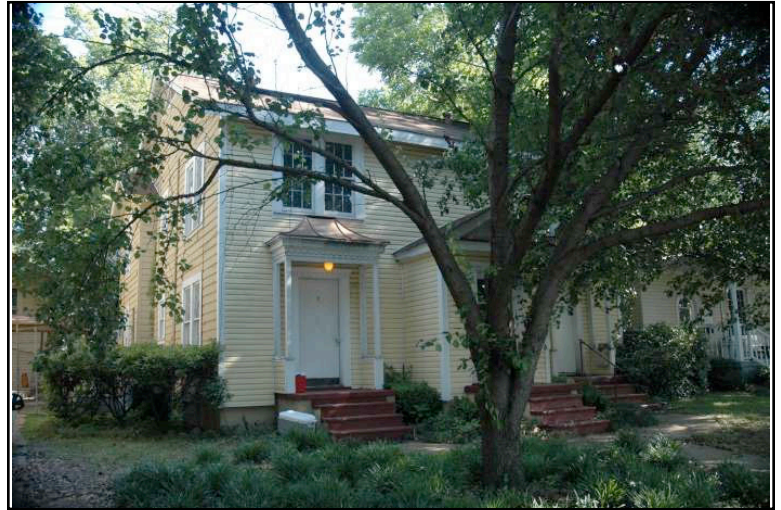
Rectangular 2-story frame dwelling with a side gable composition shingle roof; faces south, 3x3 bay core with 1-story front-facing gable projection centered at facade; hipped stoops at entrances at outer bays of facade with entrances wood posts, entrance at projection, double 6/6 double hung sash windows at upper level, similar single and double windows at side elevations; replacement vinyl siding; concrete block foundation.

Condition: good _____ Integrity: fair _____ Ownership: private _____ Category: Building _____
Historic Use: Single Dwelling - Non Farm _____ Current Use: Multiple Dwelling _____
Function: Residence _____ Function: Apartment Building _____

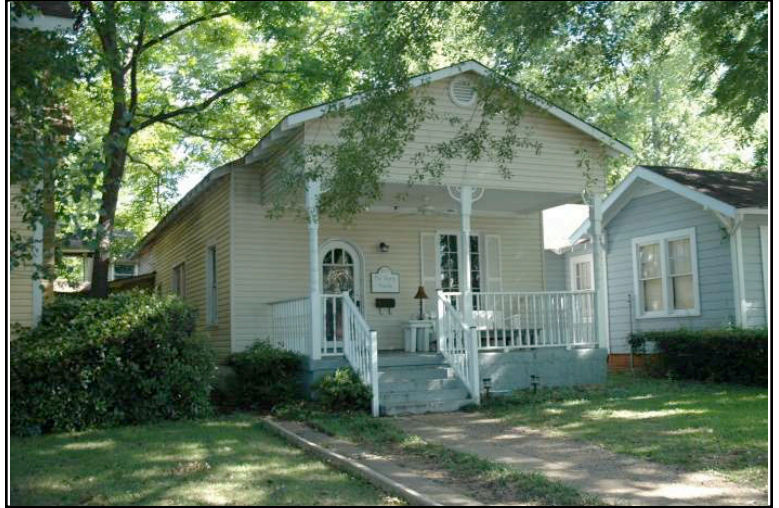
Rectangular 1-story frame dwelling with a front-facing gable composition shingle roof; faces south, 2x4 bay core; less than full facade gable porch with turned posts; entrance at west bay of facade flanked by a single window, single 6/6 double hung sash windows at side elevations; replacement vinyl siding; concrete block foundation.

Condition: good _____ Integrity: poor _____ Ownership: private _____ Category: Building _____
Historic Use: Single Dwelling - Non Farm _____ Current Use: Commerce/Trade _____
Function: Residence _____ Function: Meeting Hall _____

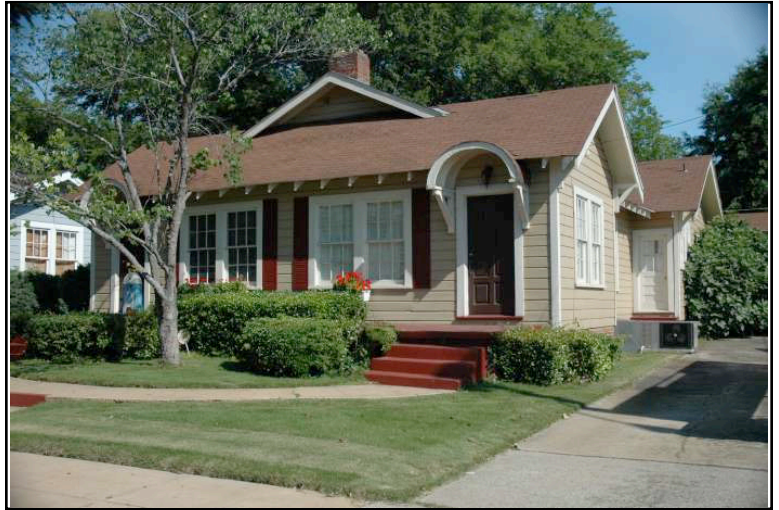
H-shaped 1-story frame duplex with a cross gable composition shingle roof; faces south, 4x4 bay core; no porch; entrances at east and west bays of facade have round arched hoods and flank double 6/6 double hung sash windows, similar single and double windows at side elevations; wood novelty siding; brick foundation; rear ancillary building.

Condition: good Integrity: good Ownership: private Category: Building
 Historic Use: Multiple Dwelling Current Use: Commerce/Trade
 Function: Duplex Function: Business/Professional Office

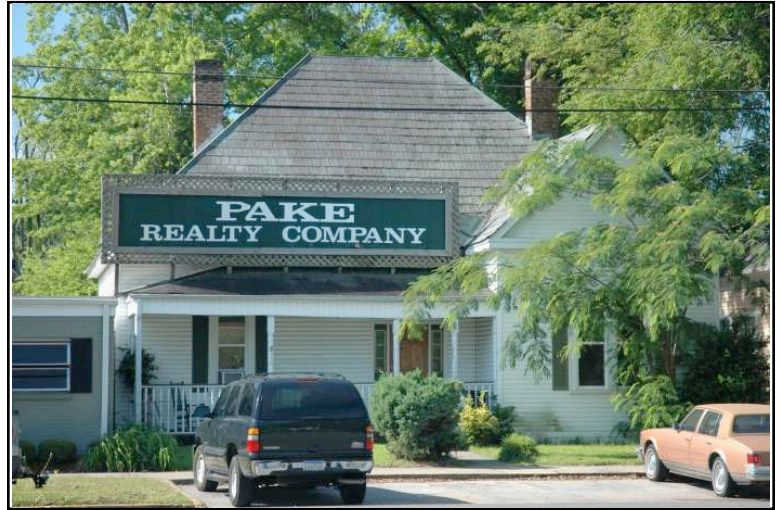
Rectangular 1-story frame dwelling with a tall hipped pressed metal shingle roof with front-facing gable projection with boxed cornice with returns, two interior brick chimneys; faces north, 3x2 bay core; less than full facade hipped porch with turned posts; off center entrance at facade with sidelights flanked by single 1/1 replacement windows, similar windows at side elevations; replacement vinyl siding; foundation not visible.

Condition: good _____ Integrity: fair _____ Ownership: private _____ Category: Building _____
Historic Use: Single Dwelling - Non Farm _____ Current Use: Commerce/Trade _____
Function: Residence _____ Function: Business/Professional Office _____

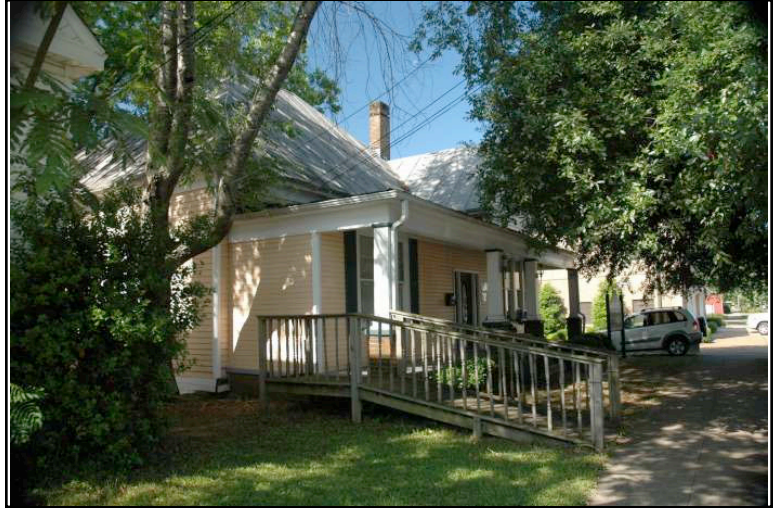
Rectangular 1-story frame dwelling with a tall hipped raised seam metal shingle roof with front-facing gable projection with boxed cornice with returns, two interior brick chimneys; faces north, 3x3 bay core; less than full facade hipped porch with wood supports on brick pedestals; off center entrance at facade with sidelights flanked by single 1/1 double hung sash windows, similar windows at side elevations; wood novelty; brick foundation.

Condition: good _____ Integrity: good _____ Ownership: private _____ Category: Building _____
Historic Use: Single Dwelling - Non Farm _____ Current Use: Commerce/Trade _____
Function: Residence _____ Function: Business/Professional Office _____

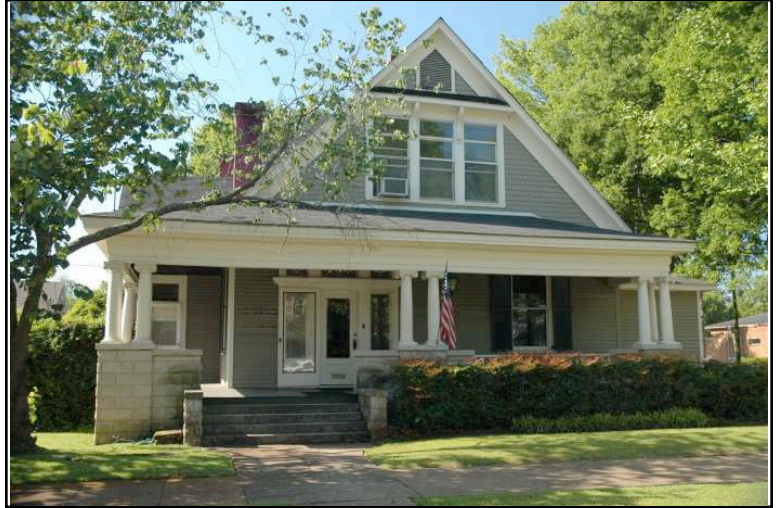
Rectangular 1.5-story frame dwelling with a hipped composition shingle with front-facing gable, two interior brick chimneys; faces north, 3x3 bay core with rear gable extension; full facade hipped porch with paired columns on brick pedestals wraps to east elevation; off center entrance at facade with stained glass transom & sidelights flanked to the west by a by single 1/1 double hung sash window and to the east by a recessed by with a single entrance with transom, similar windows at side elevations; plain weatherboard siding; cut stone foundation.

Condition: good _____ Integrity: good _____ Ownership: private _____ Category: Building _____
Historic Use: Single Dwelling - Non Farm _____ Current Use: Commerce/Trade _____
Function: Residence _____ Function: Business/Professional Office _____

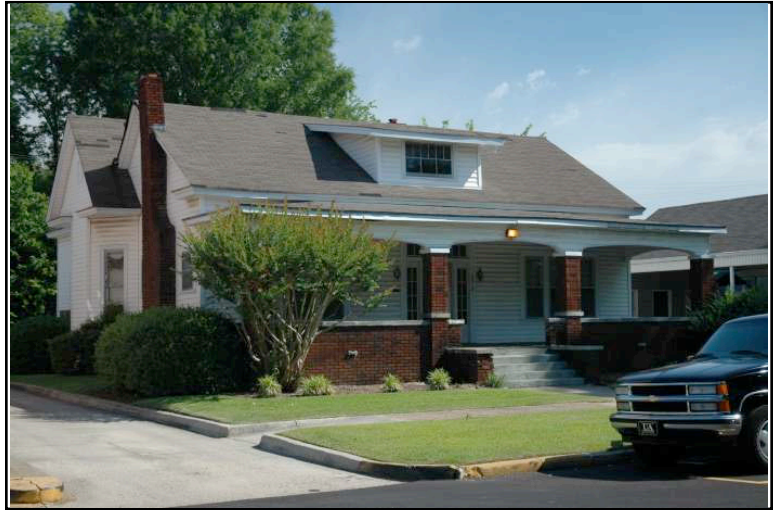
Rectangular 1-story frame dwelling with a side gable composition shingle with a decorative shed dormer, 1 exterior brick chimney; faces south, 3x2 bay core with side gable cutaway bay at the rear bay of its west elevation, rear extension; full facade hipped porch with brick pillars and apron wall; central entrance at facade with transom & sidelights flanked by triple 9/1 double hung sash windows, similar single and double 9/1 and 4/1 windows at side elevations; replacement vinyl siding; brick foundation.

Condition: good _____ Integrity: fair _____ Ownership: private _____ Category: Building _____
Historic Use: Single Dwelling - Non Farm _____ Current Use: Single Dwelling - Non Farm _____
Function: Residence _____ Function: Residence _____

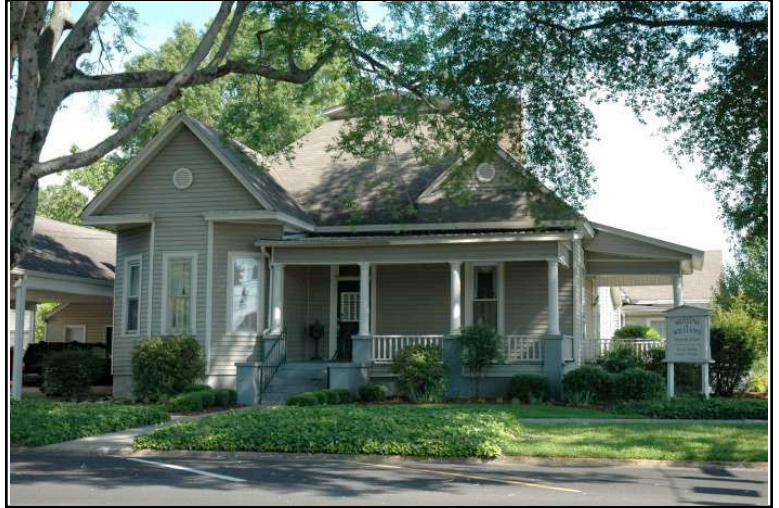
Rectangular 1-story frame dwelling with a gable on hip composition shingle with a front-facing gable cutaway bay at the west bay of its facade and a pedimented gable projection, 2 interior brick chimneys; faces south, 3x2 bay core with side gable cutaway bay at the rear bay of its west elevation, rear extension; less than full facade shed porch with columns on brick pedestal, shed porch at east elevations; central entrance at facade with transom flanked by single 1/1 double hung sash windows, similar windows at side elevations; replacement vinyl siding; stucco foundation; modern carport addition to west.

Condition: good _____ Integrity: fair _____ Ownership: private _____ Category: Building _____
 Historic Use: Single Dwelling - Non Farm _____ Current Use: Commerce/Trade _____
 Function: Residence _____ Function: Business/Professional Office _____

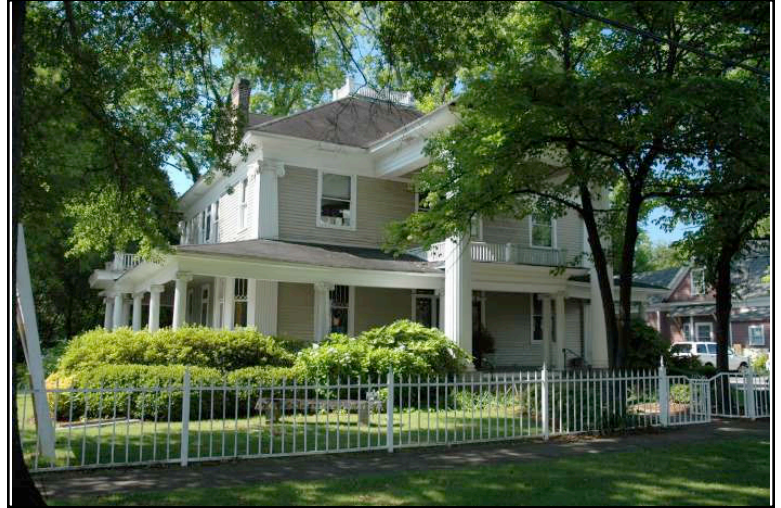
Rectangular 2-story frame Colonial Revival style dwelling with a hipped composition shingle with deck with balustrade, 2 interior brick chimneys; faces north, 3x3 bay core with side gable polygonal bay at the front bay of its east elevation, side rectangular bay at east elevation; full facade hipped 1-story porch with columns wraps to east elevation and has a monumental 2-story portico at entrance bay; central entrance at facade with transom & sidelights flanked by single 1/1 double hung sash windows, similar windows at side elevations; plain weatherboard siding, monumental pilasters at corners, boxed cornice; brick foundation,

Condition: good _____ Integrity: good _____ Ownership: private _____ Category: Building _____
Historic Use: Single Dwelling - Non Farm _____ Current Use: Commerce/Trade _____
Function: Residence _____ Function: Business/Professional Office _____

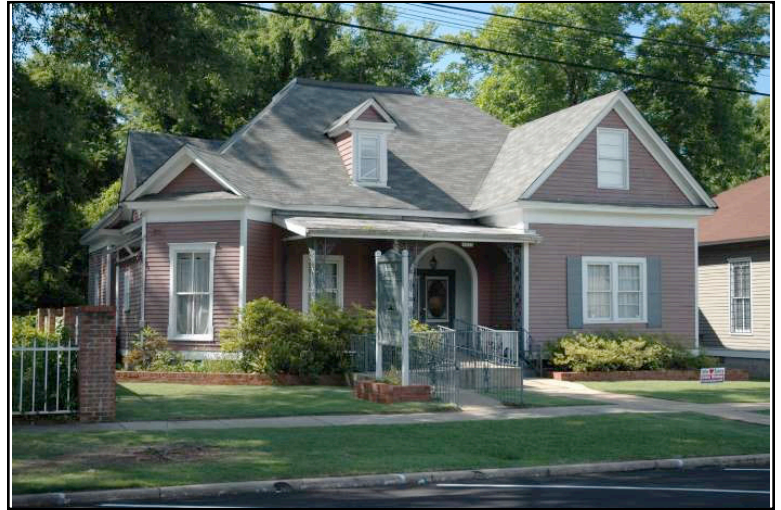
Irregular-shaped 1.5-story frame dwelling with a hipped composition shingle roof with deck and cross gables and a gable dormer; faces north, 3x4 bay core with front-facing gable wing at the west bay of its facade, angled secondary pedimented gable projection at its northeast corner, and rear extensions; less than full facade shed porch with replacement decorative metal supports; central entrance at facade recessed within round arched opening with double doors flanked by single and double horizontal 2/2 replacement windows (ca. 1955), similar windows at side elevations; plain weatherboard siding; brick foundation.

Condition: good _____ Integrity: good _____ Ownership: private _____ Category: Building _____
Historic Use: Single Dwelling - Non Farm _____ Current Use: Commerce/Trade _____
Function: Residence _____ Function: Business/Professional Office _____

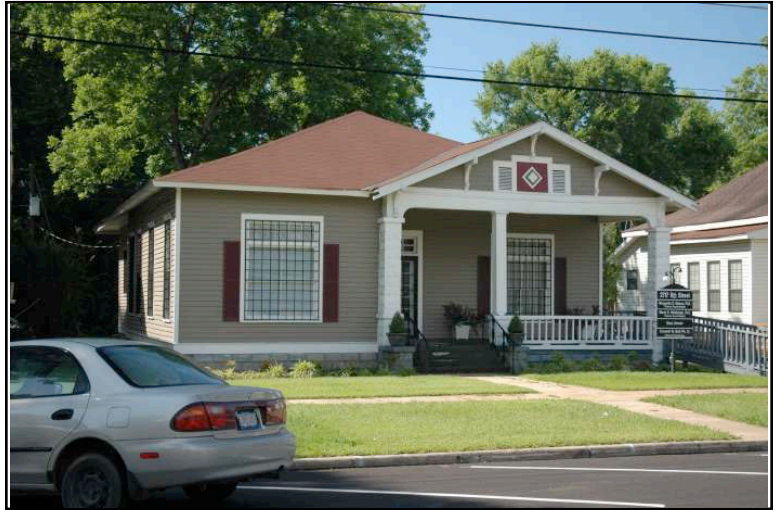
Rectangular 1-story frame dwelling with a hipped composition shingle roof; faces north, 3x5 bay core; less than full gable porch with wood posts; central entrance at facade with transom flanked by oversized single 2/2 double hung windows with transoms, similar windows without transoms at side elevations; plain weatherboard siding; concrete block foundation.

Condition: good _____ Integrity: good _____ Ownership: private _____ Category: Building _____
Historic Use: Single Dwelling - Non Farm _____ Current Use: Commerce/Trade _____
Function: Residence _____ Function: Business/Professional Office _____

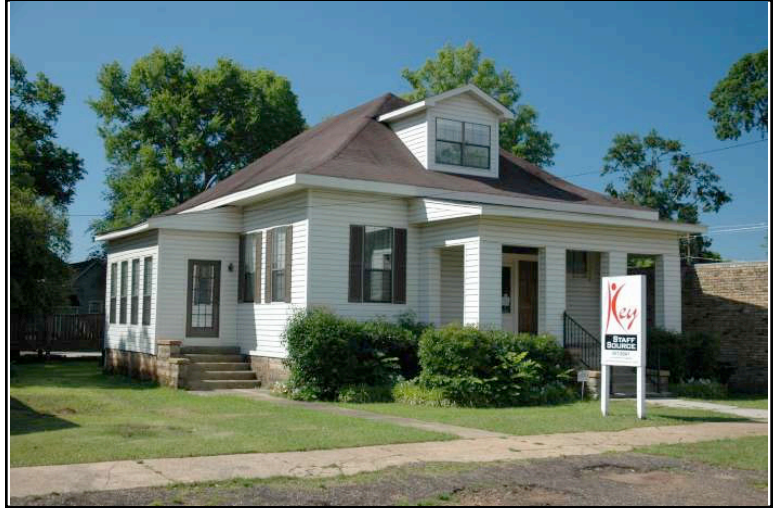
Rectangular 1.5-story frame dwelling with a hipped composition shingle roof, modern gable dormer at front slope; faces north, 3x3 bay core with small shed addition at east elevation less than full shed modern replacement porch with piers; central entrance at facade with transom and sidelights flanked to the west by a single high-placed window and to the east by a single replacement 9/6 window (c. 1990), similar windows at side elevations; replacement vinyl siding (1990 ca.); concrete block foundation.

Condition: good _____ Integrity: poor _____ Ownership: private _____ Category: Building _____
 Historic Use: Single Dwelling - Non Farm _____ Current Use: Commerce/Trade _____
 Function: Residence _____ Function: Business/Professional Office _____

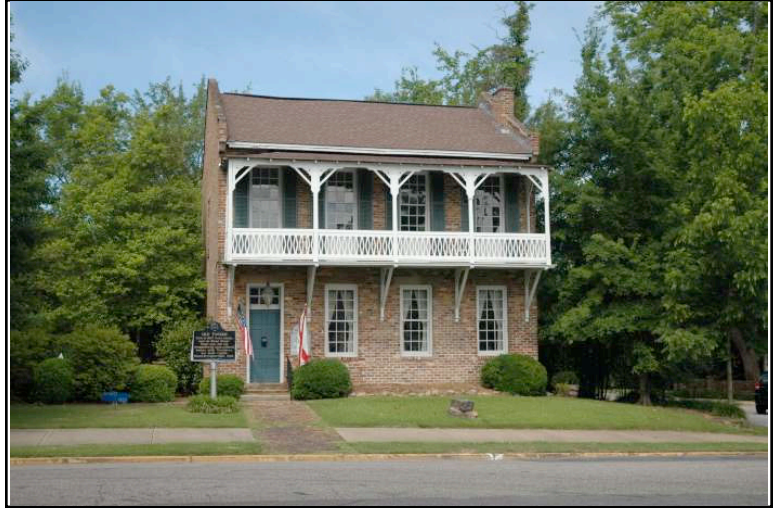
Rectangular 2-story brick tavern building with a side gable composition with end parapets; faces east, 4x2 bay core; full facade shed balcony at facade with turned wood posts and sawn brackets and balustrade supported by angle braces; single entrance with transom at south bay of 1st level flanked by three wood 9/9 windows, similar jib windows at upper level, similar single windows side elevations; exposed brick walls set in stretcher bond; brick foundation.

Condition: good _____ Integrity: good _____ Ownership: private _____ Category: Building _____
Historic Use: Commerce/Trade _____ Current Use: Recreation/Culture _____
Function: Tavern _____ Function: Museum _____

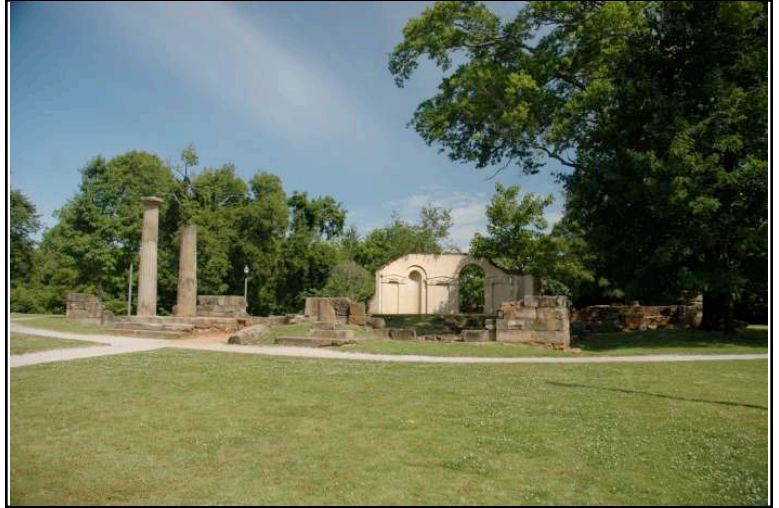
Reconstructed ruins of the former State Capitol building.

Condition: _____ Integrity: _____ Ownership: city Category: Building
 Historic Use: Government Current Use: Recreation/Culture
 Function: Government Office Function: Museum

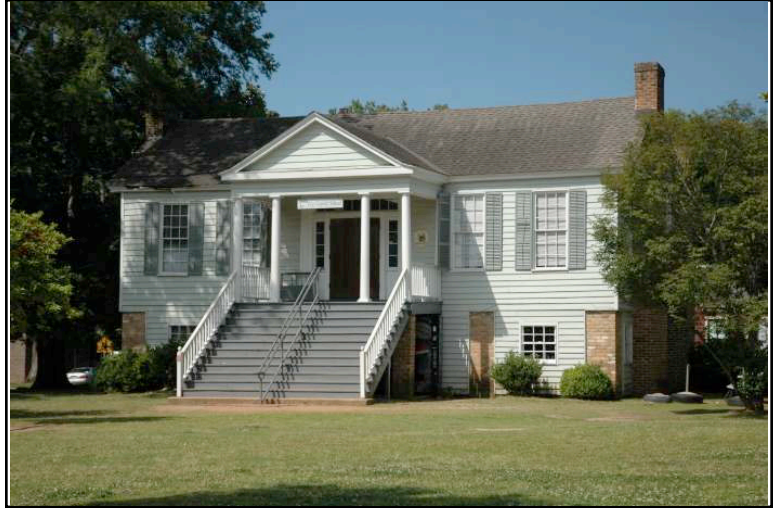
Rectangular 1-story frame dwelling on a raised basement with a side gable composition shingle roof, 2 exterior end brick chimneys; faces east, 5x3 bay core; central entrance at facade with transom sidelights flanked by single wood 9/9 double hung sash windows similar windows at side elevations; wood weatherboard siding, exposed brick foundation pillars at raised basement level with weartherboarded infill.

Condition: good _____ Integrity: good _____ Ownership: private _____ Category: Building _____
Historic Use: Single Dwelling - Non Farm _____ Current Use: Education _____
Function: Residence _____ Function: School _____

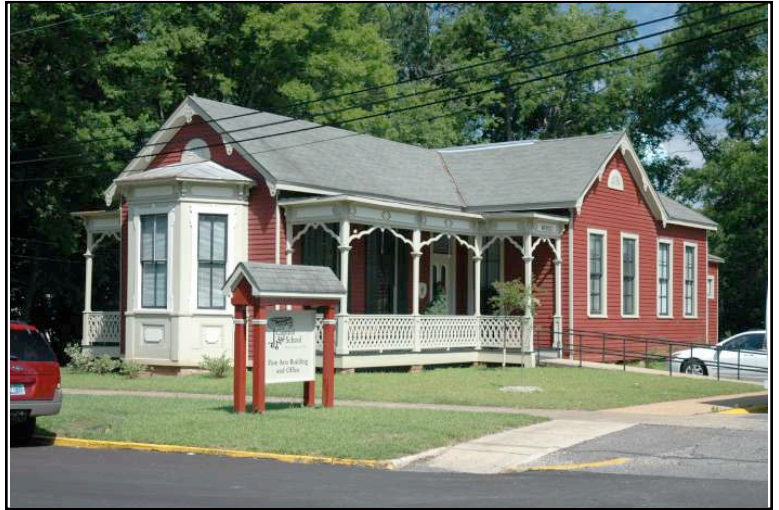
Irregular-shaped 1-story frame dwelling with a cross gable composition shingle roof; faces south, 1x7 bay core with a polygonal bay window at its facade, 2x4 bay projection to the east and rear extensions; less than full facade hipped porch with chamfered wood posts and sawn brackets and balustrade; entrance at east elevation within porch with transom flanked by single wood 2/2 double hung sash windows similar windows at facade and side elevations; wood weatherboard siding, brick foundation.

Condition: good _____ Integrity: good _____ Ownership: private _____ Category: Building _____
Historic Use: Single Dwelling - Non Farm _____ Current Use: Commerce/Trade _____
Function: Residence _____ Function: School _____

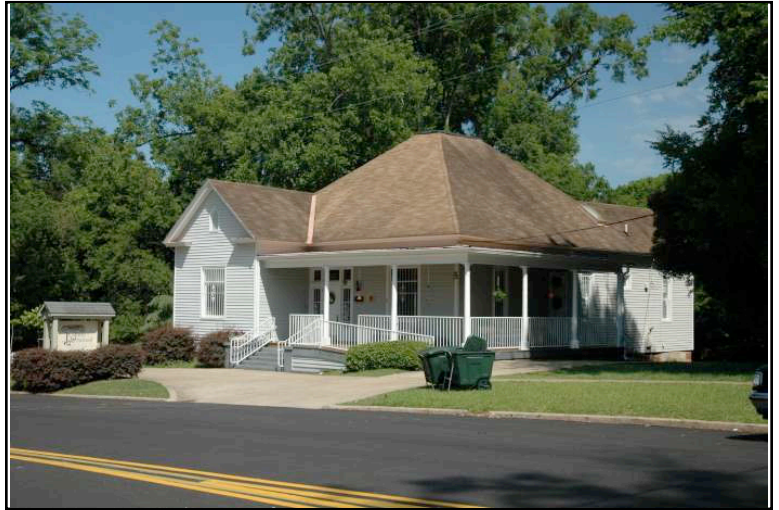
Rectangular 1-story frame dwelling with a hipped composition shingle roof with front-facing cross gable; faces south, 3x2 bay core with a front-facing gable projection at the west bay of its facade and a rear gable wing; less than full facade hipped porch with columns wraps to east elevation; central entrance at facade with transom & sidelights flanked by single wood 1/1 double hung sash windows, similar windows at side elevations; replacement vinyl siding (1990 ca.), brick foundation.

Condition: good _____ Integrity: fair _____ Ownership: private _____ Category: Building _____
 Historic Use: Single Dwelling - Non Farm _____ Current Use: Commerce/Trade _____
 Function: Residence _____ Function: School _____

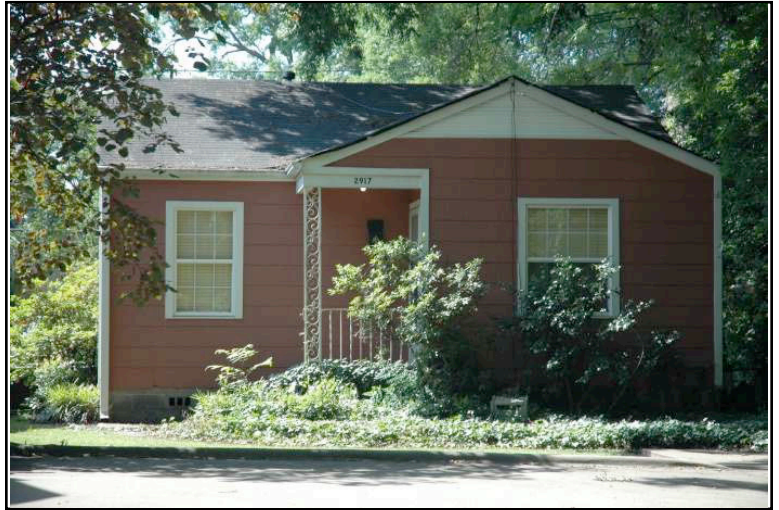
Rectangular 1-story frame dwelling with a cross gable composition shingle roof; faces north, 2x2 bay core with a front-facing gable projection at the west bay of its facade; entrance bay recessed porch with decorative metal support; entrance at east elevation within porch flanked by single wood 6/6 double hung sash windows, similar windows at side elevations; asbestos shingle siding; concrete block foundation.

Condition: good _____ Integrity: good _____ Ownership: private _____ Category: Building _____
 Historic Use: Single Dwelling - Non Farm _____ Current Use: Single Dwelling - Non Farm _____
 Function: Residence _____ Function: Residence _____

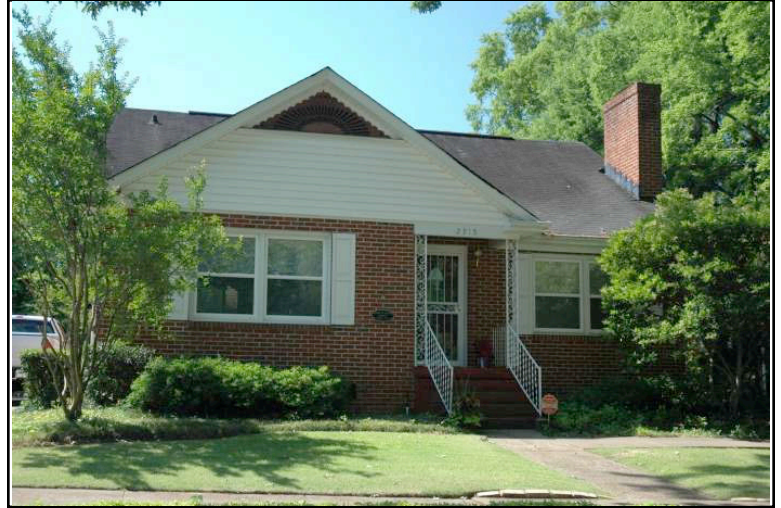
Rectangular 1-story brick veneer dwelling with a cross gable composition shingle roof, 1 exterior end chimney; faces north, 3x2 bay core with a front-facing gable projection at the east bay of its facade, rear extension; entrance bay recessed porch with decorative metal support; central entrance at facade flanked by double replacement 1/1 windows (1985 ca.), similar windows at side elevations; exposed brick veneer exterior walls; brick foundation.

Condition: good _____ Integrity: fair _____ Ownership: private _____ Category: Building _____
Historic Use: Single Dwelling - Non Farm _____ Current Use: Single Dwelling - Non Farm _____
Function: Residence _____ Function: Residence _____

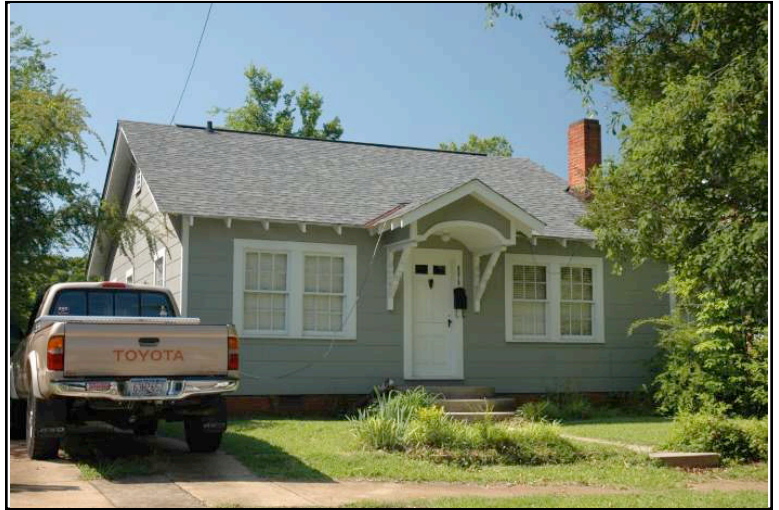
Rectangular 1-story frame dwelling with a side gable composition shingle roof with exposed rafter ends, 1 exterior end chimney; faces north, 3x2 bay core with small gable wing to west and rear extension; entrance bay gable hood supported by angle braces; central entrance at facade flanked by double wood 6/6 double hung sash windows, similar single windows at side elevations; replacement asbestos shingle siding (1955 ca.); brick foundation.

Condition: good _____ Integrity: good _____ Ownership: private _____ Category: Building _____
 Historic Use: Single Dwelling - Non Farm _____ Current Use: Single Dwelling - Non Farm _____
 Function: Residence _____ Function: Residence _____

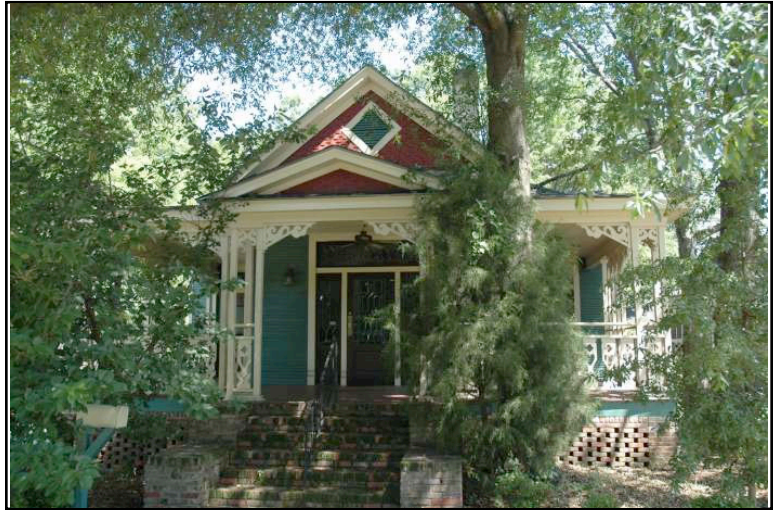
Irregular-shaped 1-story frame dwelling with a cross gable composition shingle roof; faces south, 3x5 bay core with rectangular bay widows at side elevations; full facade hipped porch with wood posts and sawn brackets and balustrade; central entrance at facade with leaded glass transom and sidelight flanked by recessed bays with single entrances, wood 2/2 double hung sash windows at facade and side elevations; wood weatherboard siding, brick foundation.

Condition: good _____ Integrity: excellent _____ Ownership: private _____ Category: Building _____
Historic Use: Single Dwelling - Non Farm _____ Current Use: Single Dwelling - Non Farm _____
Function: Residence _____ Function: Residence _____

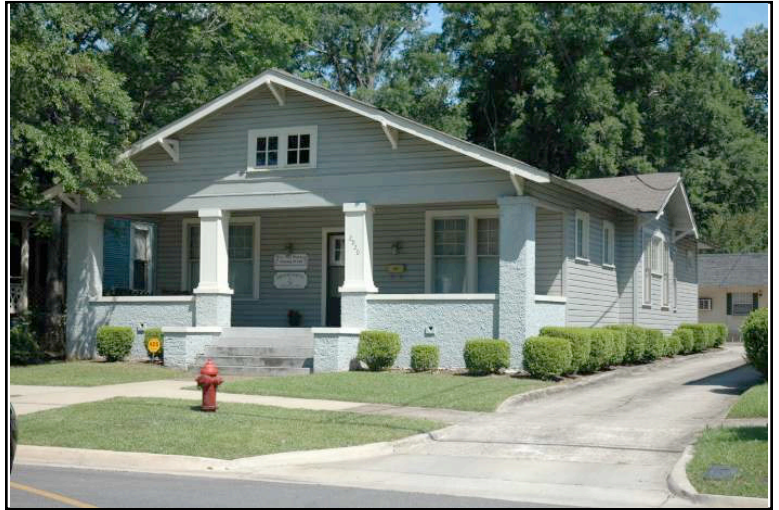
Rectangular 1-story frame dwelling with a hipped composition shingle roof with secondary cross gables and angle bracketed eaves; faces south, 3x3 bay core; full facade recessed porch with wood supports on brick pedestals and apron wall; central entrance at facade flanked by double wood 9/1 double hung sash windows, similar single and double windows at side elevations; wood novelty siding, stucco foundation.

Condition: good _____ Integrity: good _____ Ownership: private _____ Category: Building _____
 Historic Use: Single Dwelling - Non Farm _____ Current Use: Commerce/Trade _____
 Function: Residence _____ Function: Business/Professional Office _____

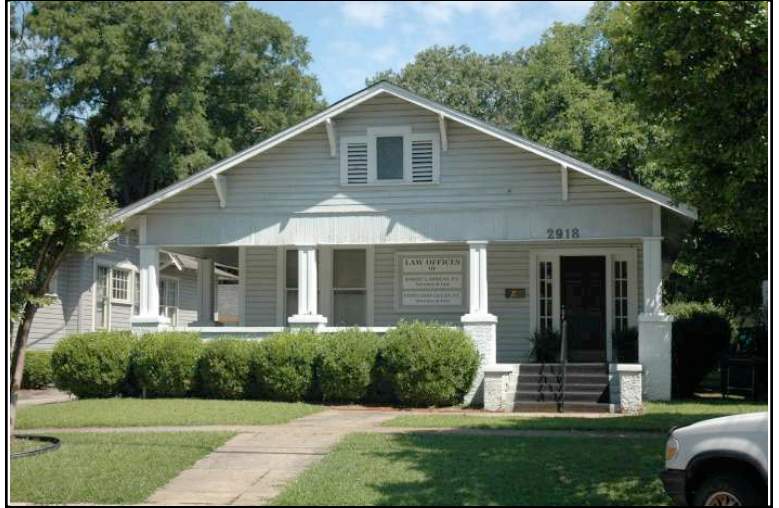
Rectangular 1-story frame dwelling with a hipped composition shingle roof with angle bracketed eaves; faces south, 2x3 bay core; full facade recessed porch with paired wood supports on brick pedestals and apron wall; entrance with sidelights at east bay of facade flanked by a double wood 1/1 double hung sash window, similar single and double windows at side elevations; wood novelty siding, stucco foundation.

Condition: good _____ Integrity: good _____ Ownership: private _____ Category: Building _____
Historic Use: Single Dwelling - Non Farm _____ Current Use: Commerce/Trade _____
Function: Residence _____ Function: Business/Professional Office _____

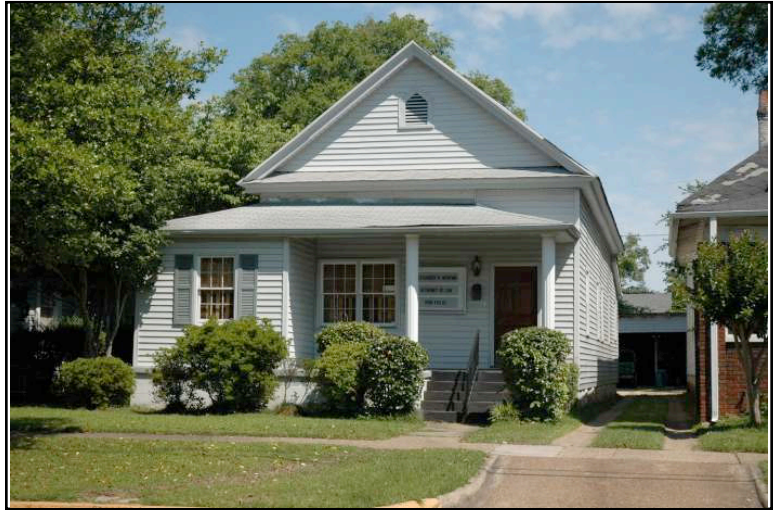
Rectangular 1-story frame dwelling with a front-facing gable composition shingle roof; faces south, 2x4 bay core with rear shed extension; full facade hipped porch with replacement aluminum columns with west bay now enclosed (ca. 1975); entrance at east bay of facade flanked by single and double replacement 6/6 windows (1975 ca.), similar single windows at side elevations; aluminum siding (1975 ca.), stucco foundation.

Condition: good _____ Integrity: fair _____ Ownership: private _____ Category: Building _____
 Historic Use: Single Dwelling - Non Farm _____ Current Use: Commerce/Trade _____
 Function: Residence _____ Function: Business/Professional Office _____

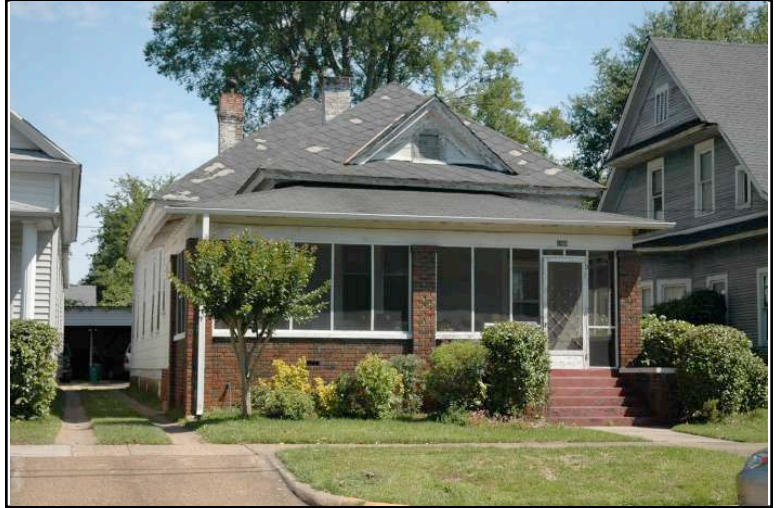
Rectangular 1-story frame dwelling with a hipped composition shingle roof with front-facing pedimented gable projection, 2 interior brick chimneys; faces south, 3x4 bay core with projecting bay at eastern bays of front; full facade hipped porch with brick piers and apron wall, modern insect screening; entrance with transom at east bay of facade flanked by a double double hung sash window and a single window, similar single windows at side elevations; replacement asbestos shingle siding (1955 ca.), brick foundation.

Condition: fair _____ Integrity: good _____ Ownership: private _____ Category: Building _____
 Historic Use: Single Dwelling - Non Farm _____ Current Use: Single Dwelling - Non Farm _____
 Function: Residence _____ Function: Residence _____

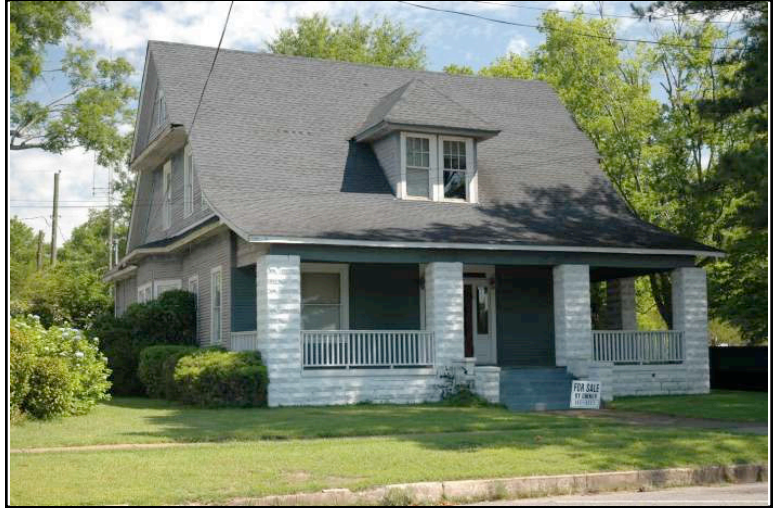
Rectangular 1.5-story frame dwelling with a side-gable composition shingle roof, central hipped dormer; faces south, 4x3 bay core with recessed bay at east bay of facade, secondary rear gable wing, polygonal bay windows at side elevations; full facade shed porch with patterned concrete block piers wraps to east elevation; slightly projecting central entrance with leaded glass transom and sidelights flanked single 1/1 double hung sash windows, similar single windows at side elevations; wood weatherboard siding; patterned concrete block foundation.

Condition: good _____ Integrity: good _____ Ownership: private _____ Category: Building _____
Historic Use: Single Dwelling - Non Farm _____ Current Use: Single Dwelling - Non Farm _____
Function: Residence _____ Function: Residence _____

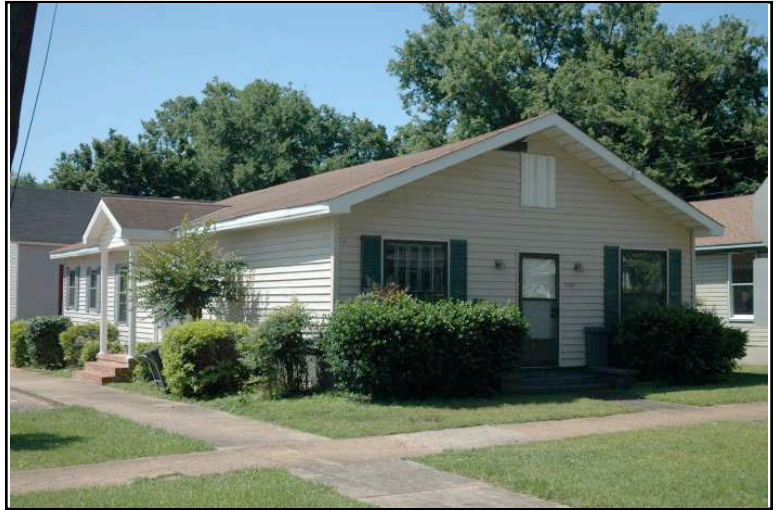
Rectangular 1-story frame dwelling with a front-facing gable composition shingle roof; faces north, 3x3 bay core; modern gable porch at east elevation; central entrance at facade flanked by single wood geometric double hung sash windows, similar windows at side elevations; replacement vinyl siding; brick foundation.

Condition: good _____ Integrity: poor _____ Ownership: private _____ Category: Building _____
Historic Use: Single Dwelling - Non Farm _____ Current Use: Commerce/Trade _____
Function: Residence _____ Function: Business/Professional Office _____

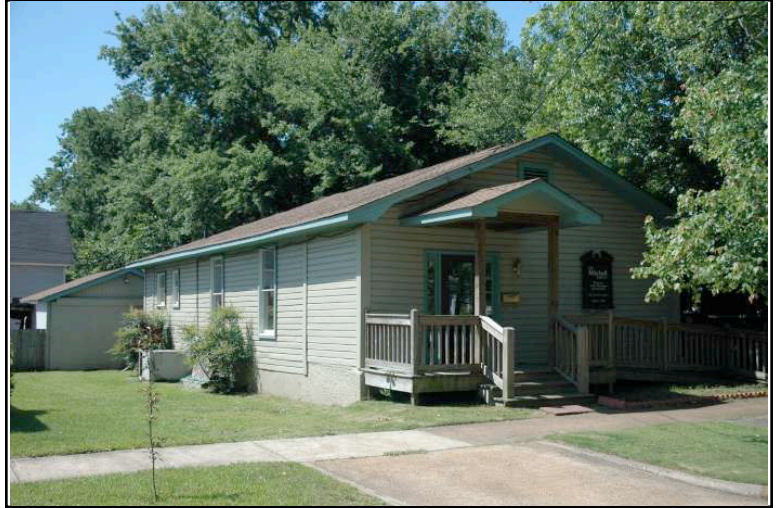
Rectangular 1-story frame dwelling with a front-facing gable composition shingle roof; faces north, 2x3 bay core; modern entrance bay gable porch; entrance at west bay of facade, west bay now blank, single replacement windows at side elevations; replacement vinyl siding; foundation not visible.

Condition: good _____ Integrity: poor _____ Ownership: private _____ Category: Building _____
Historic Use: Single Dwelling - Non Farm _____ Current Use: Commerce/Trade _____
Function: Residence _____ Function: Business/Professional Office _____

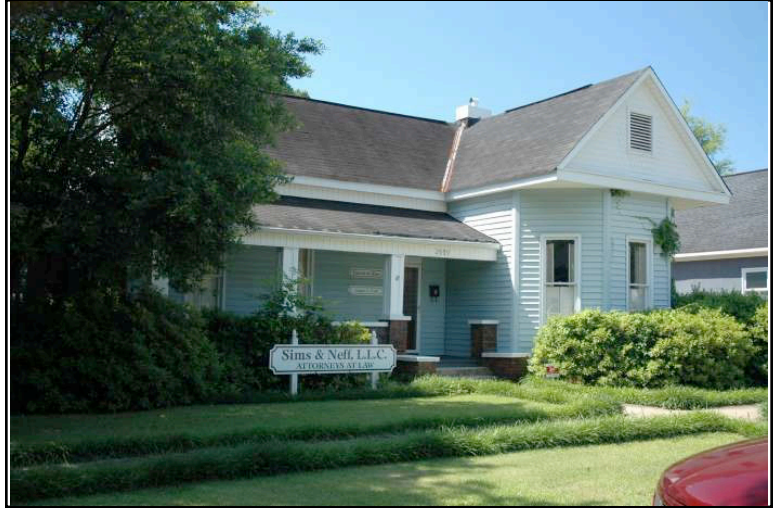
Rectangular 1-story frame dwelling with a cross pedimented gable gable composition shingle roof; faces north, 3x2 bay core with front-facing gable wing to the west with cutaway bay; less than full facade hipped porch with wood supports on brick pedestals (ca. 1925); off-center entrance at facade flanked by single wood 1/1 double hung sash windows, similar windows at side elevations; replacement aluminum siding (1975 ca.), historic wood shingles at gable end; brick foundation.

Condition: good _____ Integrity: fair _____ Ownership: private _____ Category: Building _____
 Historic Use: Single Dwelling - Non Farm _____ Current Use: Commerce/Trade _____
 Function: Residence _____ Function: Business/Professional Office _____

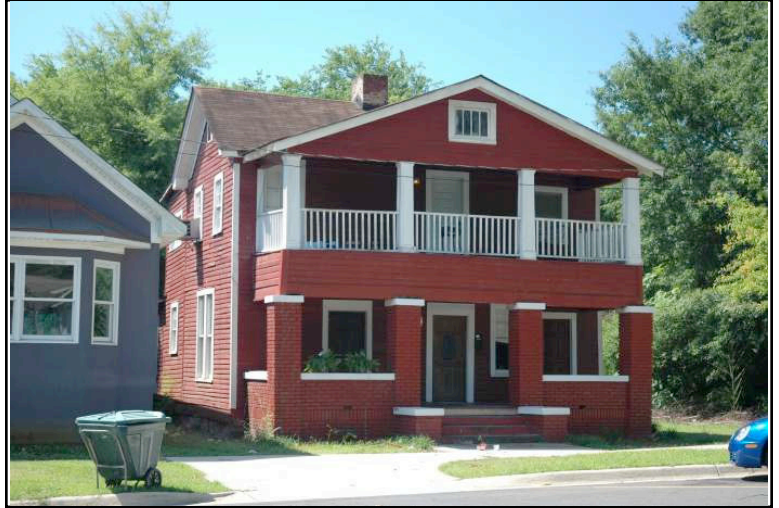
Rectangular 2-story frame dwelling with a side gable composition shingle roof; faces north, 4x2 bay core with rear shed extension; full facade 2-tier gable porch with brick pillars and apron wall at lower level and wood pillars at upper level; three entrances and a single wood 1/1 double hung sash window at 1st level, similar 1/1 and 6/6 windows at upper level and side elevations; wood weatherboard siding; brick foundation.

Condition: good _____ Integrity: good _____ Ownership: private _____ Category: Building _____
 Historic Use: Single Dwelling - Non Farm _____ Current Use: Multiple Dwelling _____
 Function: Residence _____ Function: Apartment Building _____
