Tuscaloosa

Greater Downtown Study
Historic Resource Survey - 2006

Survey Number: _____ 1 _____
Historic name(s): House, Not Named
Common name: Southeast Appraisers
Location: University Blvd., 2720

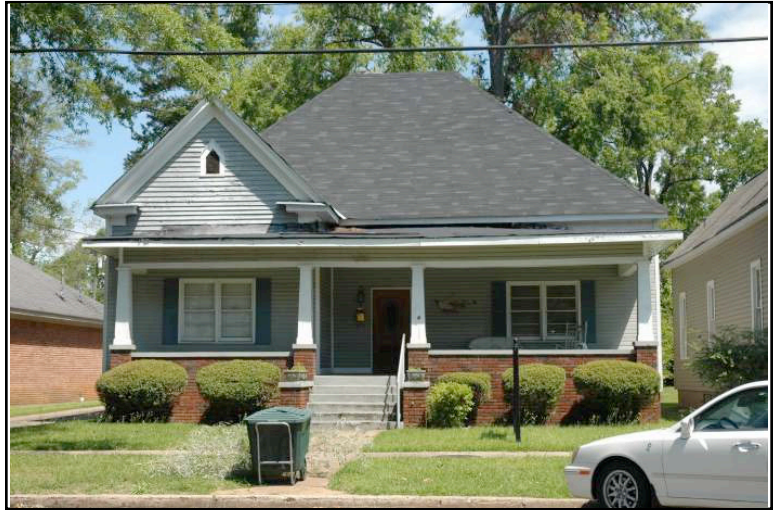
Rectangular 1-story frame dwelling with a hipped composition shingle roof with a cross gable; faces south, 3x3 bay core with front-facing gable projection to the west; full facade hipped porch with tapered wood supports on brick pedestals (ca. 1925); central entrance at facade flanked by double wood horizontal 2/2 replacement windows (1955 ca.), similar single windows at side elevations; wood novelty siding; brick foundation.

Condition: good _____ Integrity: fair _____ Ownership: private _____ Category: Building _____
 Historic Use: Single Dwelling - Non Farm _____ Current Use: Commerce/Trade _____
 Function: Residence _____ Function: Business/Professional Office _____

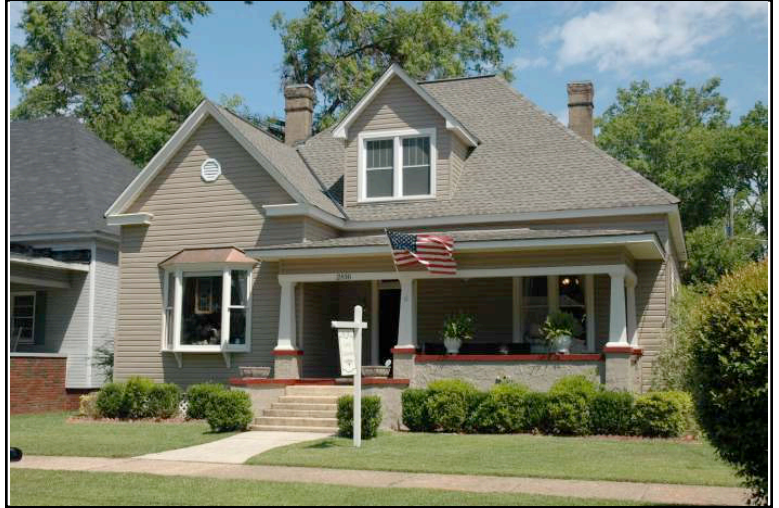
Rectangular 1.5-story frame dwelling with a hipped composition shingle roof with a cross gable and central gable dormer (modern); faces south, 3x3 bay core with front-facing gable projection to the west; less than full facade hipped porch with tapered wood supports on brick pedestals (ca. 1925); central entrance at facade with transom flanked to the west by a modern bay window (2000 ca.) and to the east by a double wood 1/1 double hung sash window, similar single windows at side elevations; replacement vinyl siding; brick foundation.

Condition: good _____ Integrity: fair _____ Ownership: private _____ Category: Building _____
 Historic Use: Single Dwelling - Non Farm _____ Current Use: Commerce/Trade _____
 Function: Residence _____ Function: Business/Professional Office _____

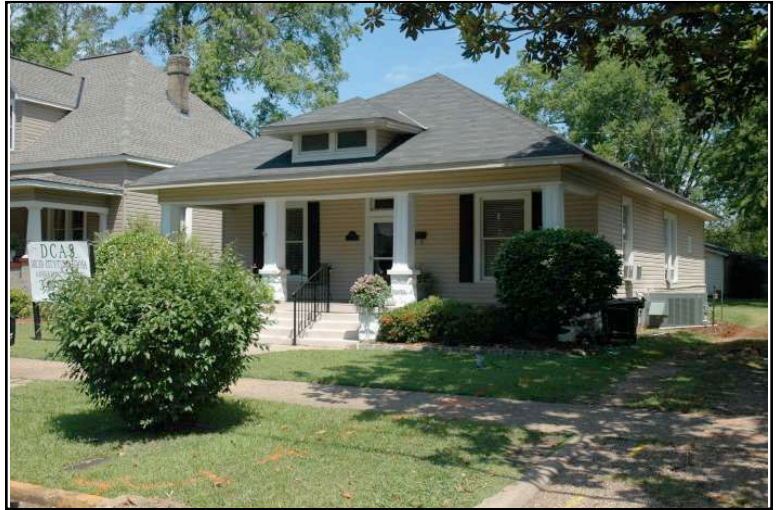
Rectangular 1-story frame dwelling with a hipped composition shingle roof and a decorative hipped dormer; faces south, 3x2 bay core; full facade recessed porch with wood supports on patterned concrete block pedestals; central entrance at facade with transom flanked by single wood 1/1 double hung sash windows, similar single and double windows at side elevations; replacement vinyl siding; concrete block foundation.

Condition: good _____ Integrity: good _____ Ownership: private _____ Category: Building _____
Historic Use: Single Dwelling - Non Farm _____ Current Use: Commerce/Trade _____
Function: Residence _____ Function: Business/Professional Office _____

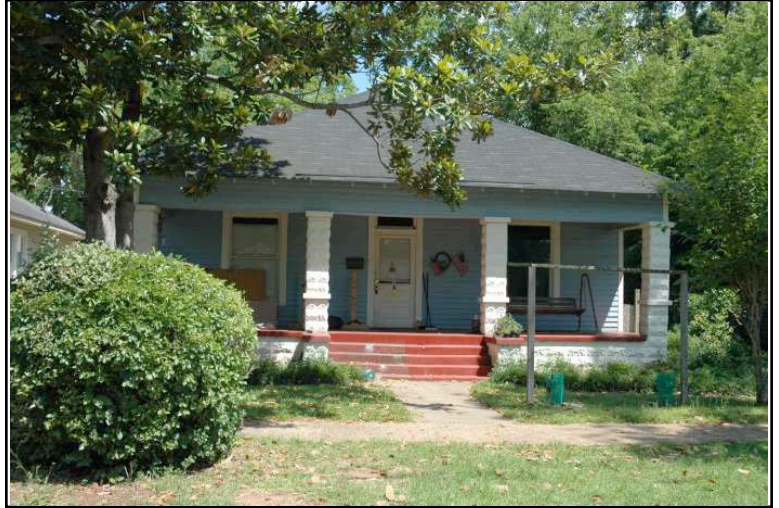
Rectangular 1-story frame dwelling with a hipped composition shingle roof; faces south, 3x2 bay core; full facade recessed porch with patterned concrete block pillars; central entrance at facade with transom flanked by single wood 1/1 double hung sash windows, similar single and double windows at side elevations; wood novelty siding; concrete block foundation.

Condition: good _____ Integrity: good _____ Ownership: private _____ Category: Building _____
Historic Use: Single Dwelling - Non Farm _____ Current Use: Single Dwelling - Non Farm _____
Function: Residence _____ Function: Residence _____

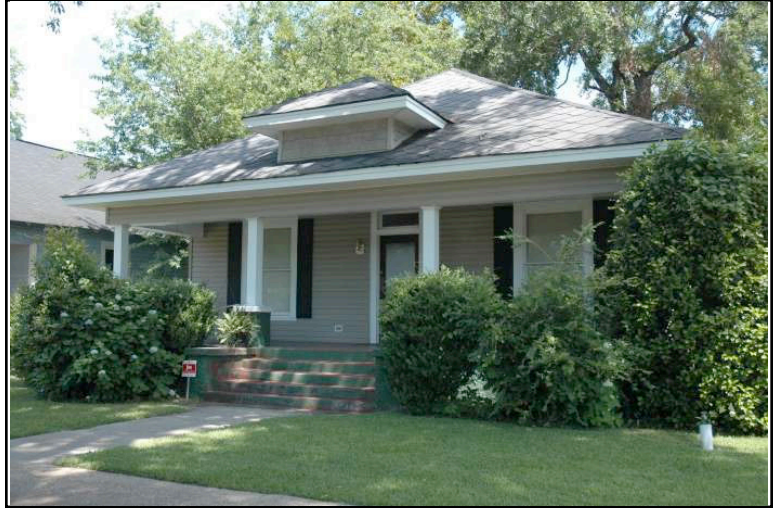
Rectangular 1-story frame dwelling with a hipped composition shingle roof and central decorative hipped dormer; faces south, 3x2 bay core; full facade recessed porch with wood supports on brick pedestals; central entrance at facade with transom flanked by single wood 1/1 double hung sash windows, similar single and double windows at side elevations; replacement vinyl siding; brick foundation.

Condition: good _____ Integrity: good _____ Ownership: private _____ Category: Building _____
 Historic Use: Single Dwelling - Non Farm _____ Current Use: Single Dwelling - Non Farm _____
 Function: Residence _____ Function: Residence _____

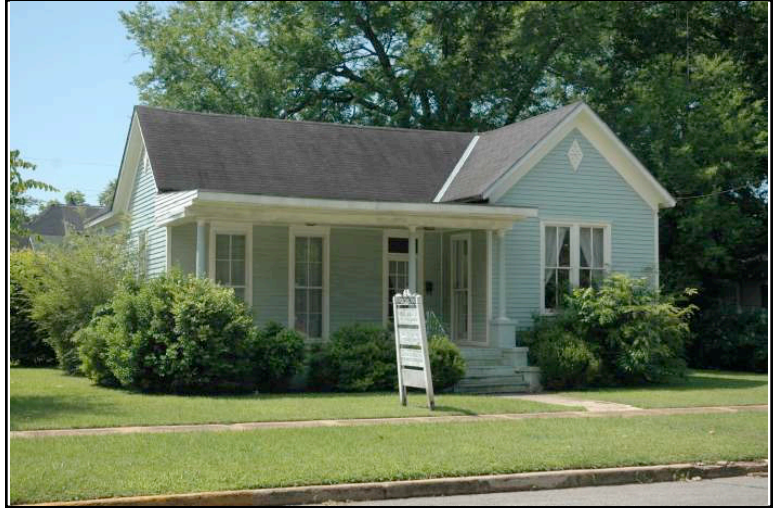
L-shaped 1-story frame dwelling with a cross gable composition shingle roof; faces north, 4x1 bay core with front-facing gable wing to east, rear extension; less than full facade shed porch with wood columns on brick pedestals; off center entrance at facade with transom flanked by single wood 1/1 double hung sash windows, similar windows at side elevations; plain weatherboard siding; brick foundation.

Condition: good _____ Integrity: good _____ Ownership: private _____ Category: Building _____
Historic Use: Single Dwelling - Non Farm _____ Current Use: Commerce/Trade _____
Function: Residence _____ Function: Business/Professional Office _____

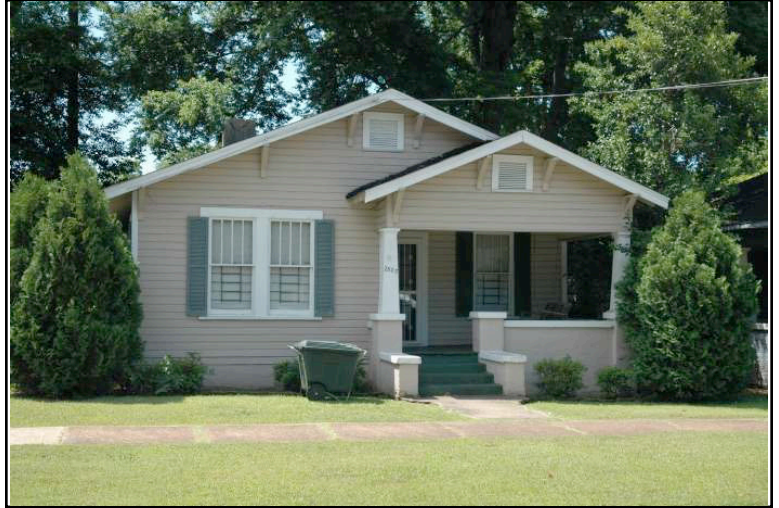
Rectangular 1-story frame dwelling with a front-facing gable composition shingle roof; faces north, 3x4 bay core with 2 eastern bays of facade recessed; less than full facade gable porch with wood supports on brick pedestals; off center entrance at facade flanked by single and double wood geometric double hung sash windows, similar windows at side elevations; wood novelty siding; stucco foundation.

Condition: good _____ Integrity: good _____ Ownership: private _____ Category: Building _____
Historic Use: Single Dwelling - Non Farm _____ Current Use: Single Dwelling - Non Farm _____
Function: Residence _____ Function: Residence _____

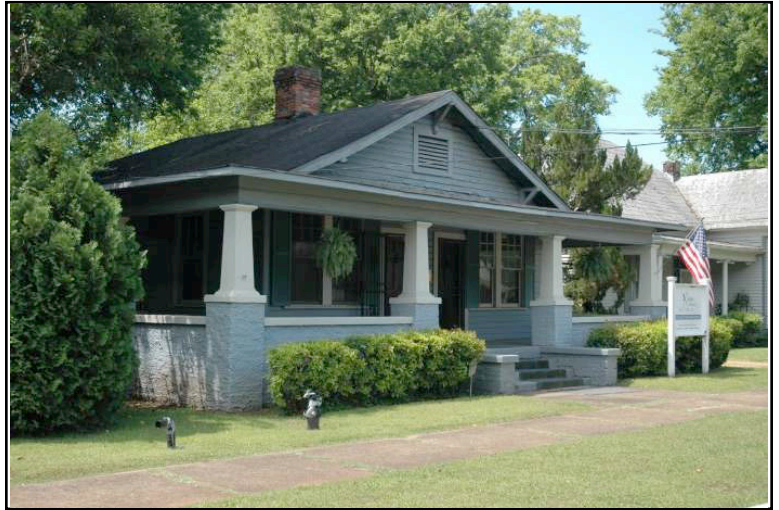
Rectangular 1-story frame dwelling with a front-facing gable composition shingle roof with angle bracketed eaves, central brick chimney; faces north, 4x4 bay core; full facade hipped porch with tapered wood supports on brick pedestals; paired central entrances at facade flanked by double wood 9/1 double hung sash windows, similar single windows at side elevations; wood novelty siding; stucco foundation.

Condition: good _____ Integrity: good _____ Ownership: private _____ Category: Building _____
Historic Use: Single Dwelling - Non Farm _____ Current Use: Commerce/Trade _____
Function: Residence _____ Function: Business/Professional Office _____

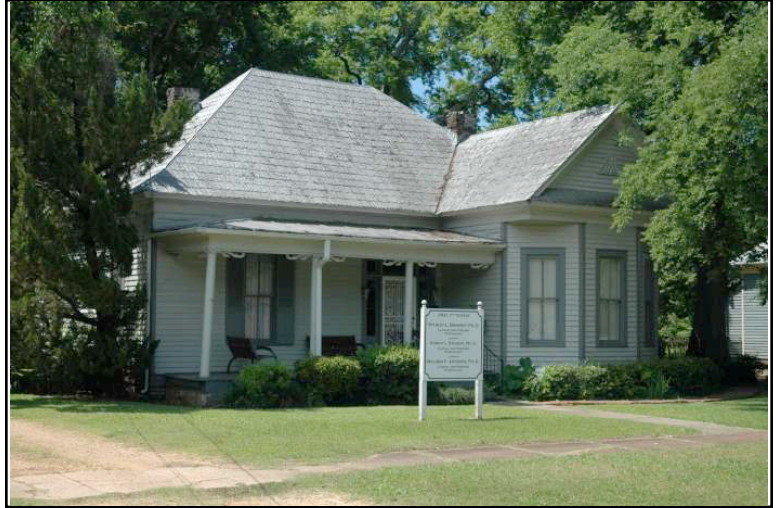
Rectangular 1-story frame dwelling with a hipped pressed metal shingle roof with a front-facing pedimented gable to the west; faces north, 3x2 bay core with pedimented gable cutaway bay wing at the west bay of its facade; less than full facade hipped porch with columns and sawn trim; central entrance with transom & sidelights at facade flanked by single wood 2/2 double hung sash windows, similar windows at side elevations; plain weatherboard siding; brick foundation.

Condition: good _____ Integrity: good _____ Ownership: private _____ Category: Building _____
Historic Use: Single Dwelling - Non Farm _____ Current Use: Commerce/Trade _____
Function: Residence _____ Function: Business/Professional Office _____

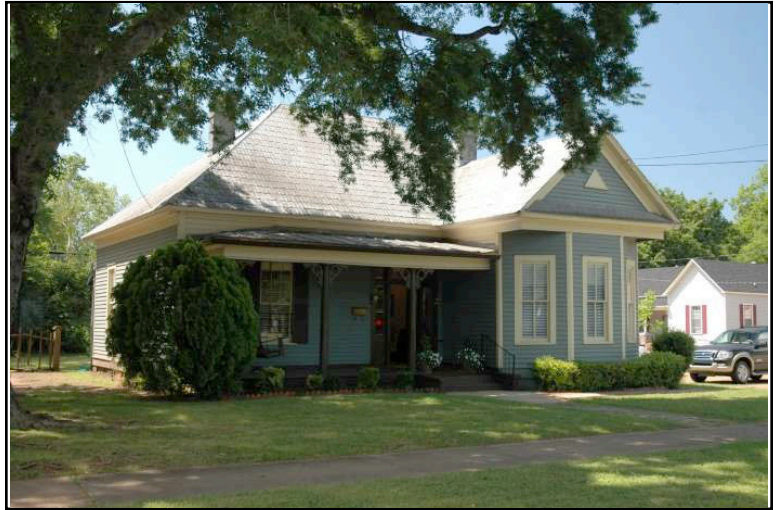
Rectangular 1-story frame dwelling with a hipped pressed metal shingle roof with a front-facing pedimented gable to the west; faces north, 3x2 bay core with pedimented gable cutaway bay wing at the west bay of its facade; less than full facade hipped porch with columns and sawn trim; central entrance with transom & sidelights at facade flanked by single wood 2/2 double hung sash windows, similar windows at side elevations; plain weatherboard siding; brick foundation.

Condition: good _____ Integrity: good _____ Ownership: private _____ Category: Building _____
Historic Use: Single Dwelling - Non Farm _____ Current Use: Commerce/Trade _____
Function: Residence _____ Function: Business/Professional Office _____

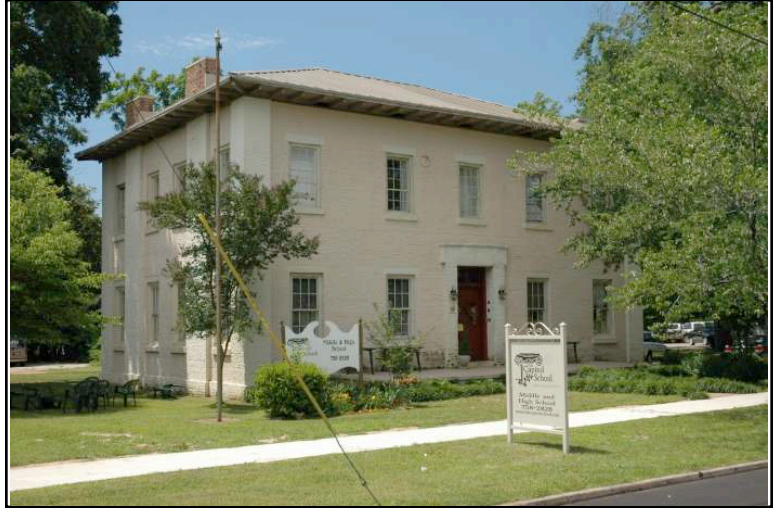
Rectangular 2-story stucco building with a hipped industrial metal roof (1995 ca.), 4 interior end chimneys; faces north, 5x4 bay core; no porch; central entrance at facade with transom with raised surround flanked by single wood 6/6 double hung sash windows, similar windows at side elevations; painted brick exterior walls with pilasters at corners; brick foundation.

Condition: good _____ Integrity: good _____ Ownership: private _____ Category: Building _____
Historic Use: Government _____ Current Use: Commerce/Trade _____
Function: Jail _____ Function: School _____

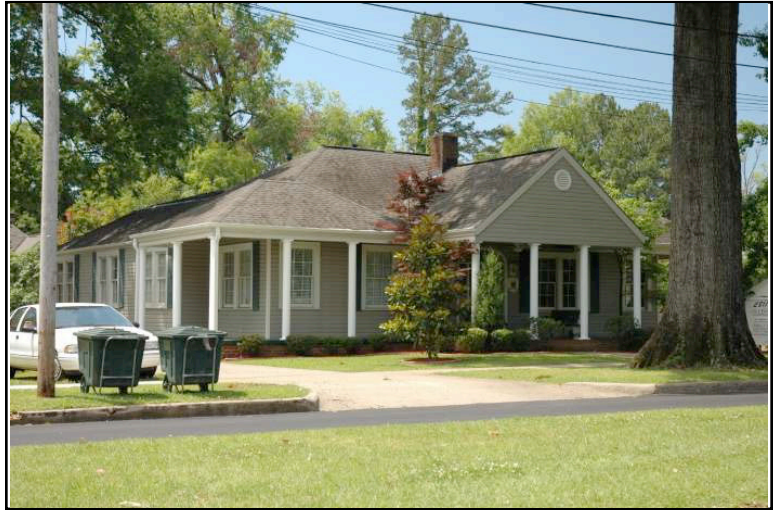
Rectangular 1-story frame dwelling with a hipped composition shingle roof; faces north.

Condition: good _____ Integrity: fair _____ Ownership: private _____ Category: Building _____
 Historic Use: Single Dwelling - Non Farm _____ Current Use: Commerce/Trade _____
 Function: Residence _____ Function: Business/Professional Office _____

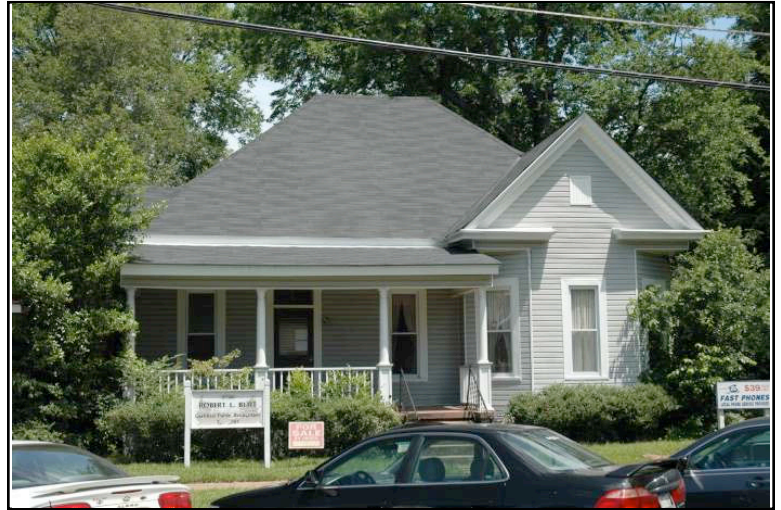
Rectangular 1-story frame dwelling with a hipped composition shingle roof with a front-facing cross gable projection at its east bay; faces south.

Condition: good _____ Integrity: fair _____ Ownership: private _____ Category: Building _____
 Historic Use: Single Dwelling - Non Farm _____ Current Use: Commerce/Trade _____
 Function: Residence _____ Function: Business/Professional Office _____

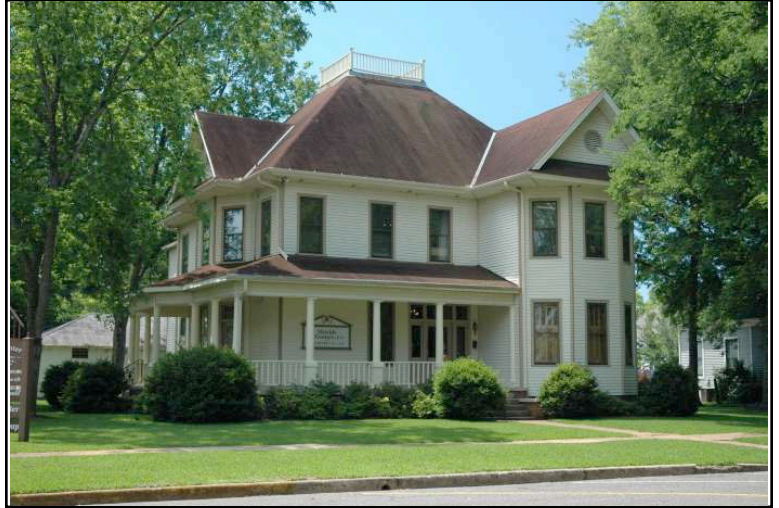
Rectangular 2-story frame dwelling with a hipped composition shingle roof with deck and a front-facing cross gable projection at its west bay; faces north.

Condition: good _____ Integrity: fair _____ Ownership: private _____ Category: Building _____
 Historic Use: Single Dwelling - Non Farm _____ Current Use: Commerce/Trade _____
 Function: Residence _____ Function: Business/Professional Office _____

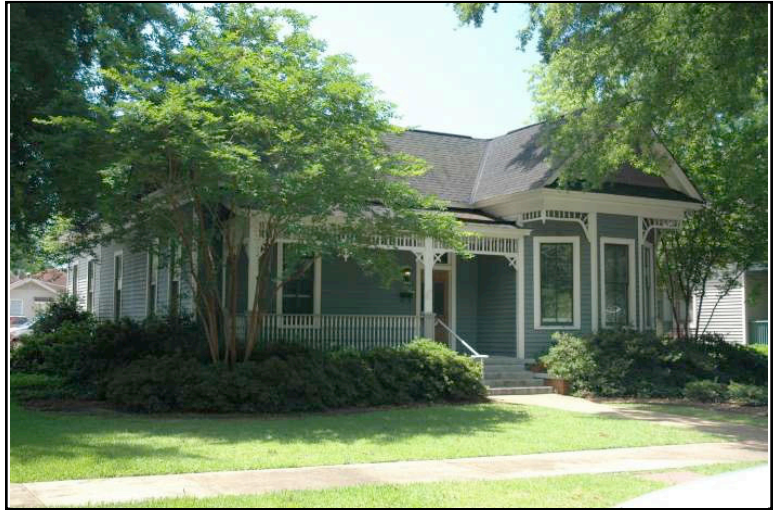
Rectangular 1-story frame dwelling with a hipped composition shingle roof with front-facing cross gable projection at its west bay; faces north.

Condition: good _____ Integrity: good _____ Ownership: private _____ Category: Building _____
 Historic Use: Single Dwelling - Non Farm _____ Current Use: Commerce/Trade _____
 Function: Residence _____ Function: Business/Professional Office _____

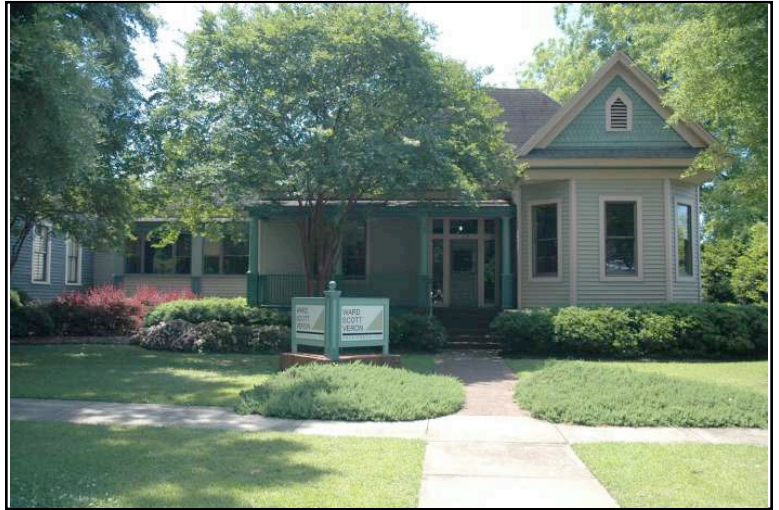
Rectangular 1-story frame dwelling with a hipped composition shingle roof with front-facing cross gable projection at its west bay; faces north; now connected to house to the east by an infill structure.

Condition: good _____ Integrity: good _____ Ownership: private _____ Category: Building _____
Historic Use: Single Dwelling - Non Farm _____ Current Use: Commerce/Trade _____
Function: Residence _____ Function: Business/Professional Office _____

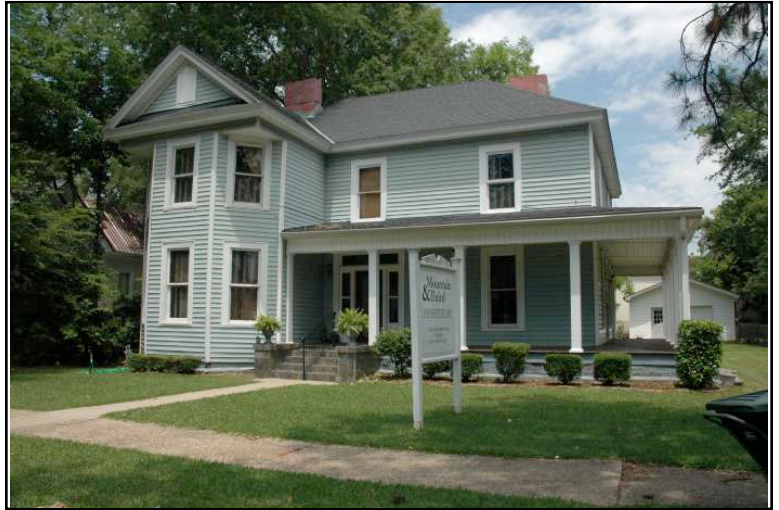
Rectangular 2-story frame dwelling with a hipped composition shingle roof with front-facing cross gable projection at its west bay; faces south.

Condition: good _____ Integrity: fair _____ Ownership: private _____ Category: Building _____
 Historic Use: Single Dwelling - Non Farm _____ Current Use: Commerce/Trade _____
 Function: Residence _____ Function: Business/Professional Office _____

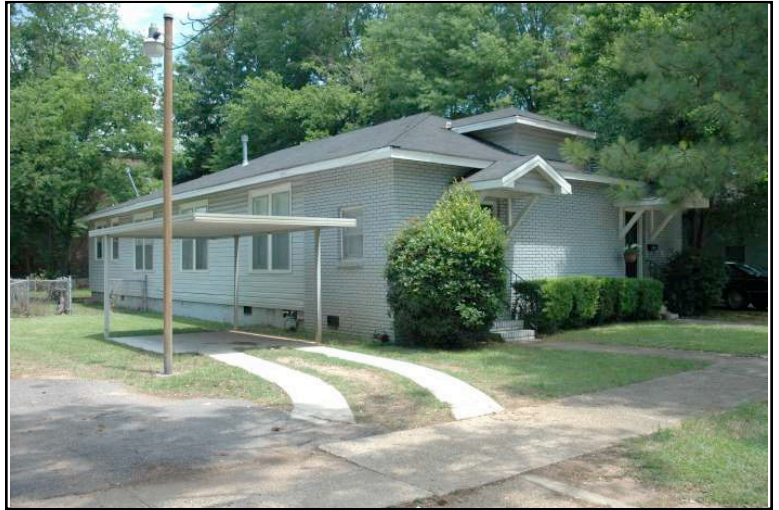
Rectangular 1-story frame dwelling with a hipped composition shingle roof with a central decorative hipped dormer; faces south.

Condition: good _____ Integrity: poor _____ Ownership: private _____ Category: Building _____
 Historic Use: Single Dwelling - Non Farm _____ Current Use: Commerce/Trade _____
 Function: Residence _____ Function: Business/Professional Office _____

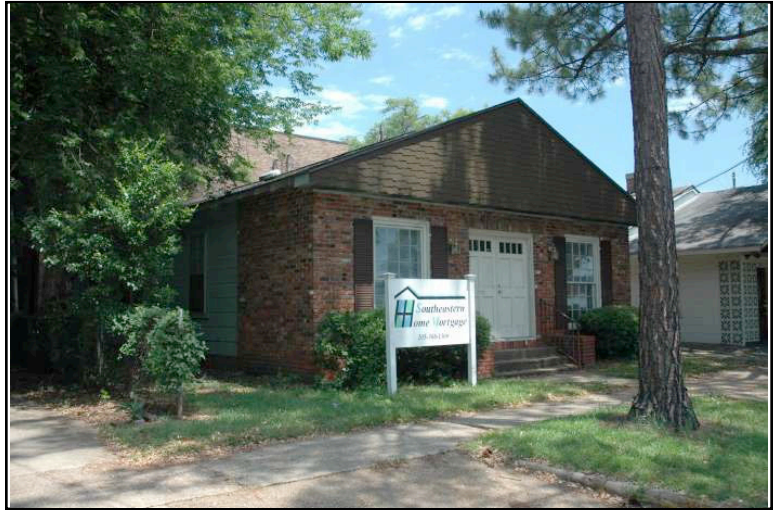
Rectangular 1-story frame dwelling with a front-facing gable composition shingle roof; faces south.

Condition: good _____ Integrity: poor _____ Ownership: private _____ Category: Building _____
 Historic Use: Single Dwelling - Non Farm _____ Current Use: Commerce/Trade _____
 Function: Residence _____ Function: Business/Professional Office _____

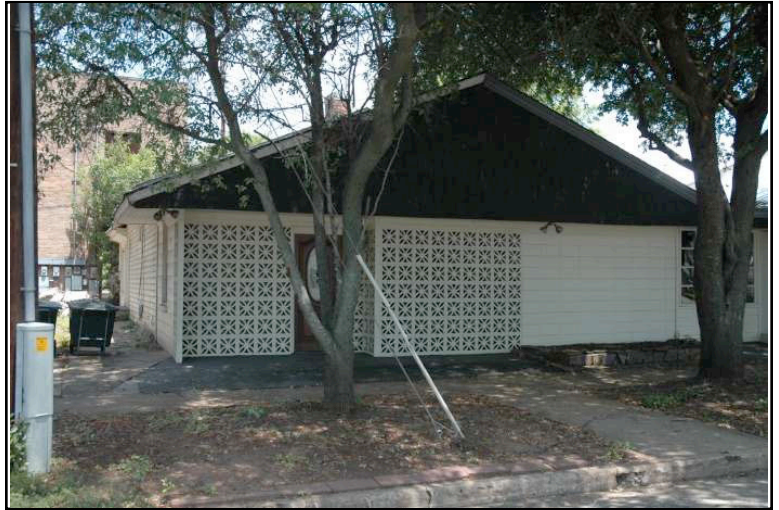
Rectangular 1-story frame dwelling with a front-facing gable composition shingle roof; faces south.

Condition: good _____ Integrity: poor _____ Ownership: private _____ Category: Building _____
 Historic Use: Single Dwelling - Non Farm _____ Current Use: Commerce/Trade _____
 Function: Residence _____ Function: Business/Professional Office _____

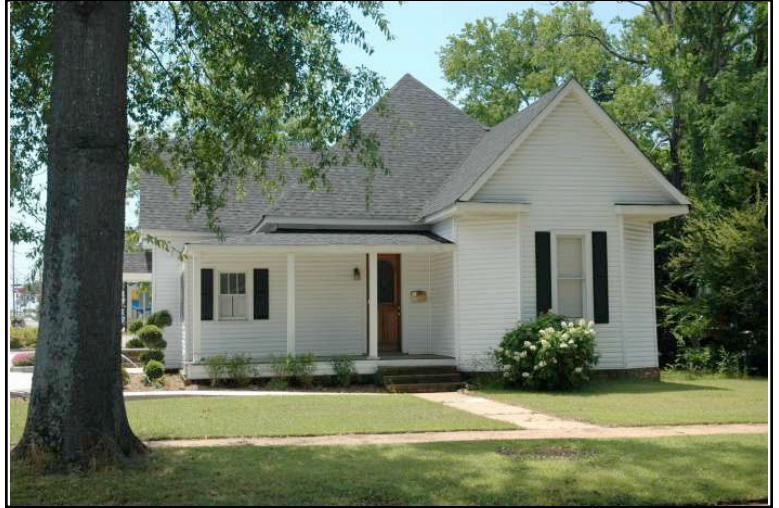
Rectangular 1-story frame dwelling with a hipped composition shingle roof with front-facing cross gable projection at its west bay; faces north.

Condition: good _____ Integrity: fair _____ Ownership: private _____ Category: Building _____
 Historic Use: Single Dwelling - Non Farm _____ Current Use: Commerce/Trade _____
 Function: Residence _____ Function: Business/Professional Office _____

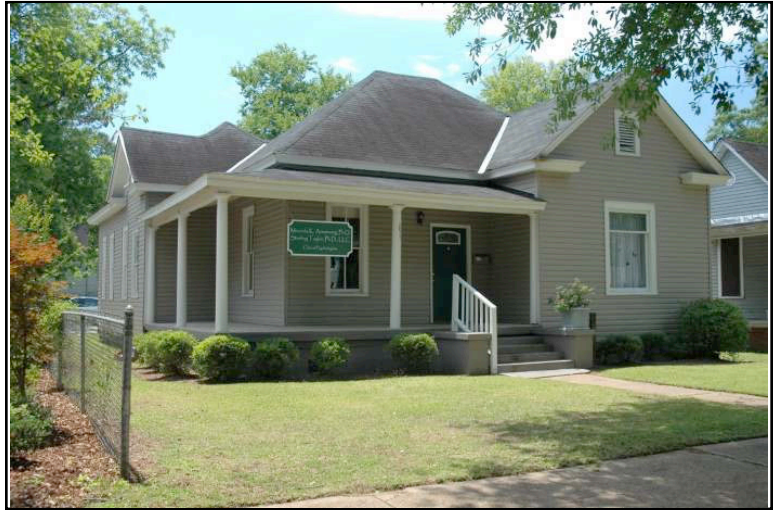
Rectangular 1-story frame dwelling with a hipped composition shingle roof with front-facing cross gable projection at its west bay and a side facing gable to the east; faces north.

Condition: good _____ Integrity: good _____ Ownership: private _____ Category: Building _____
 Historic Use: Single Dwelling - Non Farm _____ Current Use: Commerce/Trade _____
 Function: Residence _____ Function: Business/Professional Office _____

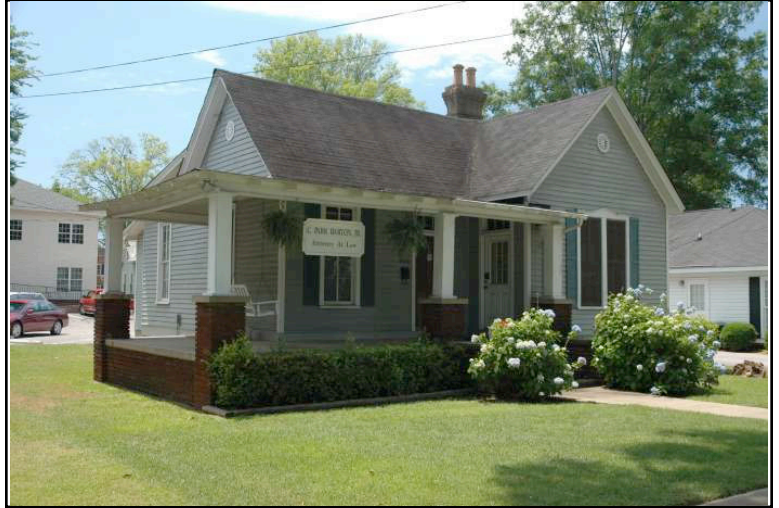
Rectangular 1-story frame dwelling with a cross gable composition shingle roof with front-facing cross gable projection at its west bay; faces north.

Condition: good Integrity: good Ownership: private Category: Building
 Historic Use: Single Dwelling - Non Farm Current Use: Commerce/Trade
 Function: Residence Function: Business/Professional Office

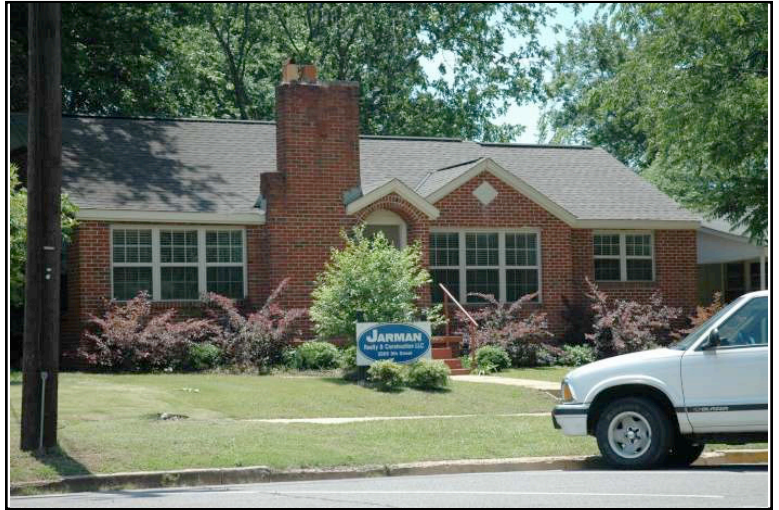
Rectangular 1-story brick veneer dwelling with a side gable composition shingle roof; faces north.

Condition: good _____ Integrity: good _____ Ownership: private _____ Category: Building _____
 Historic Use: Single Dwelling - Non Farm _____ Current Use: Commerce/Trade _____
 Function: Residence _____ Function: Business/Professional Office _____

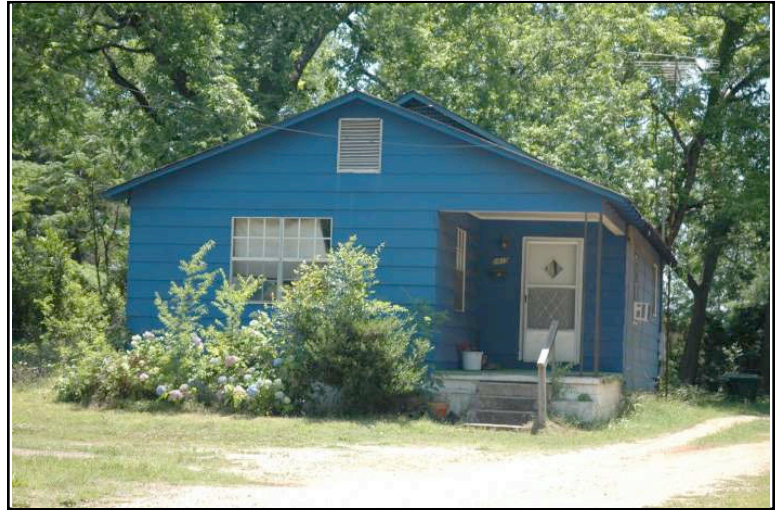
Rectangular 1-story frame dwelling with a front-facing gable composition shingle roof; faces north.

Condition: fair _____ Integrity: poor _____ Ownership: private _____ Category: Building _____
 Historic Use: Single Dwelling - Non Farm _____ Current Use: Single Dwelling - Non Farm _____
 Function: Residence _____ Function: Residence _____

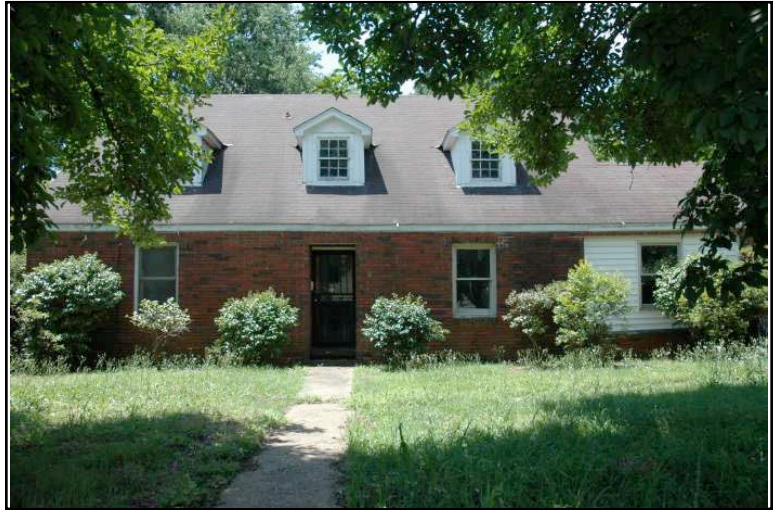
Rectangular 1.5-story brick veneer dwelling with a side gable composition shingle roof; faces east.

Condition: fair _____ Integrity: fair _____ Ownership: private _____ Category: Building _____
 Historic Use: Single Dwelling - Non Farm _____ Current Use: Single Dwelling - Non Farm _____
 Function: Residence _____ Function: Residence _____

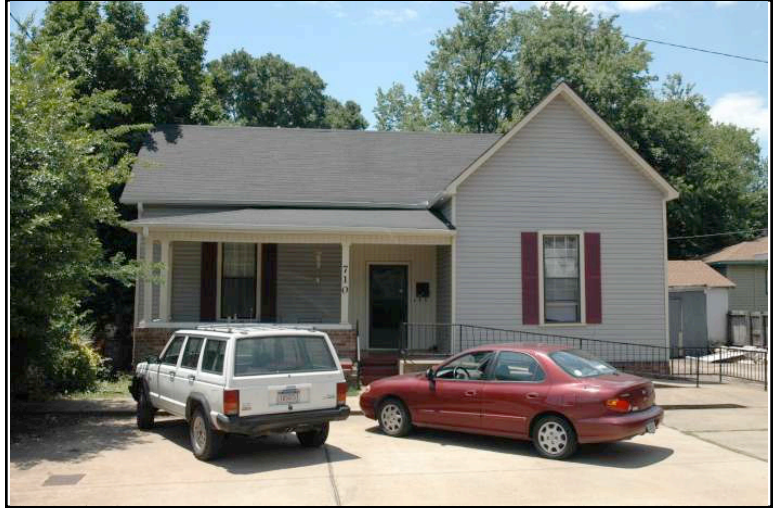
L-shaped 1-story frame dwelling with a cross gable composition shingle roof; faces east.

Condition: good _____ Integrity: fair _____ Ownership: private _____ Category: Building _____
 Historic Use: Single Dwelling - Non Farm _____ Current Use: Commerce/Trade _____
 Function: Residence _____ Function: Business/Professional Office _____

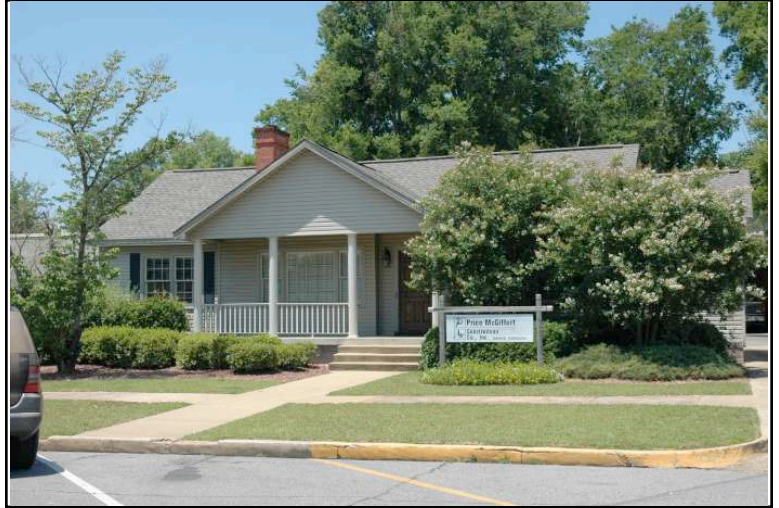
Rectangular 1-story frame dwelling with a side gable composition shingle roof; faces south.

Condition: good Integrity: fair Ownership: private Category: Building
 Historic Use: Single Dwelling - Non Farm Current Use: Commerce/Trade
 Function: Residence Function: Business/Professional Office

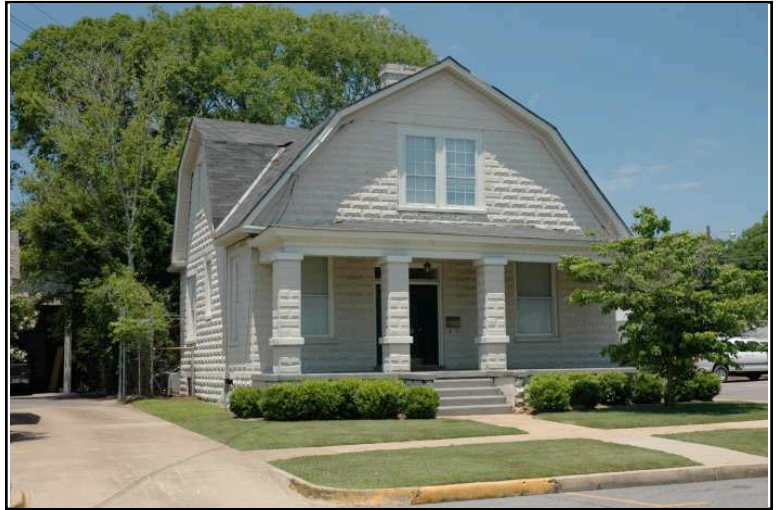
Rectangular 1.5-story patterned concrete block dwelling with a gross gambrell composition shingle roof; faces south.

Condition: good _____ Integrity: good _____ Ownership: private _____ Category: Building _____
 Historic Use: Single Dwelling - Non Farm _____ Current Use: Single Dwelling - Non Farm _____
 Function: Residence _____ Function: Residence _____

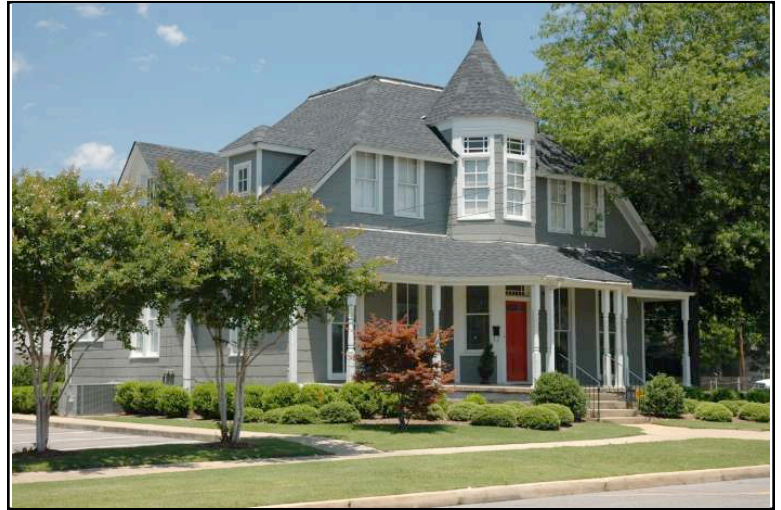
Rectangular 2-story frame dwelling with a hipped composition shingle roof with deck; faces south.

Condition: good _____ Integrity: good _____ Ownership: private _____ Category: Building _____
 Historic Use: Single Dwelling - Non Farm _____ Current Use: Commerce/Trade _____
 Function: Residence _____ Function: Business/Professional Office _____

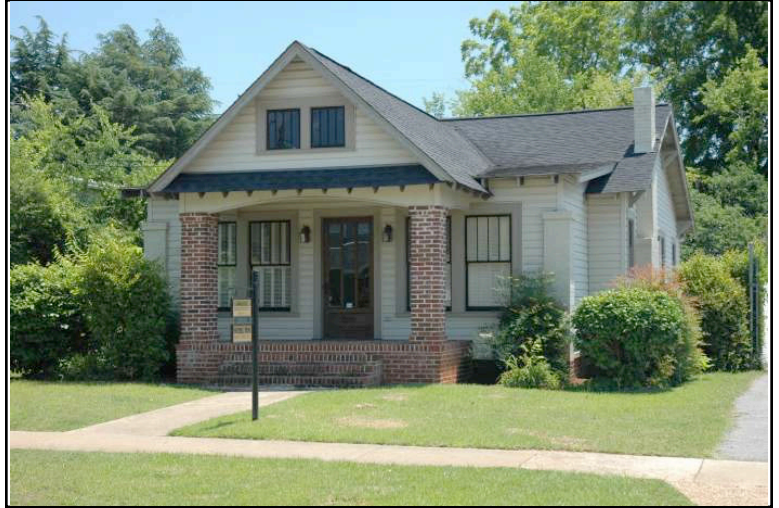
Rectangular 1-story frame dwelling with a side gable composition shingle roof; faces north.

Condition: good _____ Integrity: good _____ Ownership: private _____ Category: Building _____
 Historic Use: Single Dwelling - Non Farm _____ Current Use: Commerce/Trade _____
 Function: Residence _____ Function: Business/Professional Office _____

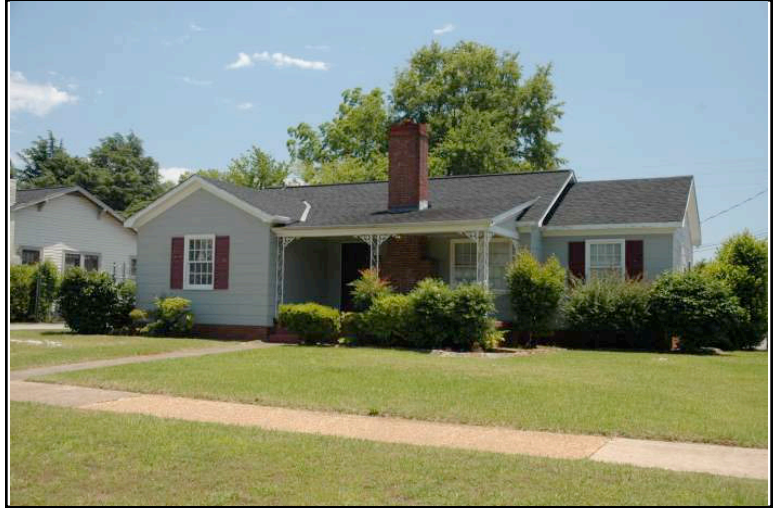
Rectangular 1-story frame dwelling with a side gable composition shingle roof; faces north.

Condition: good _____ Integrity: good _____ Ownership: private _____ Category: Building _____
 Historic Use: Single Dwelling - Non Farm _____ Current Use: Commerce/Trade _____
 Function: Residence _____ Function: Business/Professional Office _____

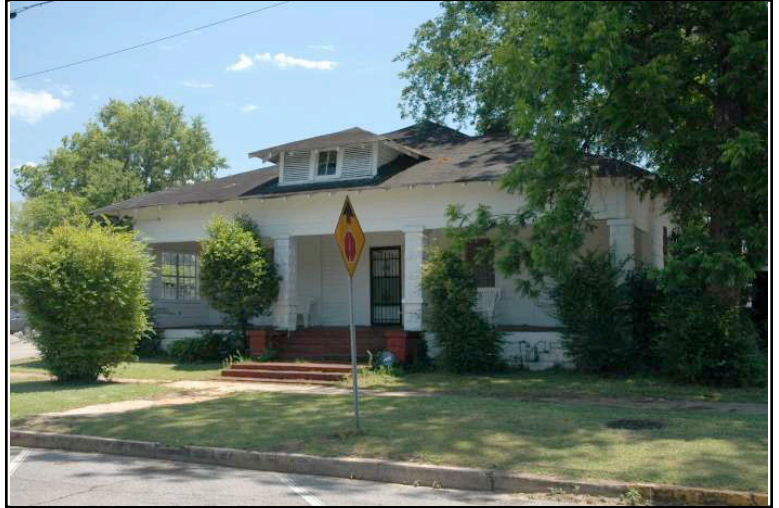
Rectangular 1-story frame dwelling with a hipped composition shingle roof; faces north.

Condition: good _____ Integrity: fair _____ Ownership: private _____ Category: Building _____
 Historic Use: Single Dwelling - Non Farm _____ Current Use: Single Dwelling - Non Farm _____
 Function: Residence _____ Function: Residence _____

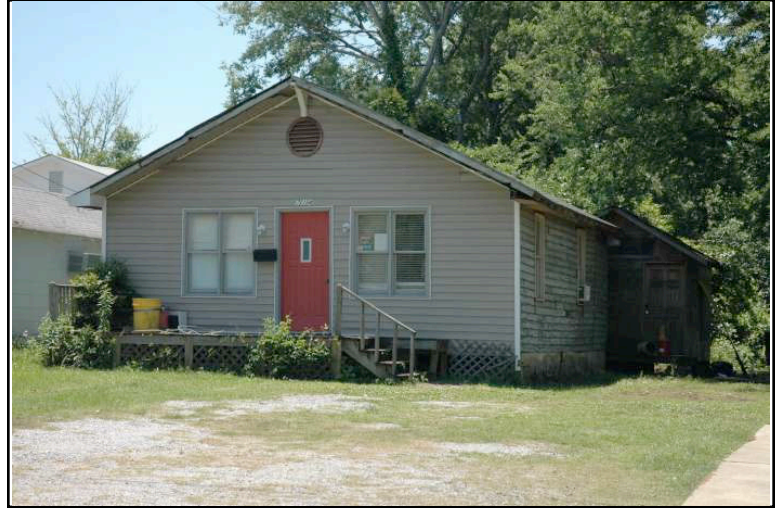
Rectangular 1-story frame dwelling with a front-facing gable composition shingle roof; faces east.

Condition: good _____ Integrity: fair _____ Ownership: private _____ Category: Building _____
 Historic Use: Single Dwelling - Non Farm _____ Current Use: Single Dwelling - Non Farm _____
 Function: Residence _____ Function: Residence _____

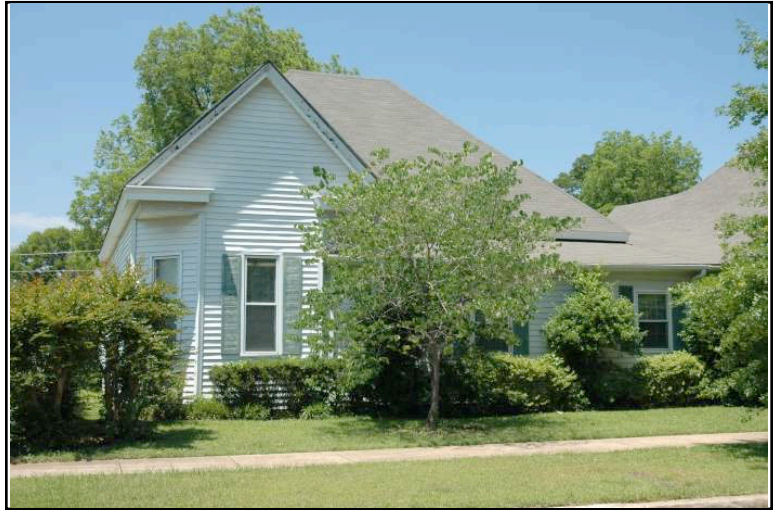
Rectangular 1-story frame dwelling with a hipped composition shingle roof with a front-facing gable projection at its west bay; faces south; now attached to adjacent house to the east by an infill addition.

Condition: good _____ Integrity: fair _____ Ownership: private _____ Category: Building _____
 Historic Use: Single Dwelling - Non Farm _____ Current Use: Commerce/Trade _____
 Function: Residence _____ Function: Business/Professional Office _____

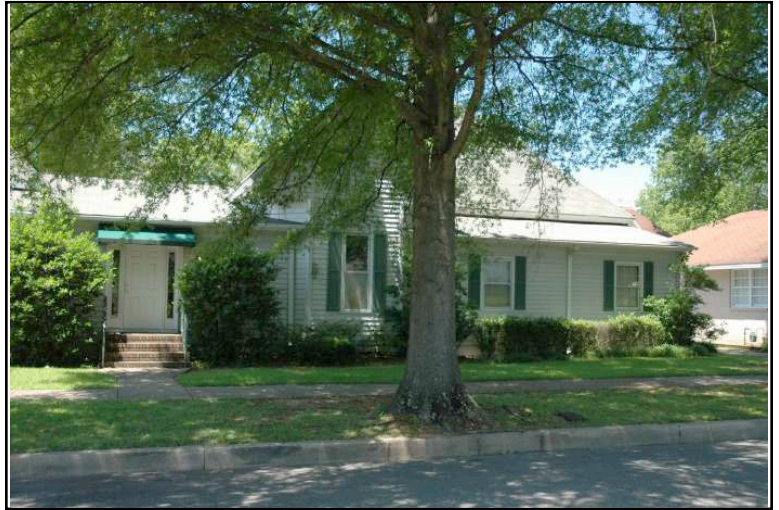
Rectangular 1-story frame dwelling with a hipped composition shingle roof with a front-facing gable projection at its west bay; faces south; now attached to adjacent house to the west by an infill addition.

Condition: good _____ Integrity: fair _____ Ownership: private _____ Category: Building _____
 Historic Use: Single Dwelling - Non Farm _____ Current Use: Commerce/Trade _____
 Function: Residence _____ Function: Business/Professional Office _____

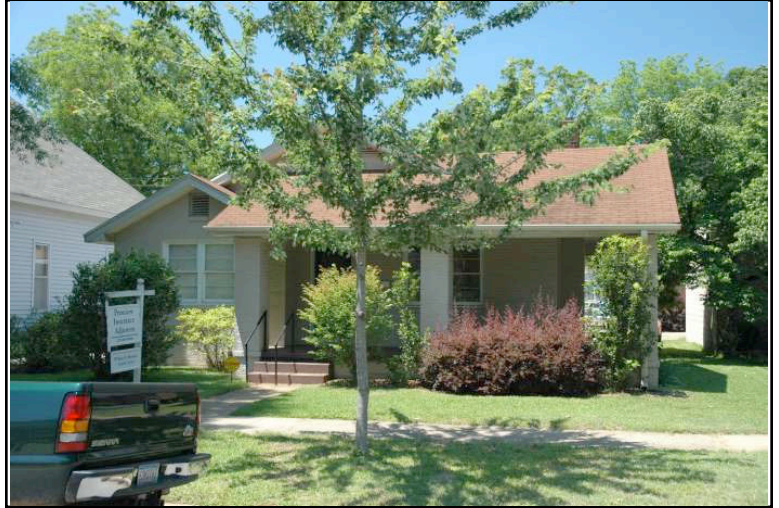
Rectangular 1-story brick dwelling with a side gable composition shingle roof with a front-facing gable projection at its east bay; faces south.

Condition: good _____ Integrity: fair _____ Ownership: private _____ Category: Building _____
 Historic Use: Single Dwelling - Non Farm _____ Current Use: Commerce/Trade _____
 Function: Residence _____ Function: Business/Professional Office _____

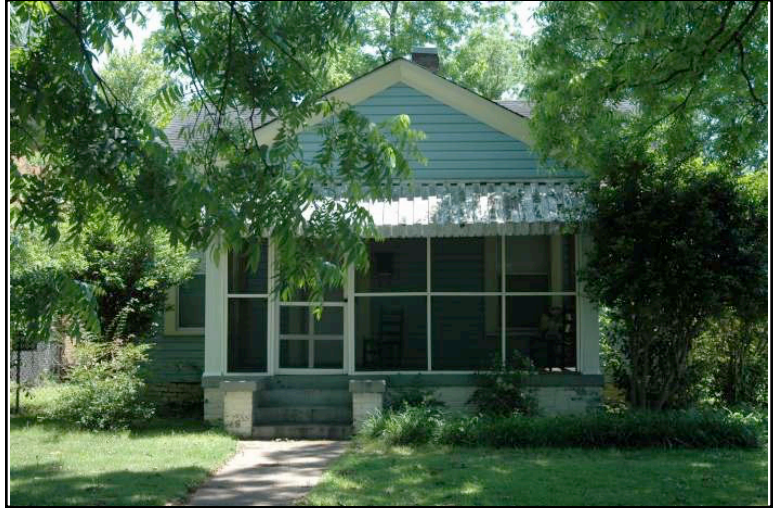
Rectangular 1-story frame dwelling with a front-facing gable composition shingle; faces north.

Condition: good _____ Integrity: fair _____ Ownership: private _____ Category: Building _____
 Historic Use: Single Dwelling - Non Farm _____ Current Use: Single Dwelling - Non Farm _____
 Function: Residence _____ Function: Residence _____

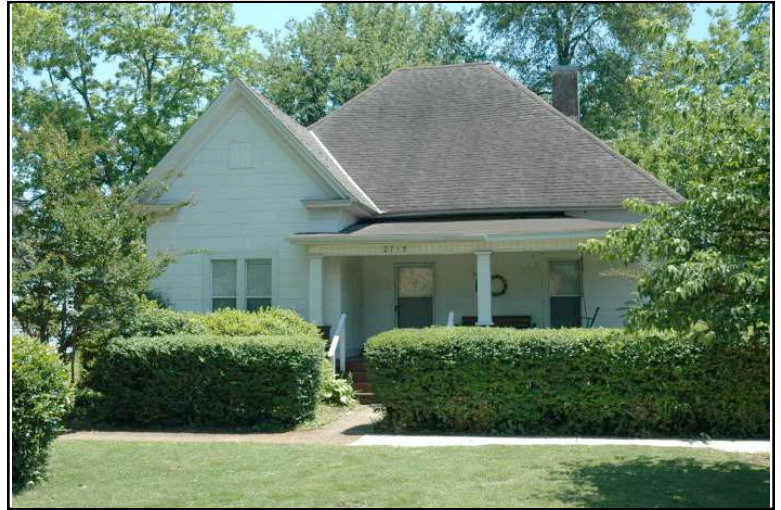
Rectangular 1-story frame dwelling with a hipped composition shingle roof with a front-facing gable projection at its east bay; faces north.

Condition: good _____ Integrity: fair _____ Ownership: private _____ Category: Building _____
 Historic Use: Single Dwelling - Non Farm _____ Current Use: Single Dwelling - Non Farm _____
 Function: Residence _____ Function: Residence _____

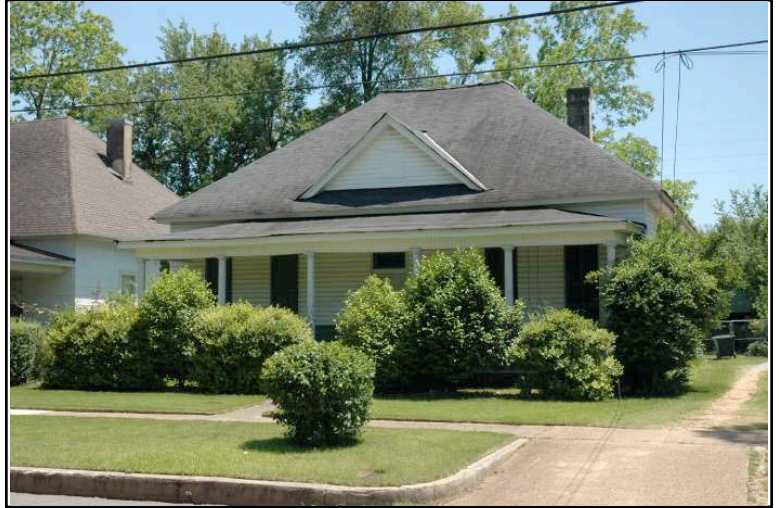
Rectangular 1-story frame dwelling with a hipped composition shingle roof with a central front-facing gable projection; faces north.

Condition: good _____ Integrity: fair _____ Ownership: private _____ Category: Building _____
 Historic Use: Single Dwelling - Non Farm _____ Current Use: Single Dwelling - Non Farm _____
 Function: Residence _____ Function: Residence _____

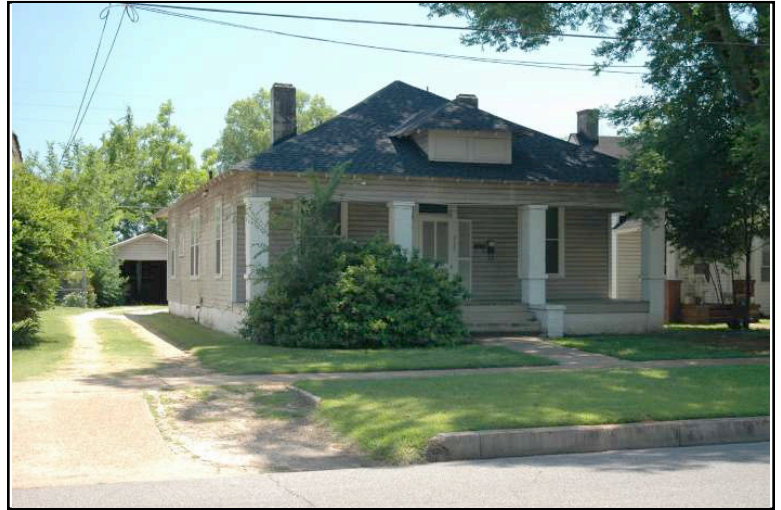
Rectangular 1-story frame dwelling with a hipped composition shingle roof with a central decorative hipped dormer; faces north.

Condition: good _____ Integrity: good _____ Ownership: private _____ Category: Building _____
 Historic Use: Single Dwelling - Non Farm _____ Current Use: Single Dwelling - Non Farm _____
 Function: Residence _____ Function: Residence _____

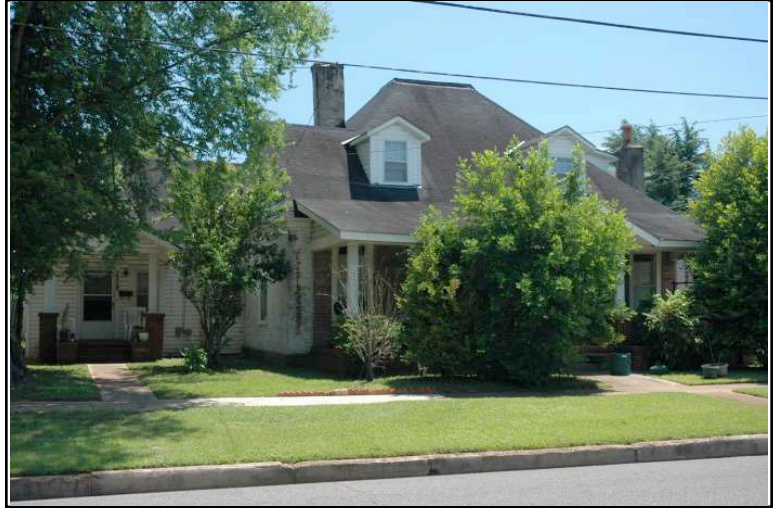
Rectangular 1.5-story brick dwelling with a hipped composition shingle roof with two modern gable dormers (1980 ca.) faces north.

Condition: good _____ Integrity: fair _____ Ownership: private _____ Category: Building _____
 Historic Use: Single Dwelling - Non Farm _____ Current Use: Single Dwelling - Non Farm _____
 Function: Residence _____ Function: Residence _____

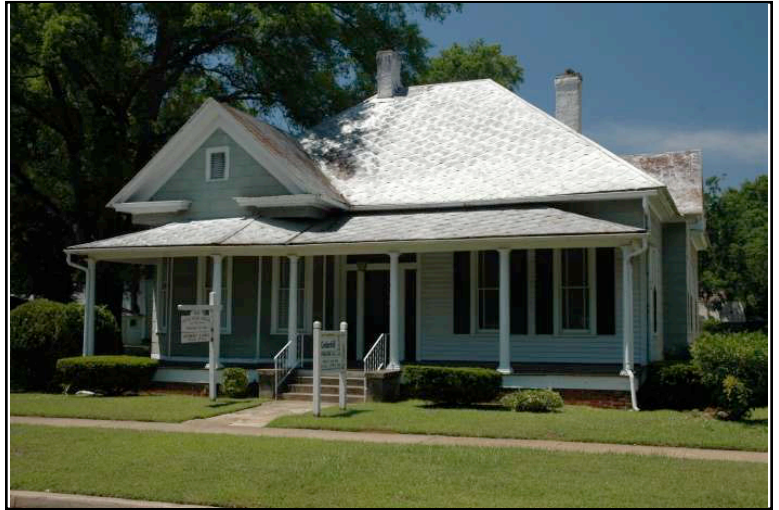
Rectangular 1-story frame dwelling with a hipped pressed metal shingle roof with a front-facing gable projection at its west bay; faces south.

Condition: good _____ Integrity: good _____ Ownership: private _____ Category: Building _____
 Historic Use: Single Dwelling - Non Farm _____ Current Use: Commerce/Trade _____
 Function: Residence _____ Function: Business/Professional Office _____
