Tuscaloosa

Greater Downtown Study
Historic Resource Survey - 2006

Survey Number: _____ 1 _____
Historic name(s): House, Not Named
Common name: Southeast Appraisers
Location: University Blvd., 2720

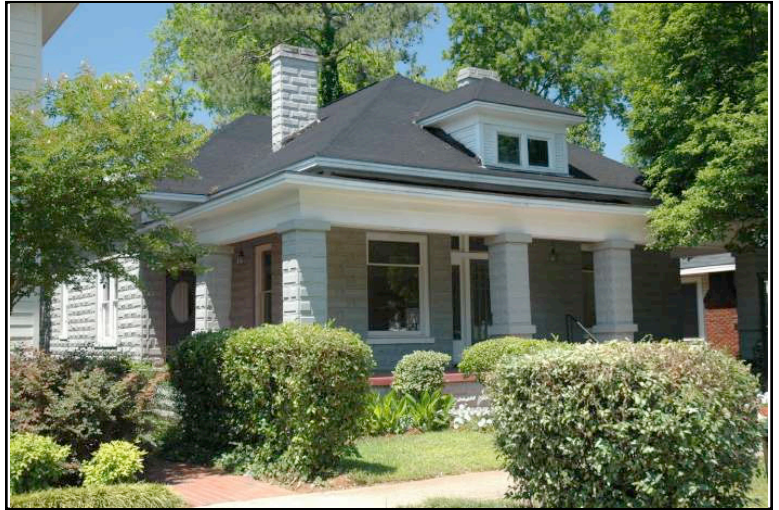
Rectangular 1-story frame dwelling with a hipped composition shing roof with a central hipped decorative dormer; faces south.

Condition: good _____ Integrity: good _____ Ownership: private _____ Category: Building _____
 Historic Use: Single Dwelling - Non Farm _____ Current Use: Commerce/Trade _____
 Function: Residence _____ Function: Business/Professional Office _____

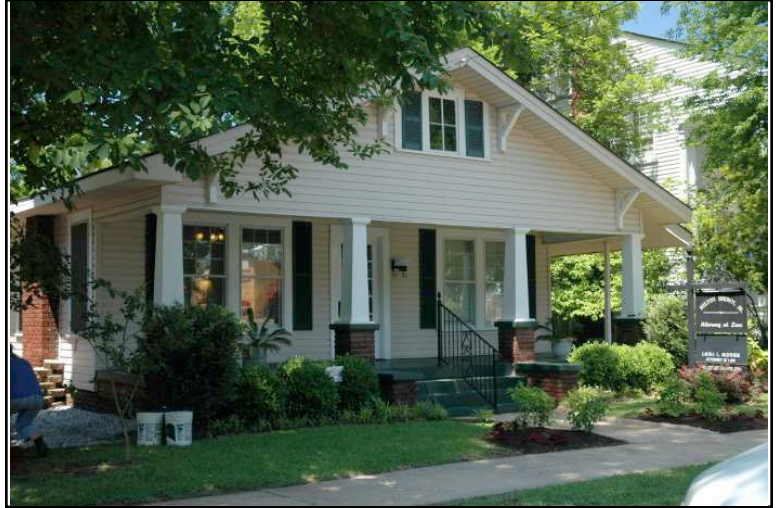
Rectangular 1-story frame dwelling with a front-facing gable composition shingle roof; faces south.

Condition: good _____ Integrity: good _____ Ownership: private _____ Category: Building _____
 Historic Use: Single Dwelling - Non Farm _____ Current Use: Commerce/Trade _____
 Function: Residence _____ Function: Business/Professional Office _____

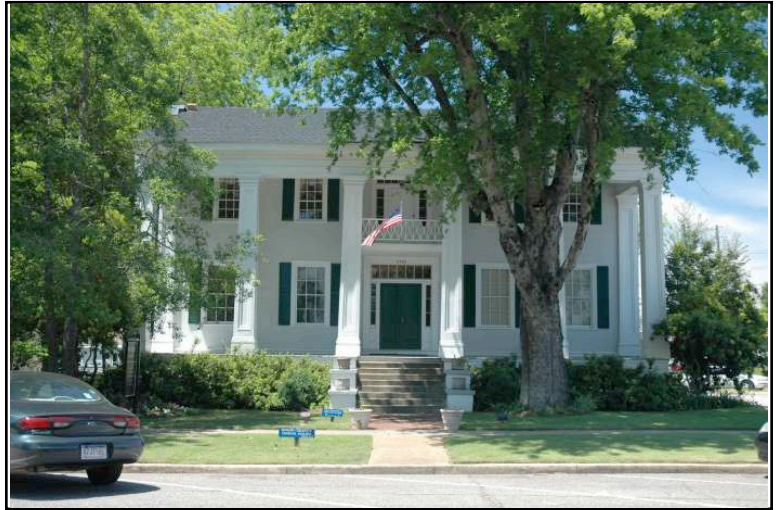
Rectangular 2-story frame dwelling with a side gable composition shingle roof; faces south.

Condition: good _____ Integrity: good _____ Ownership: private _____ Category: Building _____
 Historic Use: Single Dwelling - Non Farm _____ Current Use: Commerce/Trade _____
 Function: Residence _____ Function: Business/Professional Office _____

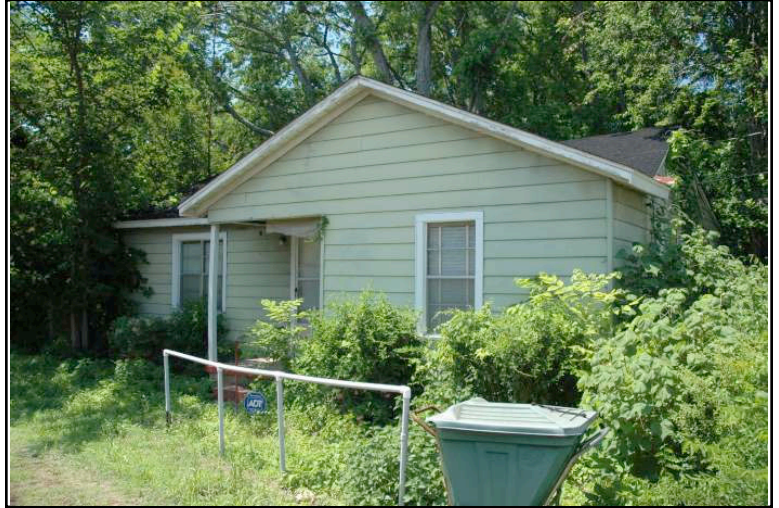
Rectangular 1-story frame dwelling with a front-facing gable composition shingle roof, faces south.

Condition: fair _____ Integrity: fair _____ Ownership: private _____ Category: Building _____
 Historic Use: Single Dwelling - Non Farm _____ Current Use: Single Dwelling - Non Farm _____
 Function: Residence _____ Function: Residence _____

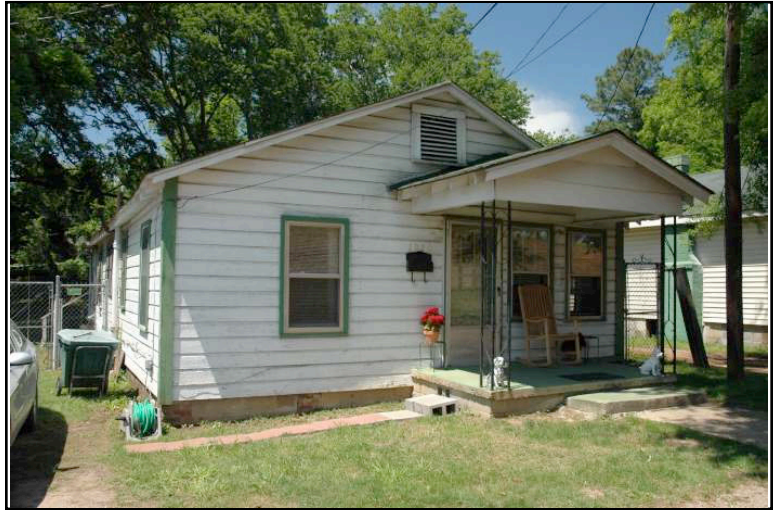
Rectangular 1-story frame dwelling with a front-facing gable composition shingle roof, faces south.

Condition: good _____ Integrity: good _____ Ownership: private _____ Category: Building _____
 Historic Use: Single Dwelling - Non Farm _____ Current Use: Single Dwelling - Non Farm _____
 Function: Residence _____ Function: Residence _____

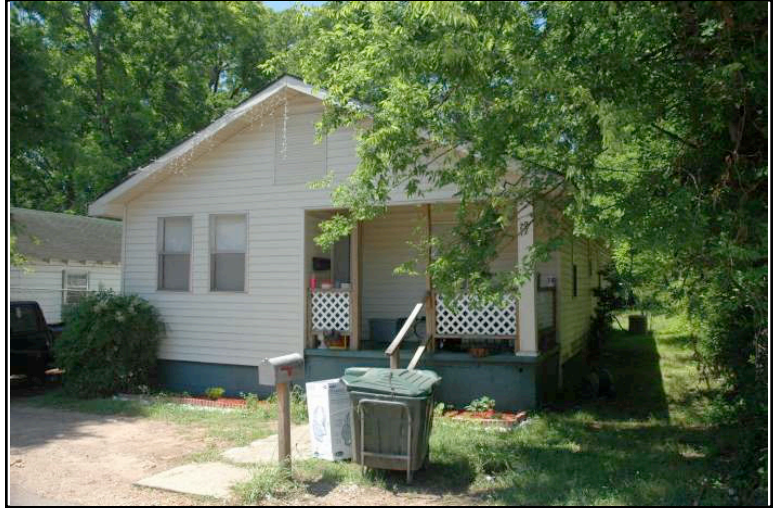
Rectangular 1-story frame dwelling with a front-facing gable composition shingle roof, faces south.

Condition: good _____ Integrity: poor _____ Ownership: private _____ Category: Building _____
 Historic Use: Single Dwelling - Non Farm _____ Current Use: Single Dwelling - Non Farm _____
 Function: Residence _____ Function: Residence _____

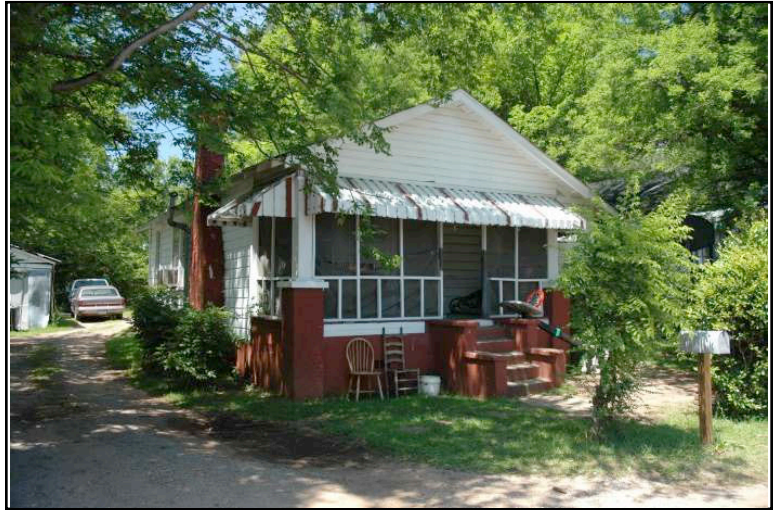
Rectangular 1-story frame dwelling with a front-facing gable composition shingle roof, faces south.

Condition: good _____ Integrity: good _____ Ownership: private _____ Category: Building _____
 Historic Use: Single Dwelling - Non Farm _____ Current Use: Single Dwelling - Non Farm _____
 Function: Residence _____ Function: Residence _____

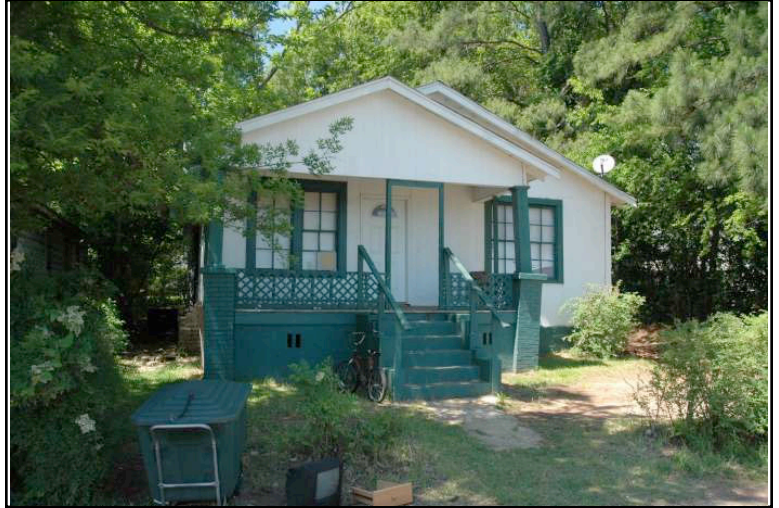
Rectangular 1-story frame dwelling with a front-facing gable composition shingle roof, faces south.

Condition: good _____ Integrity: poor _____ Ownership: private _____ Category: Building _____
 Historic Use: Single Dwelling - Non Farm _____ Current Use: Single Dwelling - Non Farm _____
 Function: Residence _____ Function: Residence _____

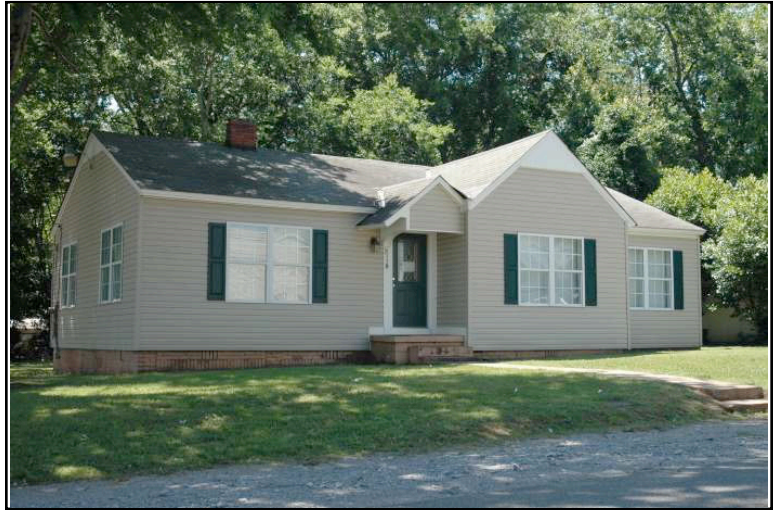
Rectangular 1-story frame dwelling with a side gable composition shingle roof, faces east.

Condition: good _____ Integrity: poor _____ Ownership: private _____ Category: Building _____
 Historic Use: Single Dwelling - Non Farm _____ Current Use: Single Dwelling - Non Farm _____
 Function: Residence _____ Function: Residence _____

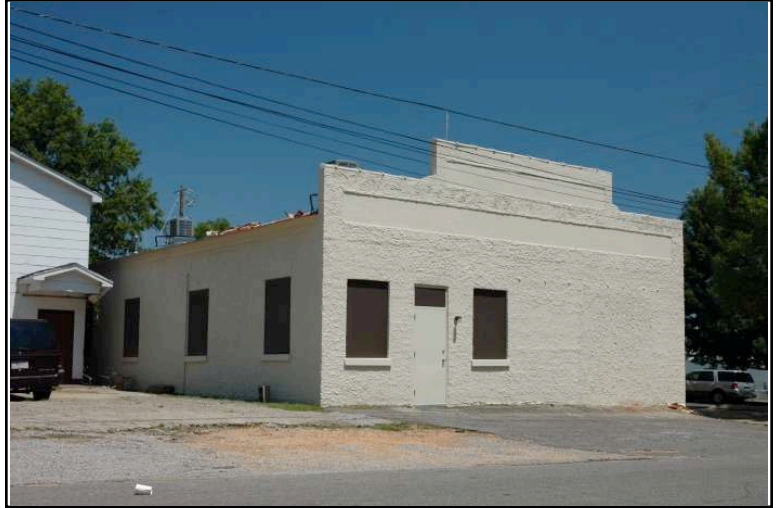
Rectangular 1-story brick commercial building with a side front-facing composition shingle roof concealed by a stepped parapet; faces west.

Condition: good _____ Integrity: fair _____ Ownership: private _____ Category: Building _____
 Historic Use: Commerce/Trade _____ Current Use: Commerce/Trade _____
 Function: Unknown _____ Function: Warehouse _____

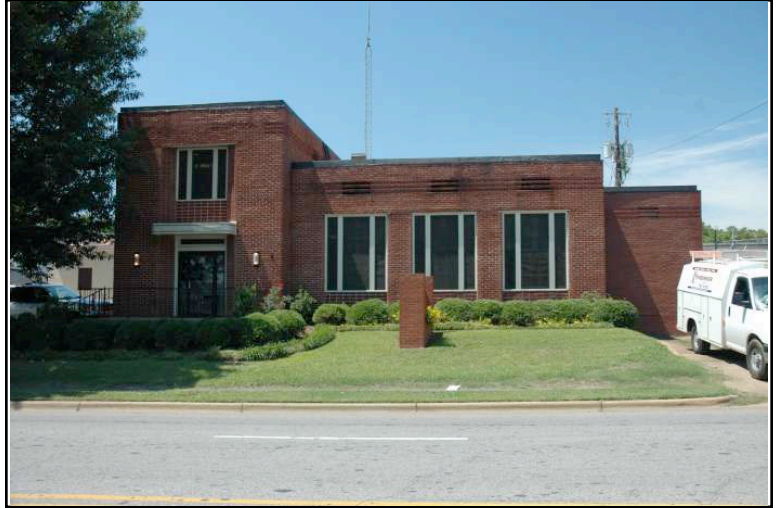
Rectangular split level brick commercial building with a flat roof concealed by a parapets; faces south.

Condition: good _____ Integrity: good _____ Ownership: private _____ Category: Building _____
 Historic Use: Commerce/Trade _____ Current Use: Commerce/Trade _____
 Function: Unknown _____ Function: Business/Professional Office _____

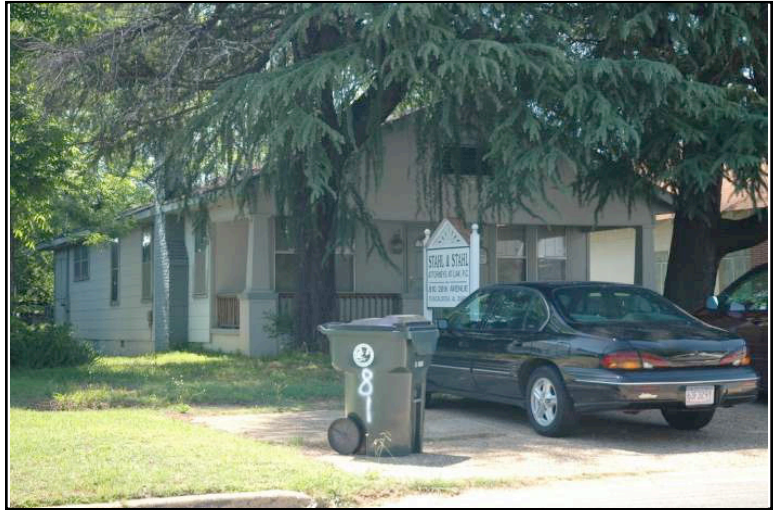
Rectangular 1-story frame dwelling with a front-facing gable composition shingle roof, faces east.

Condition: good _____ Integrity: fair _____ Ownership: private _____ Category: Building _____
 Historic Use: Single Dwelling - Non Farm _____ Current Use: Commerce/Trade _____
 Function: Residence _____ Function: Business/Professional Office _____

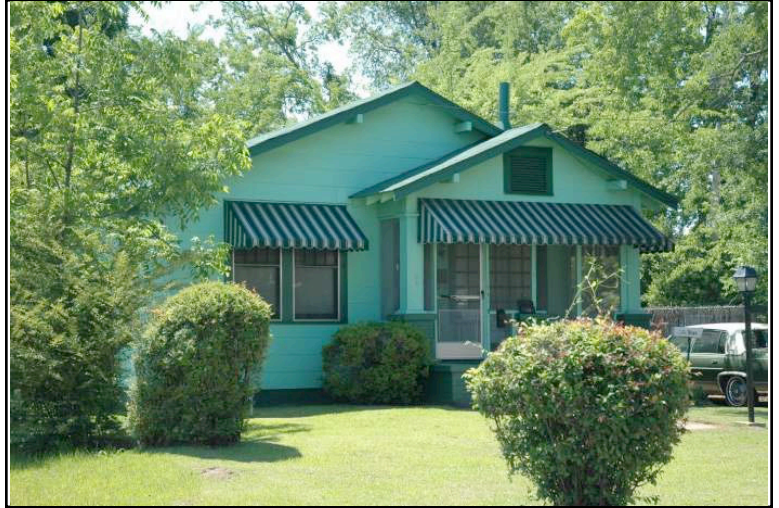
Rectangular 1-story frame dwelling with a front-facing gable composition shingle roof, faces east.

Condition: good _____ Integrity: fair _____ Ownership: private _____ Category: Building _____
 Historic Use: Single Dwelling - Non Farm _____ Current Use: Single Dwelling - Non Farm _____
 Function: Residence _____ Function: Residence _____

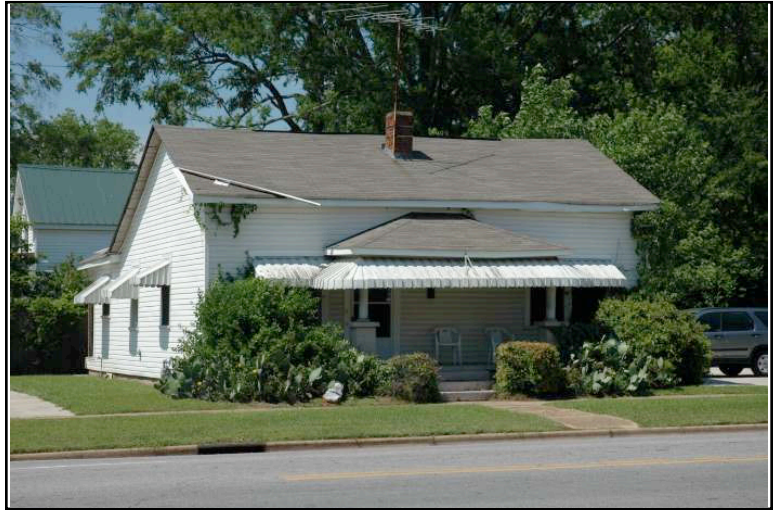
Rectangular 1-story frame dwelling with a side gable composition shingle roof, faces south.

Condition: good _____ Integrity: poor _____ Ownership: private _____ Category: Building _____
 Historic Use: Single Dwelling - Non Farm _____ Current Use: Single Dwelling - Non Farm _____
 Function: Residence _____ Function: Residence _____

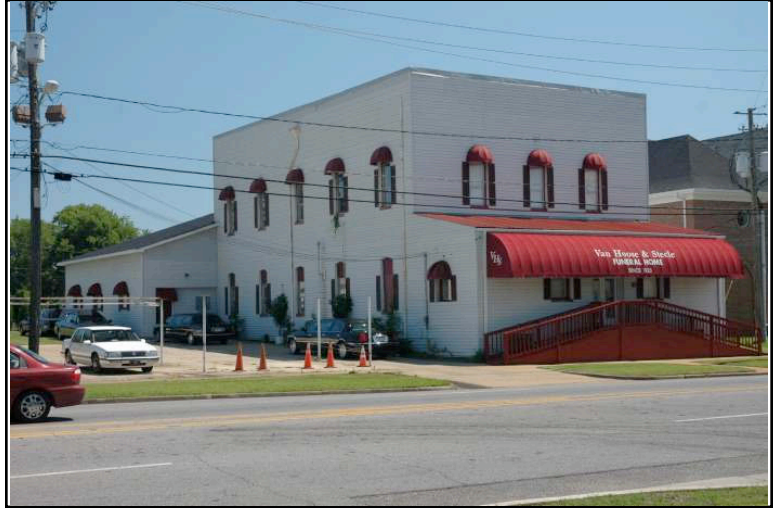
Rectangular split level brick commercial building with a flat roof concealed by a parapets; faces north.

Condition: good _____ Integrity: fair _____ Ownership: _____ Category: Building _____
 Historic Use: Commerce/Trade _____ Current Use: Commerce/Trade _____
 Function: Funeral Home _____ Function: Funeral Home _____

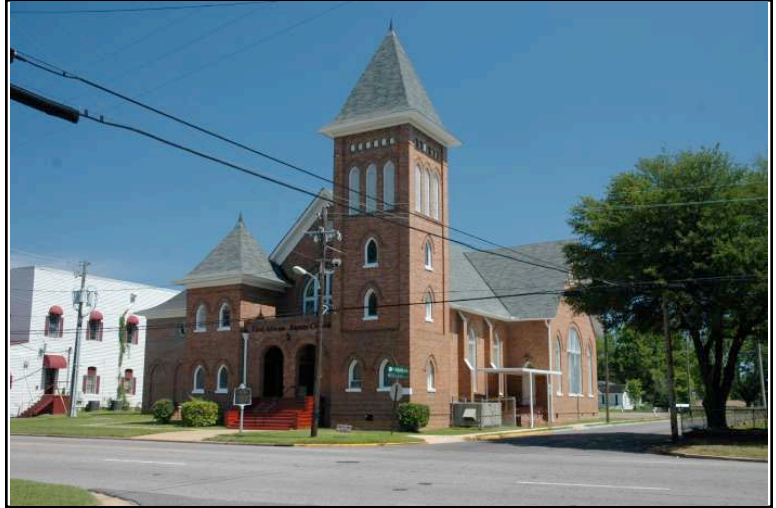
T-shaped 2-story brick church building with a cross gable composition shingle roof; faces north, rectangular 5 x 6 bay core with secondary cross gable wings at the rear bay s of its east and west elevations, 4-story corner belltower with hipped roof at its northwest corner and secondary two story tower with hipped roof at its northeast corner, recessed entrance loggia extends across facade between towers; 2 arched opening at loggia which has been glassed in (1990 ca.), paired pointed arched windows at 1st floor level of towers and at 2nd level of east tower, similar single windows at 2 upper floors of west , grouping of three pointed arched louvered openings at each face of 4th level of west tower; oversized stained glass window centered at facade of main block with round louver above; single pointed arched stained glass

Condition: good _____ Integrity: good _____ Ownership: private _____ Category: Building _____
Historic Use: Religion _____ Current Use: Religion _____
Function: Religious Facility _____ Function: Religious Facility _____

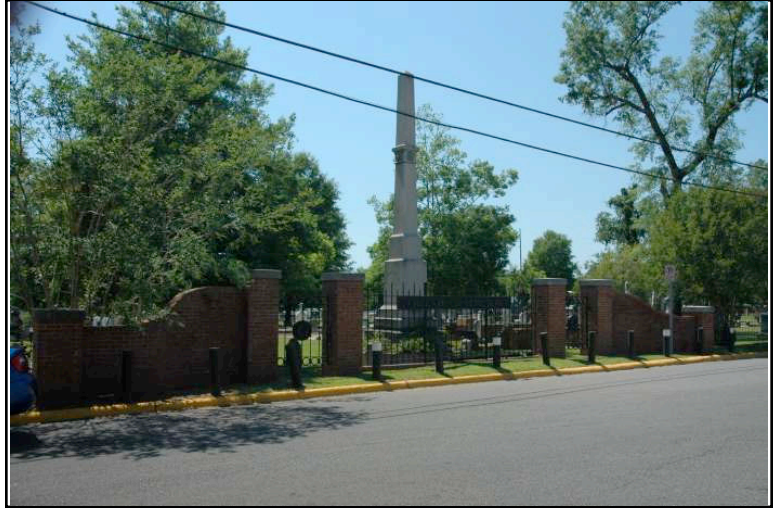
Large urban cemetery on a sloping site.

Condition: good _____ Integrity: good _____ Ownership: private _____ Category: Site _____
Historic Use: Cemetery _____ Current Use: Cemetery _____
Function: Cemetery _____ Function: Cemetery _____

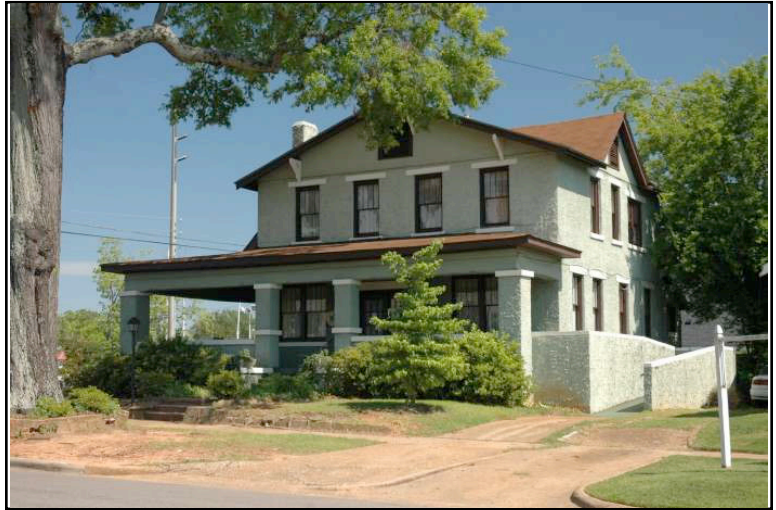
Rectangular 2-story stuccoed masonry dwelling with a cross gable composition shingle roof with angle bracketed eaves; faces north, 4x4 bay core; full facade hipped porch with stucco pillars and apron wall wraps to east elevation; central entrance with double leaf doors flanked by double wood geometric double hung sash windows, similar single windows at upper level and side elevations; painted stucco exterior walls; stucco foundation.

Condition: good _____ Integrity: good _____ Ownership: private _____ Category: Building _____
Historic Use: Single Dwelling - Non Farm _____ Current Use: Recreation/Culture _____
Function: Residence _____ Function: Museum _____

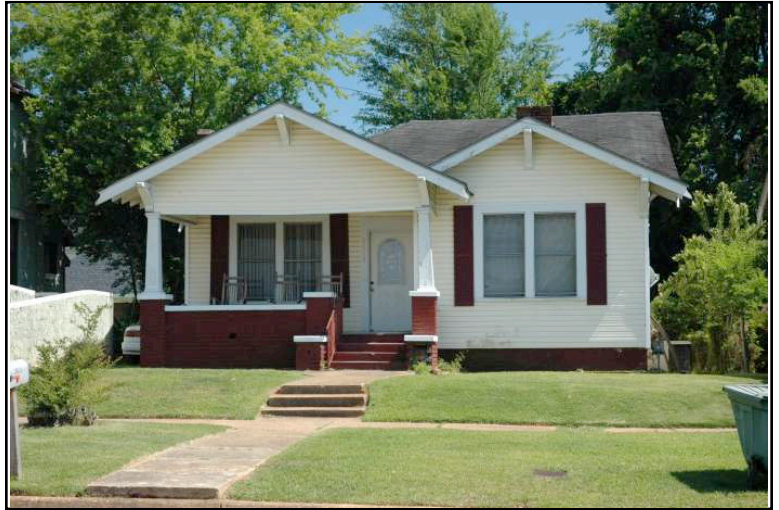
Rectangular 1-story frame dwelling with a side gable composition shingle roof; faces north.

Condition: good _____ Integrity: fair _____ Ownership: private _____ Category: Building _____
 Historic Use: Single Dwelling - Non Farm _____ Current Use: Single Dwelling - Non Farm _____
 Function: Residence _____ Function: Residence _____

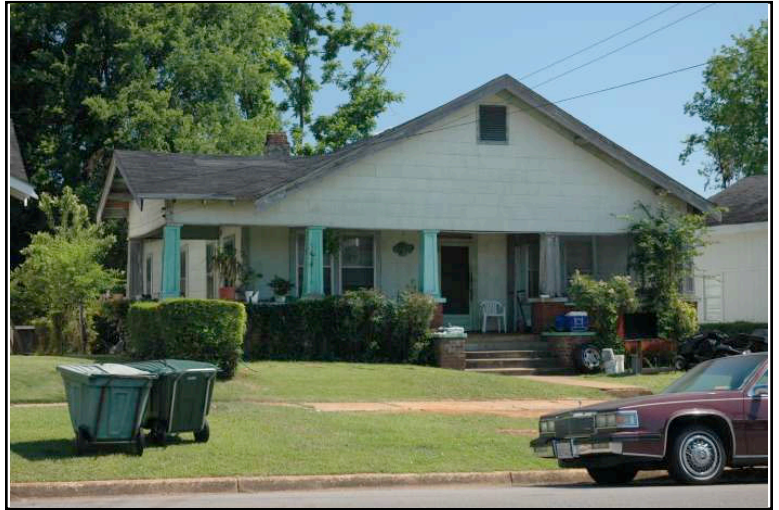
Rectangular 1-story frame dwelling with a front-facing gable composition shingle roof; faces north.

Condition: good _____ Integrity: fair _____ Ownership: private _____ Category: Building _____
 Historic Use: Single Dwelling - Non Farm _____ Current Use: Single Dwelling - Non Farm _____
 Function: Residence _____ Function: Residence _____

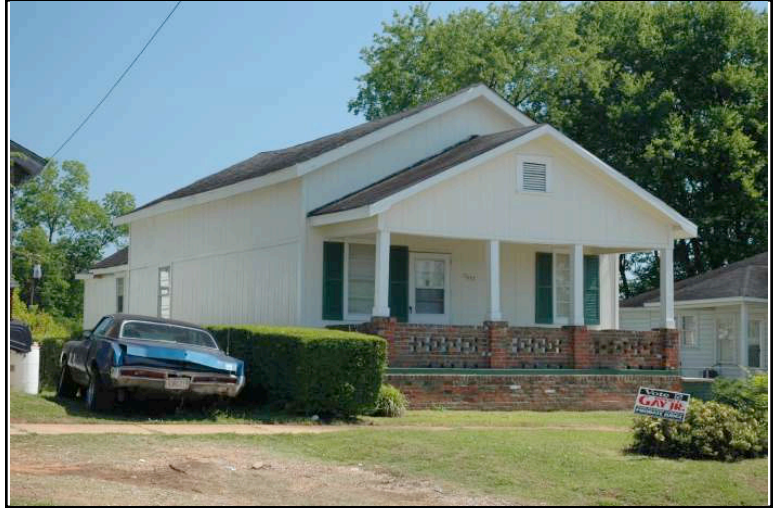
Rectangular 1-story frame dwelling with a front-facing gable composition shingle roof; faces north.

Condition: good _____ Integrity: poor _____ Ownership: private _____ Category: Building _____
 Historic Use: Single Dwelling - Non Farm _____ Current Use: Single Dwelling - Non Farm _____
 Function: Residence _____ Function: Residence _____

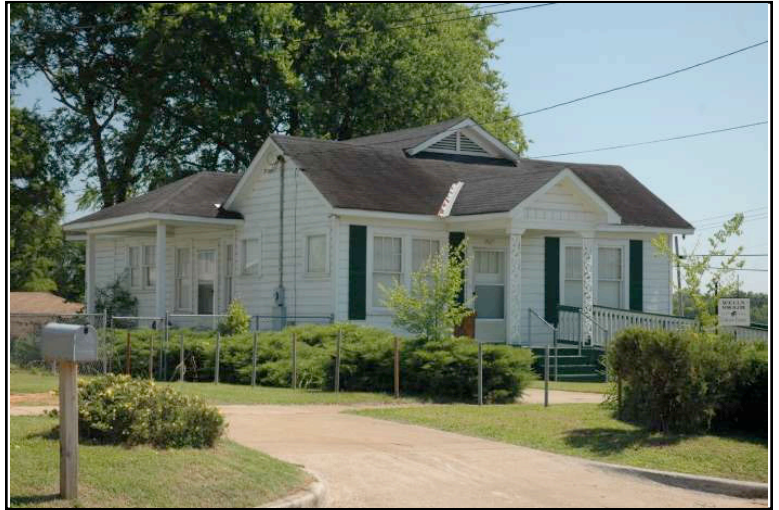
Rectangular 1-story frame dwelling with a cross gable composition shingle roof; faces north.

Condition: good _____ Integrity: good _____ Ownership: private _____ Category: Building _____
 Historic Use: Single Dwelling - Non Farm _____ Current Use: Single Dwelling - Non Farm _____
 Function: Residence _____ Function: Residence _____

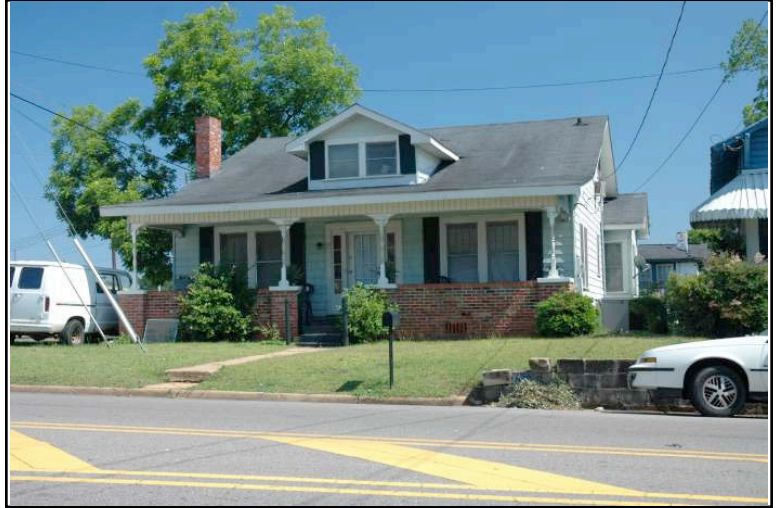
Rectangular 1-story frame dwelling with a side gable composition shingle roof; faces north.

Condition: good _____ Integrity: fair _____ Ownership: private _____ Category: Building _____
 Historic Use: Single Dwelling - Non Farm _____ Current Use: Single Dwelling - Non Farm _____
 Function: Residence _____ Function: Residence _____

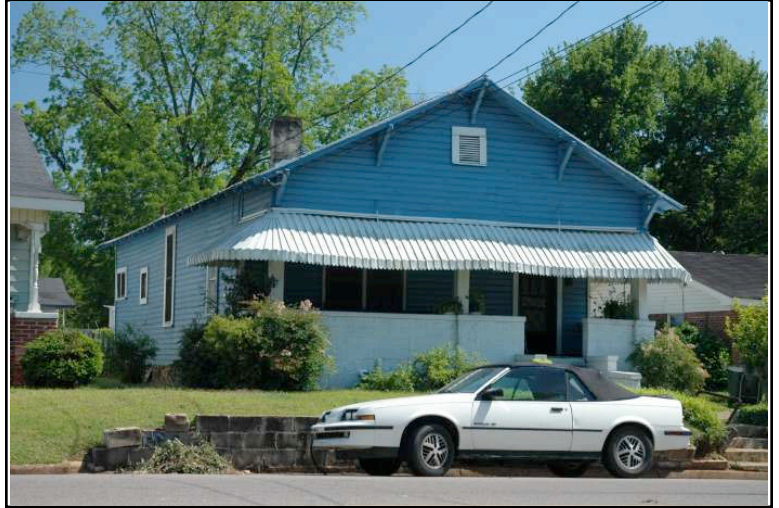
Rectangular 1-story frame dwelling with a front-facing gable composition shingle roof; faces north.

Condition: fair _____ Integrity: good _____ Ownership: private _____ Category: Building _____
 Historic Use: Single Dwelling - Non Farm _____ Current Use: Single Dwelling - Non Farm _____
 Function: Residence _____ Function: Residence _____

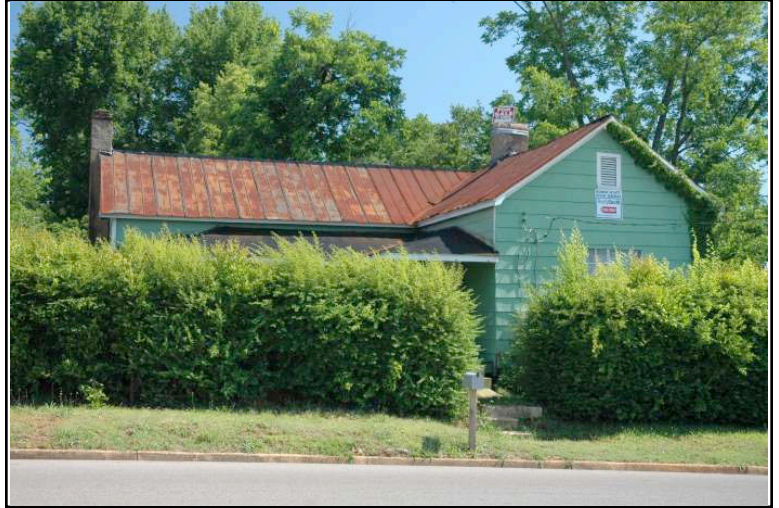
L-shaped 1-story frame dwelling with a cross gable V-crimped metal roof; faces north.

Condition: fair _____ Integrity: poor _____ Ownership: private _____ Category: Building _____
 Historic Use: Single Dwelling - Non Farm _____ Current Use: Single Dwelling - Non Farm _____
 Function: Residence _____ Function: Residence _____

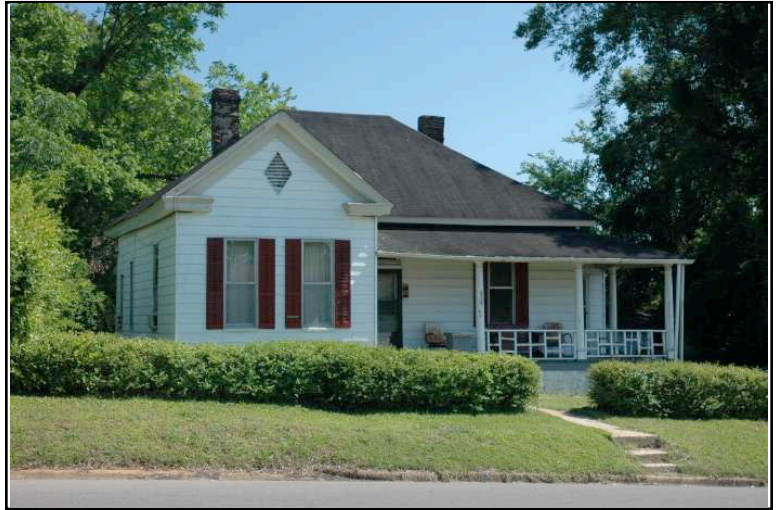
Rectangular 1-story frame dwelling with a hipped composition shingle roof with a front-facing gable projection at its west bay; faces north.

Condition: good _____ Integrity: fair _____ Ownership: private _____ Category: Building _____
 Historic Use: Single Dwelling - Non Farm _____ Current Use: Single Dwelling - Non Farm _____
 Function: Residence _____ Function: Residence _____

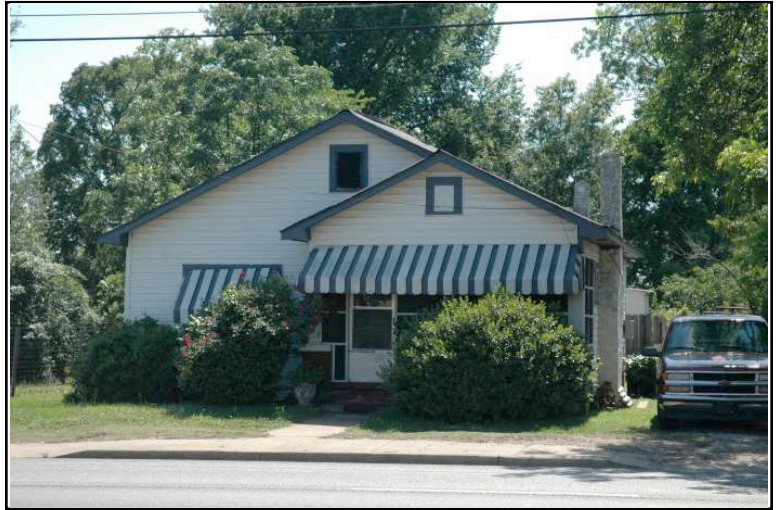
Rectangular 1-story frame dwelling with a front-facing gable composition shingle roof; faces east.

Condition: good _____ Integrity: fair _____ Ownership: private _____ Category: Building _____
 Historic Use: Single Dwelling - Non Farm _____ Current Use: Single Dwelling - Non Farm _____
 Function: Residence _____ Function: Residence _____

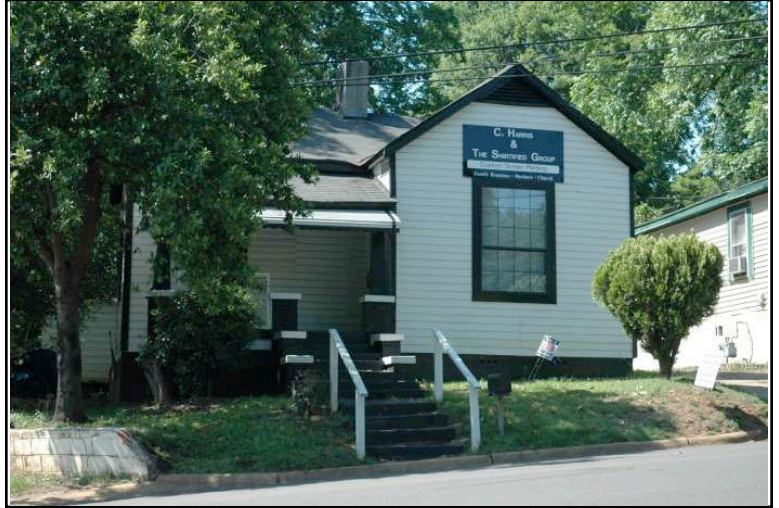
T-shaped 1-story frame dwelling with a cross gable composition shingle roof; faces south.

Condition: good _____ Integrity: fair _____ Ownership: private _____ Category: Building _____
 Historic Use: Single Dwelling - Non Farm _____ Current Use: Commerce/Trade _____
 Function: Residence _____ Function: Business/Professional Office _____

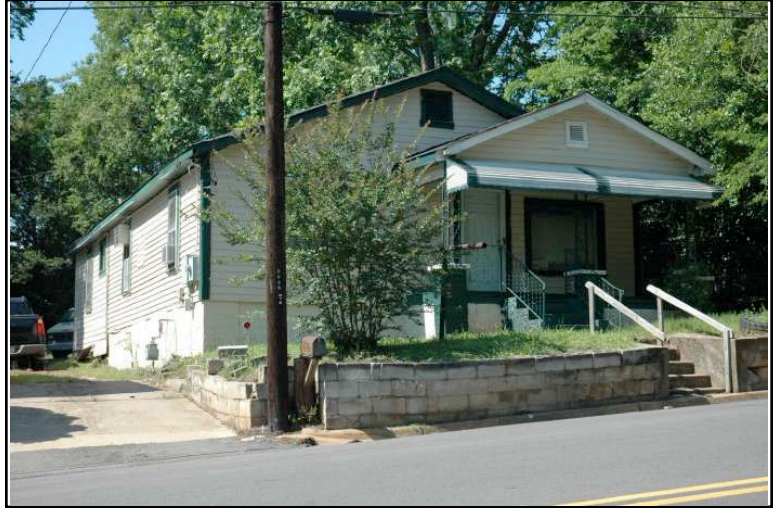
Rectangular 1-story frame dwelling with a front-facing gable composition shingle roof; faces south.

Condition: good _____ Integrity: fair _____ Ownership: private _____ Category: Building _____
 Historic Use: Single Dwelling - Non Farm _____ Current Use: Single Dwelling - Non Farm _____
 Function: Residence _____ Function: Residence _____

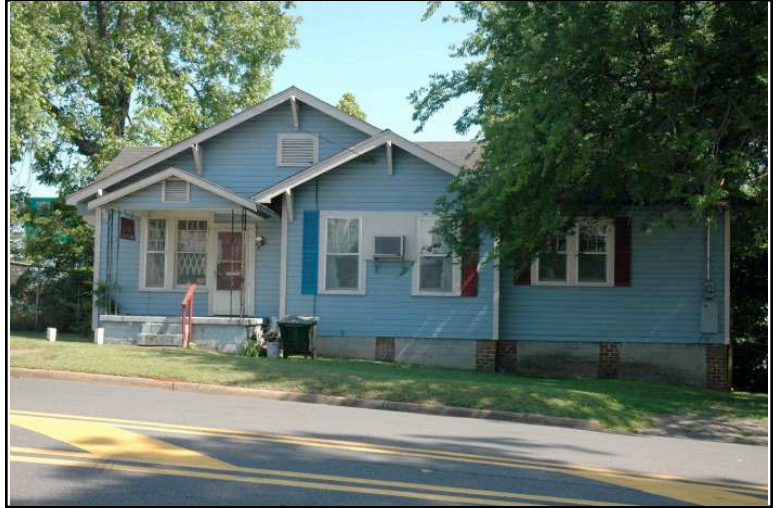
Rectangular 1-story frame dwelling with a front-facing gable composition shingle roof; faces north, 3x3 bay core with side gable addition to west.

Condition: good _____ Integrity: good _____ Ownership: private _____ Category: Building _____
 Historic Use: Single Dwelling - Non Farm _____ Current Use: Single Dwelling - Non Farm _____
 Function: Residence _____ Function: Residence _____

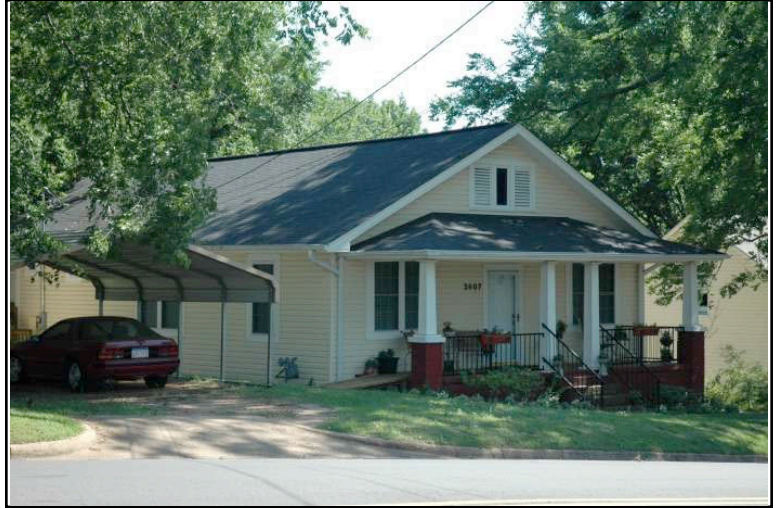
Rectangular 1-story frame dwelling with a front-facing gable composition shingle roof; faces north, 3x3 bay core with side gable addition to west.

Condition: good _____ Integrity: fair _____ Ownership: private _____ Category: Building _____
 Historic Use: Single Dwelling - Non Farm _____ Current Use: Single Dwelling - Non Farm _____
 Function: Residence _____ Function: Residence _____

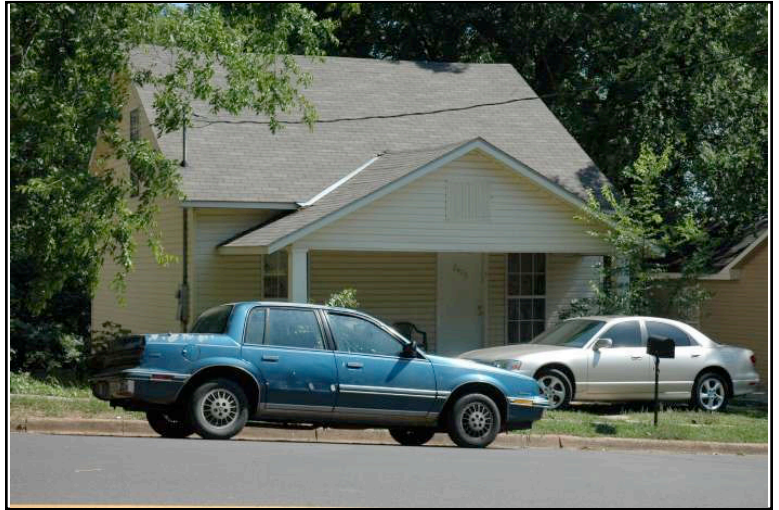
Rectangular 1-story frame dwelling with a side gable composition shingle roof; faces north, 3x2 bay core.

Condition: good _____ Integrity: poor _____ Ownership: private _____ Category: Building _____
 Historic Use: Single Dwelling - Non Farm _____ Current Use: Single Dwelling - Non Farm _____
 Function: Residence _____ Function: Residence _____

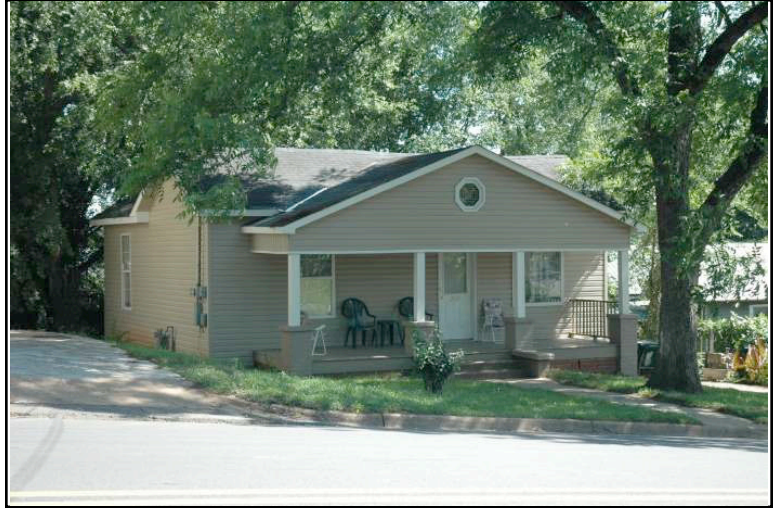
L-shaped 1-story frame dwelling with a cross gable composition shingle roof; faces north, 3x1 bay core with rear gable wing to the east.

Condition: good _____ Integrity: poor _____ Ownership: private _____ Category: Building _____
 Historic Use: Single Dwelling - Non Farm _____ Current Use: Single Dwelling - Non Farm _____
 Function: Residence _____ Function: Residence _____

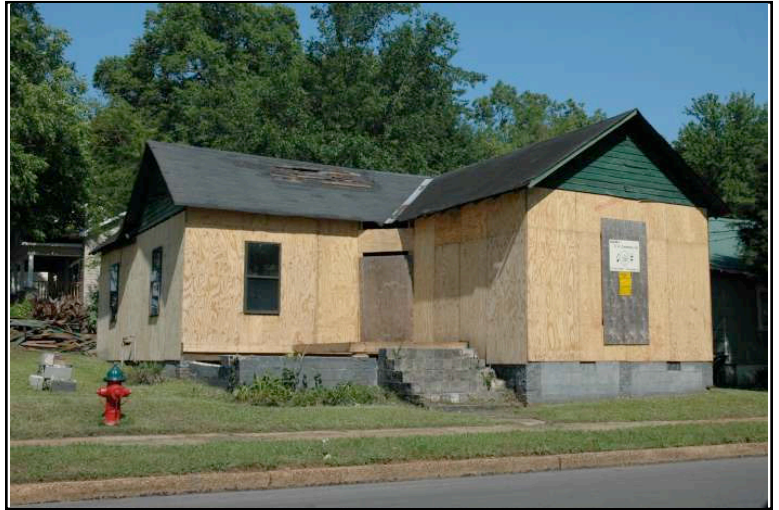
L-shaped 1-story frame dwelling with a cross gable composition shingle roof; faces west, 3x1 bay core with front gable wing to the south.

Condition: fair _____ Integrity: poor _____ Ownership: private _____ Category: Building _____
 Historic Use: Single Dwelling - Non Farm _____ Current Use: Vacant/Not in Use _____
 Function: Residence _____ Function: _____

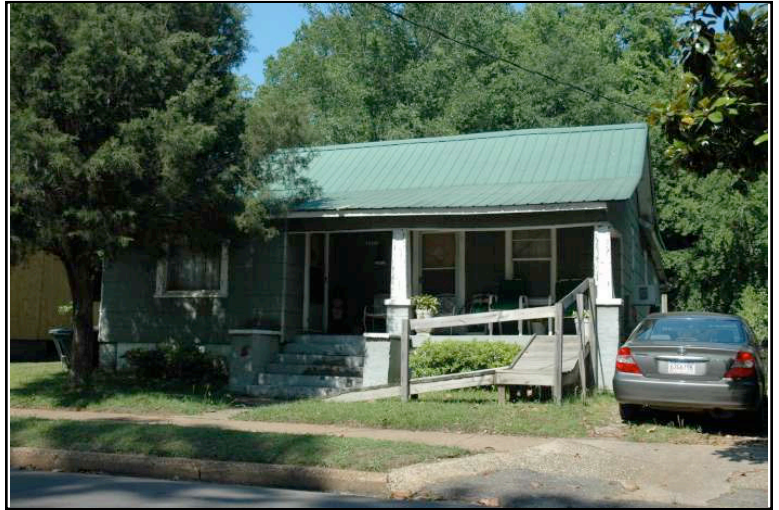
Irregular-shaped 1-story frame dwelling with a cross gable composition shingle roof; faces west, 3x1 bay core with front gable wing to the south.

Condition: fair _____ Integrity: fair _____ Ownership: private _____ Category: Building _____
 Historic Use: Single Dwelling - Non Farm _____ Current Use: Single Dwelling - Non Farm _____
 Function: Residence _____ Function: Residence _____

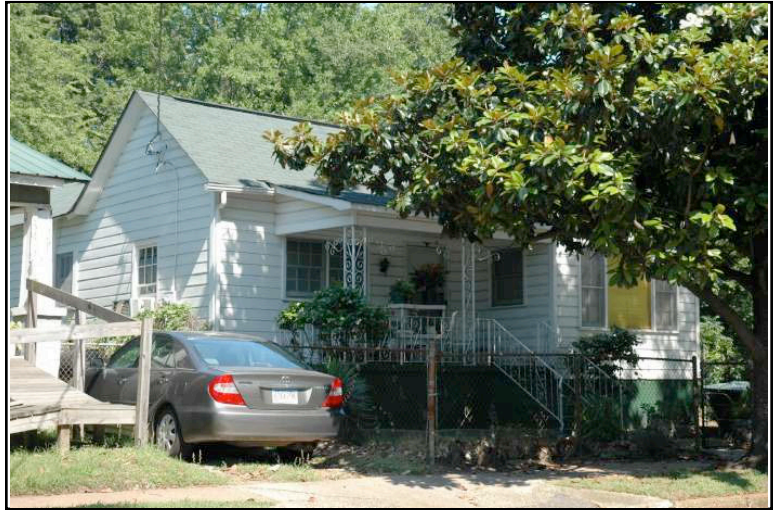
Rectangular 1-story frame dwelling with a cross gable composition shingle roof; faces west, 3x1 bay core with rear gable wing to the north.

Condition: good _____ Integrity: good _____ Ownership: private _____ Category: Building _____
 Historic Use: Single Dwelling - Non Farm _____ Current Use: Single Dwelling - Non Farm _____
 Function: Residence _____ Function: Residence _____

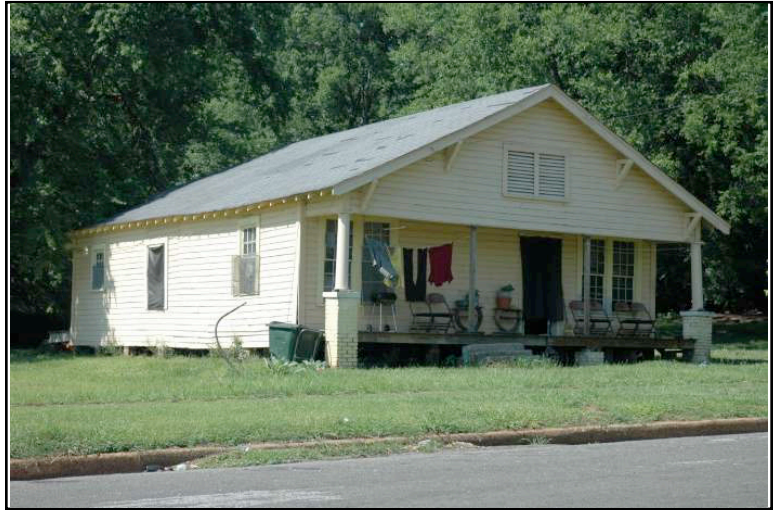
Rectangular 1-story frame dwelling with a front-facing gable composition shingle roof; faces south, 3x3 bay core.

Condition: good _____ Integrity: good _____ Ownership: private _____ Category: Building _____
Historic Use: Single Dwelling - Non Farm _____ Current Use: Single Dwelling - Non Farm _____
Function: Residence _____ Function: Residence _____

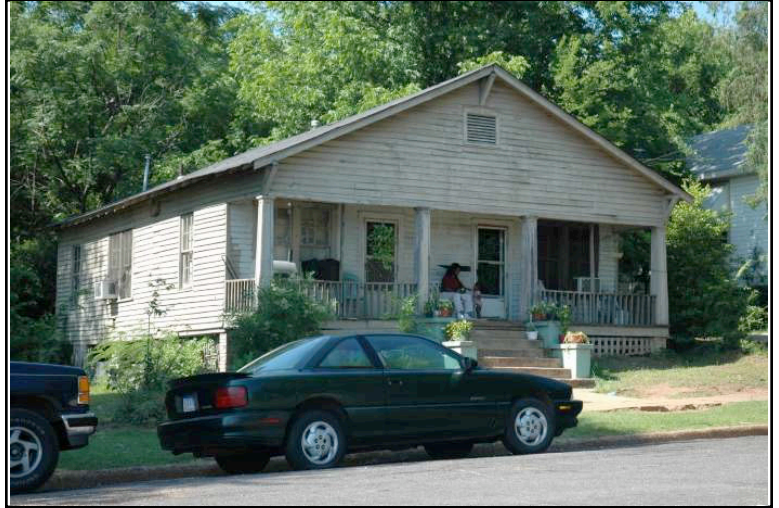
Rectangular 1-story frame dwelling with a front-facing gable composition shingle roof; faces south, 4x3 bay core.

Condition: good _____ Integrity: good _____ Ownership: private _____ Category: Building _____
 Historic Use: Single Dwelling - Non Farm _____ Current Use: Single Dwelling - Non Farm _____
 Function: Residence _____ Function: Residence _____

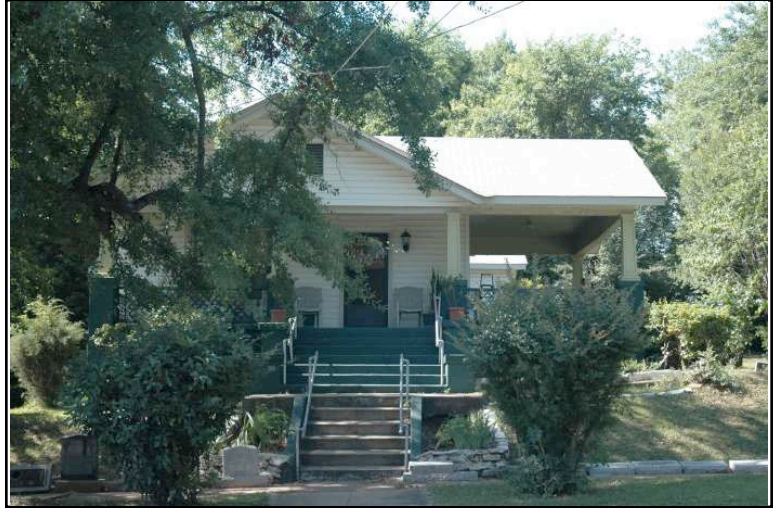
Rectangular 1-story frame dwelling with a front-facing gable composition shingle roof; faces south, 2x3 bay core with rear extensions.

Condition: good _____ Integrity: fair _____ Ownership: private _____ Category: Building _____
 Historic Use: Single Dwelling - Non Farm _____ Current Use: Single Dwelling - Non Farm _____
 Function: Residence _____ Function: Residence _____

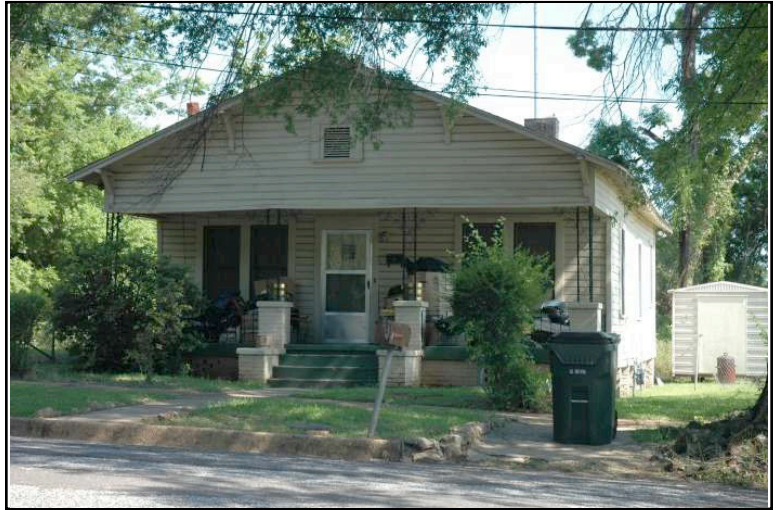
Rectangular 1-story frame dwelling with a front-facing gable composition shingle roof; faces north, 3x3 bay core.

Condition: good _____ Integrity: good _____ Ownership: private _____ Category: Building _____
 Historic Use: Single Dwelling - Non Farm _____ Current Use: Single Dwelling - Non Farm _____
 Function: Residence _____ Function: Residence _____

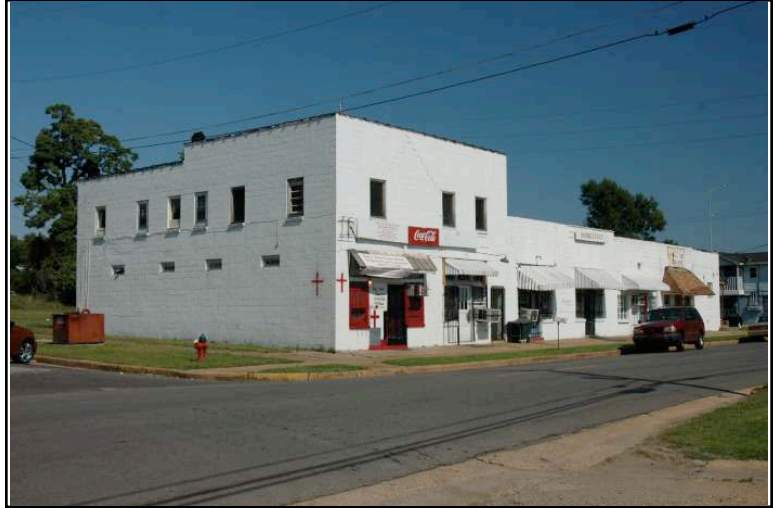
Rectangular 1 and 2 story 7-unit concrete block commercial row; faces west, 3x6 bay 2 story core to north with 1-story rectangular extension to south.

Condition: fair _____ Integrity: fair _____ Ownership: private _____ Category: Building _____
 Historic Use: Commerce/Trade _____ Current Use: Commerce/Trade _____
 Function: Specialty Store _____ Function: Specialty Store _____

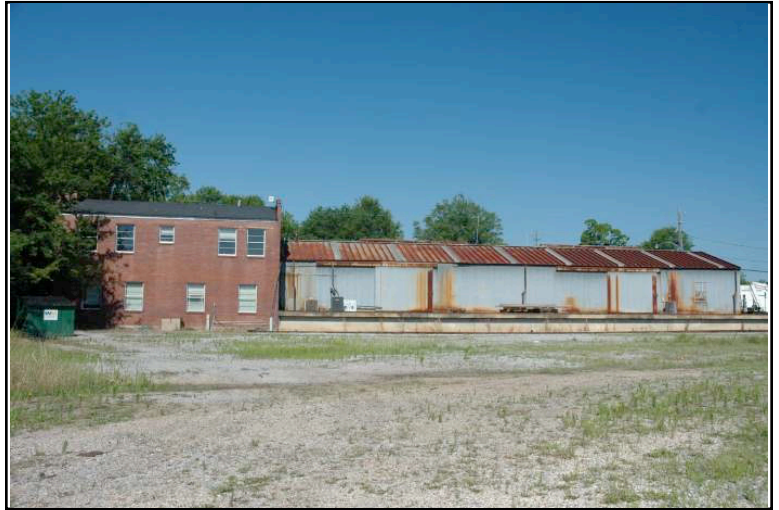
Rectangular 1 and 2 story industrial building; faces street to the east and railroad to the west, 2x5 bay 2 story brick veneer to north with 1-story rectangular warehouse extension to south clad with corrugated metal.

Condition: fair _____ Integrity: fair _____ Ownership: private _____ Category: Building _____
 Historic Use: Industry/Processing _____ Current Use: Unknown _____
 Function: _____ Function: _____

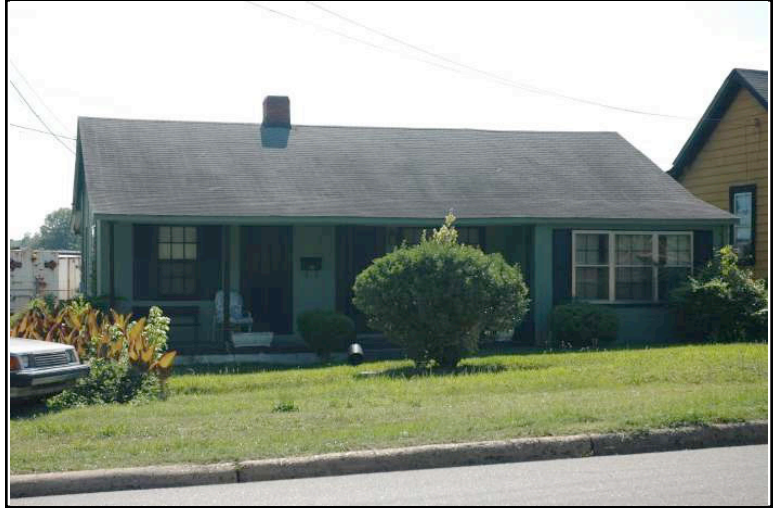
Rectangular 1-story frame dwelling with a side gable composition shingle roof; faces east, 6x2 bay core.

Condition: good _____ Integrity: fair _____ Ownership: private _____ Category: Building _____
 Historic Use: Single Dwelling - Non Farm _____ Current Use: Single Dwelling - Non Farm _____
 Function: Residence _____ Function: Residence _____

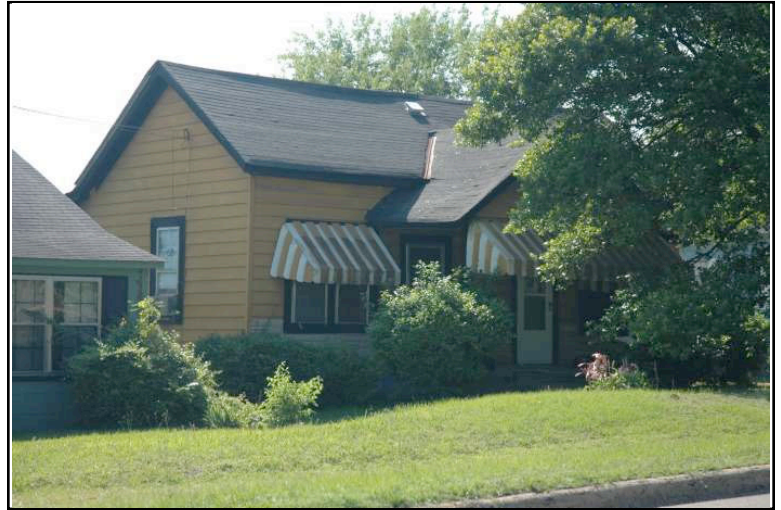
Rectangular 1-story frame dwelling with a side gable composition shingle roof; faces east, 4x1 bay core with rear extensions.

Condition: good _____ Integrity: poor _____ Ownership: private _____ Category: Building _____
 Historic Use: Single Dwelling - Non Farm _____ Current Use: Single Dwelling - Non Farm _____
 Function: Residence _____ Function: Residence _____

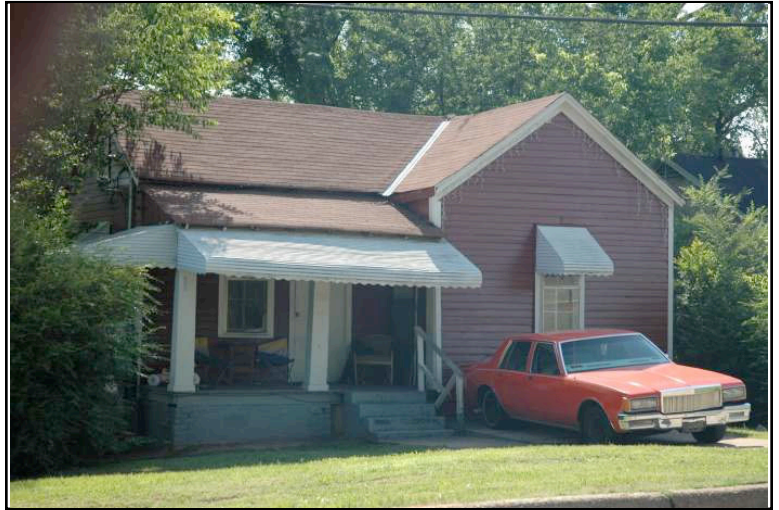
Rectangular 1-story frame dwelling with a cross gable composition shingle roof; faces east, 3x2 bay core with a slightly projecting front-facing gable wing to the north.

Condition: good _____ Integrity: good _____ Ownership: private _____ Category: Building _____
Historic Use: Single Dwelling - Non Farm _____ Current Use: Single Dwelling - Non Farm _____
Function: Residence _____ Function: Residence _____
