Tuscaloosa

Greater Downtown Study
Historic Resource Survey - 2006

Survey Number: _____ 1 _____
Historic name(s): House, Not Named
Common name: Southeast Appraisers
Location: University Blvd., 2720

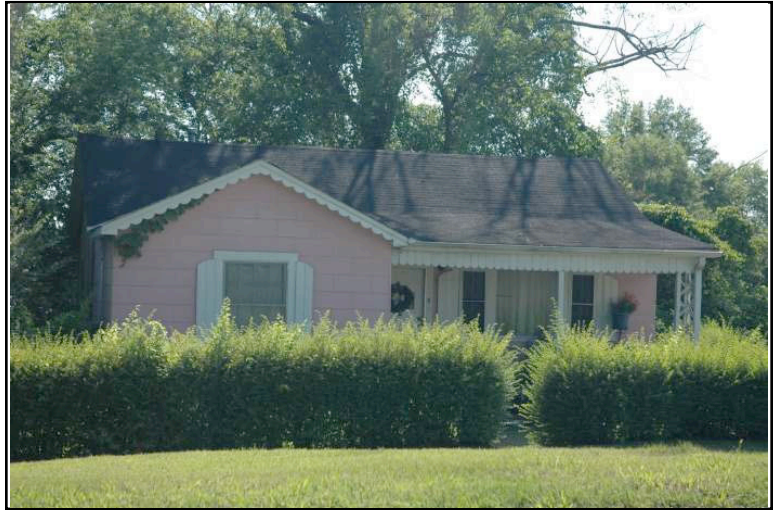
Rectangular 1-story frame dwelling with a side gable composition shingle roof; faces east, 3x2 bay core with a slightly projecting front-facing gable wing to the south.

Condition: good _____ Integrity: good _____ Ownership: private _____ Category: Building _____
 Historic Use: Single Dwelling - Non Farm _____ Current Use: Single Dwelling - Non Farm _____
 Function: Residence _____ Function: Residence _____

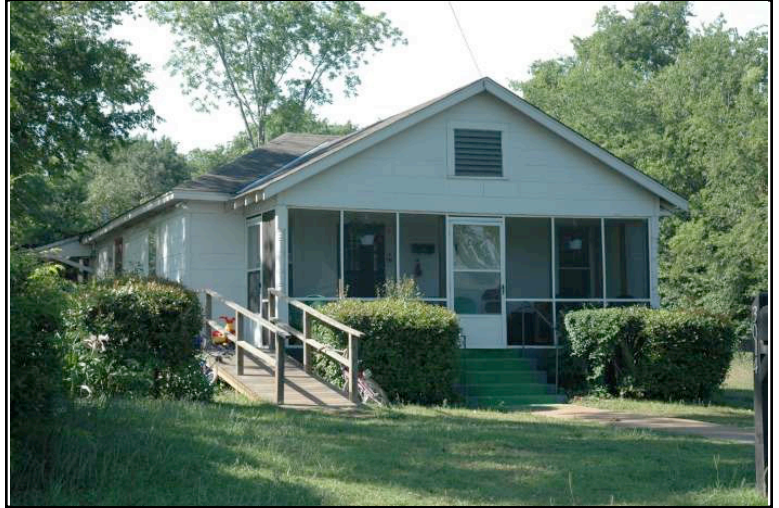
Rectangular 1-story frame dwelling with a hipped composition shingle roof; faces south, 4x3 bay core.

Condition: good _____ Integrity: fair _____ Ownership: private _____ Category: Building _____
 Historic Use: Single Dwelling - Non Farm _____ Current Use: Single Dwelling - Non Farm _____
 Function: Residence _____ Function: Residence _____

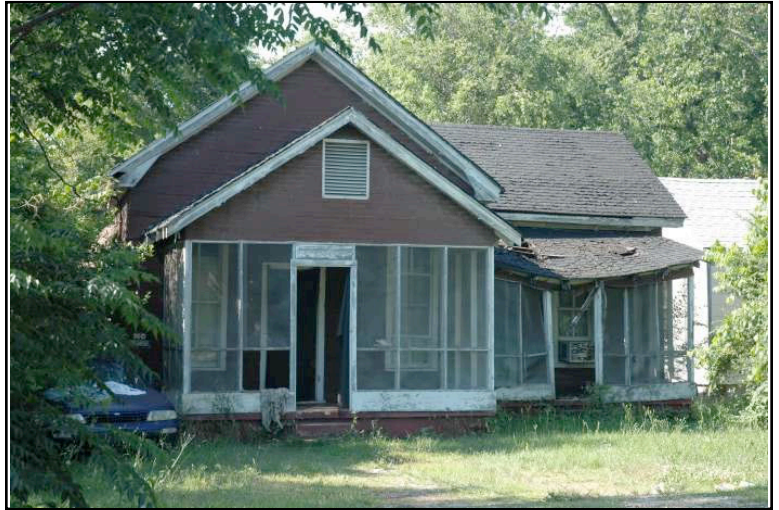
L-shaped 1-story frame dwelling with a cross gable composition shingle roof; faces south, 3x3 bay core with a 2-bay wide wing to the east.

Condition: deteriorated__ Integrity: fair_____ Ownership: private_____ Category: Building_____

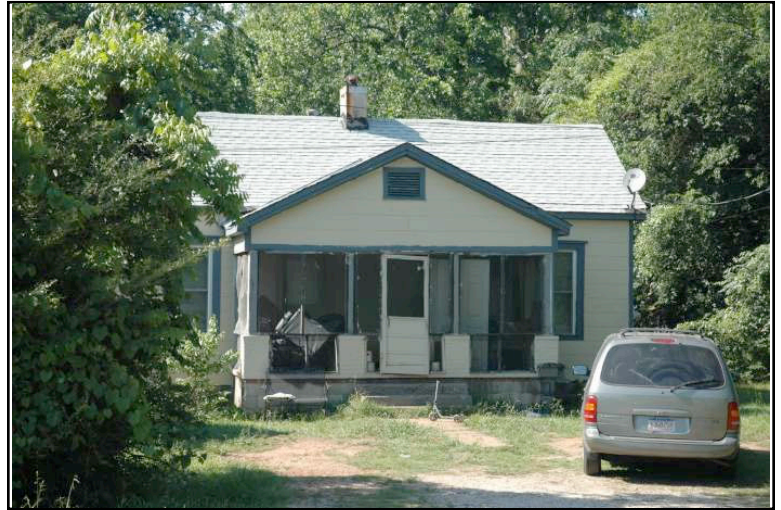
Rectangular 1-story frame dwelling with a side gable composition shingle roof; faces south, 4x2 bay core.

Condition: fair _____ Integrity: fair _____ Ownership: private _____ Category: Building _____
 Historic Use: Single Dwelling - Non Farm _____ Current Use: Single Dwelling - Non Farm _____
 Function: Residence _____ Function: Residence _____

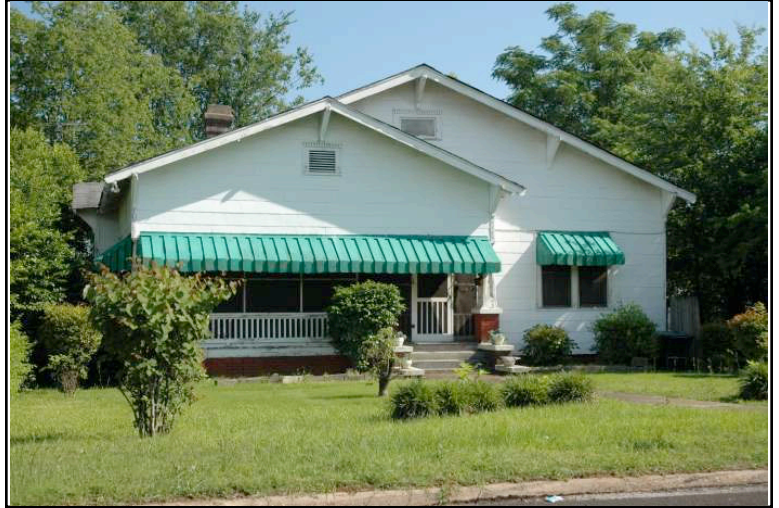
Rectangular 1-story frame dwelling with a front-facing gable composition shingle roof; faces north, 3x3 bay core with 2 eastern bays of recessed.

Condition: fair _____ Integrity: fair _____ Ownership: private _____ Category: Building _____
 Historic Use: Single Dwelling - Non Farm _____ Current Use: Single Dwelling - Non Farm _____
 Function: Residence _____ Function: Residence _____

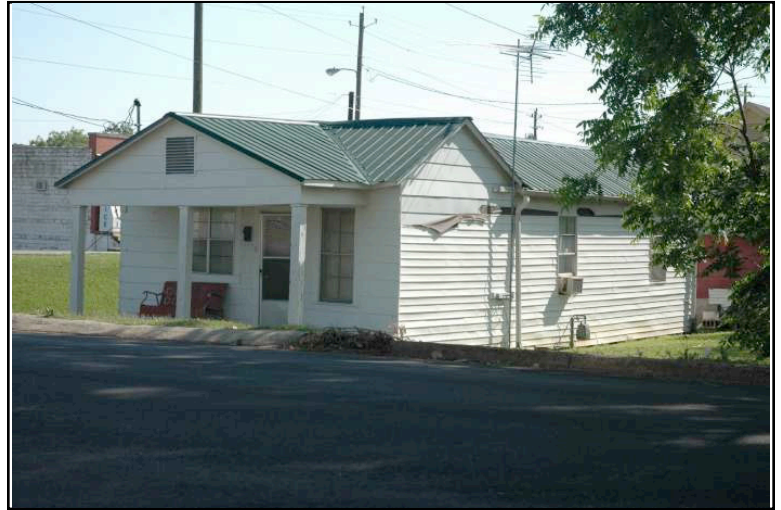
Rectangular 1-story frame dwelling with a cross gable industrial metal roof; faces east, 3x3 bay core.

Condition: fair _____ Integrity: fair _____ Ownership: private _____ Category: Building _____
 Historic Use: Single Dwelling - Non Farm _____ Current Use: Single Dwelling - Non Farm _____
 Function: Residence _____ Function: Residence _____

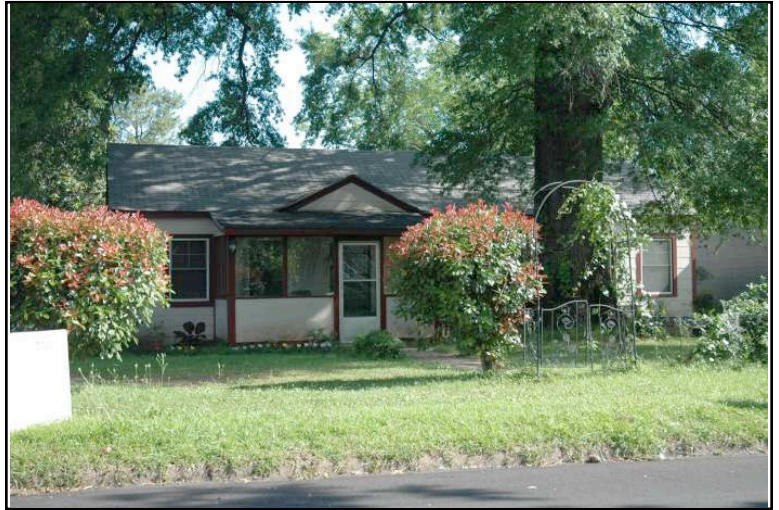
Rectangular 1-story concrete block dwelling with a side gable composition shingle roof; faces north, 5x2 bay concrete block core with 2-bay wide frame extension to east.

Condition: fair _____ Integrity: fair _____ Ownership: private _____ Category: Building _____
 Historic Use: Single Dwelling - Non Farm _____ Current Use: Single Dwelling - Non Farm _____
 Function: Residence _____ Function: Residence _____

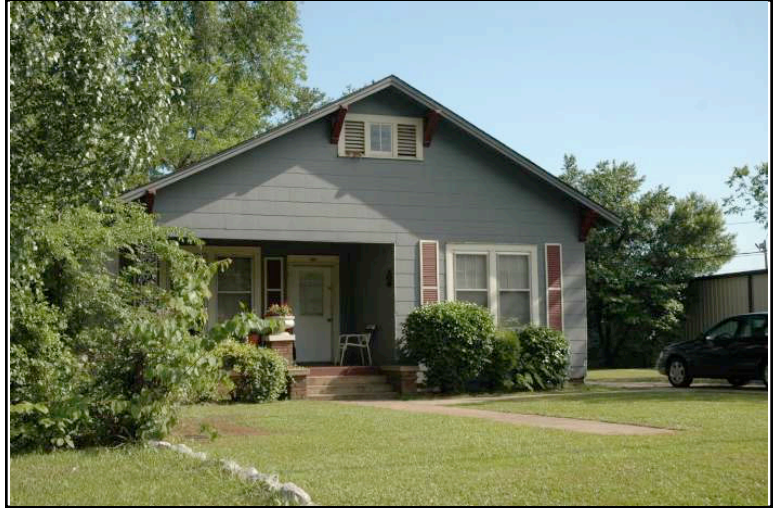
Rectangular 1-story frame dwelling with a front-facing gable composition shingle roof; faces north, 3x3 bay core with 2 eastern bays recessed.

Condition: good _____ Integrity: good _____ Ownership: private _____ Category: Building _____
 Historic Use: Single Dwelling - Non Farm _____ Current Use: Single Dwelling - Non Farm _____
 Function: Residence _____ Function: Residence _____

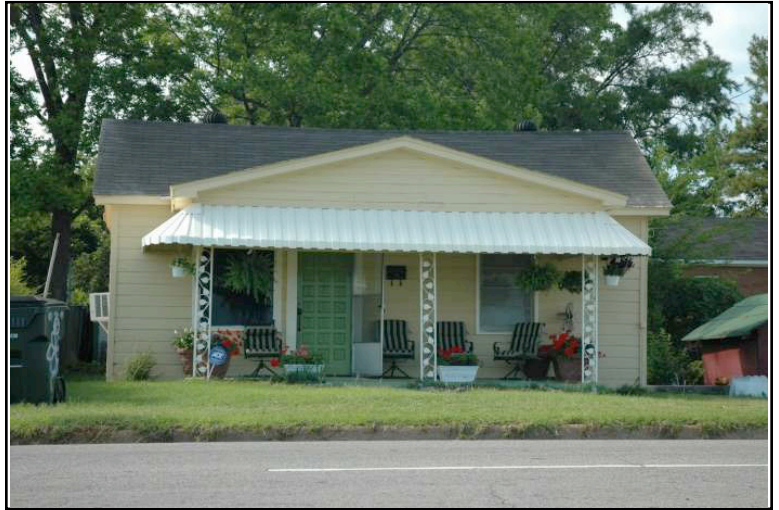
Rectangular 1-story frame dwelling with a side gable composition shingle roof; faces north, 3x3 bay core.

Condition: good _____ Integrity: good _____ Ownership: private _____ Category: Building _____
 Historic Use: Single Dwelling - Non Farm _____ Current Use: Single Dwelling - Non Farm _____
 Function: Residence _____ Function: Residence _____

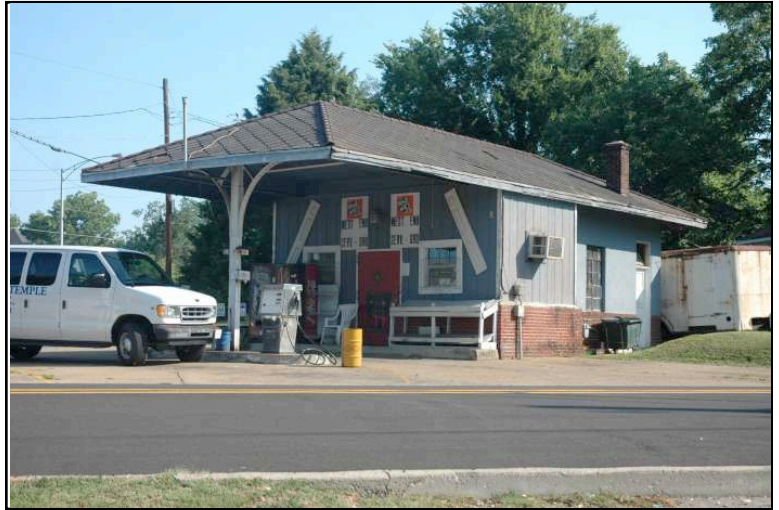
Rectangular 1-story gasoline service station with a hipped patterned composition shingle roof; faces southwest, 3x3 bay core; appears to be masonry with modern siding applied to front bay.

Condition: good _____ Integrity: fair _____ Ownership: private _____ Category: Building _____
 Historic Use: Commerce/Trade _____ Current Use: Commerce/Trade _____
 Function: Gasoline Station _____ Function: Gasoline Station _____

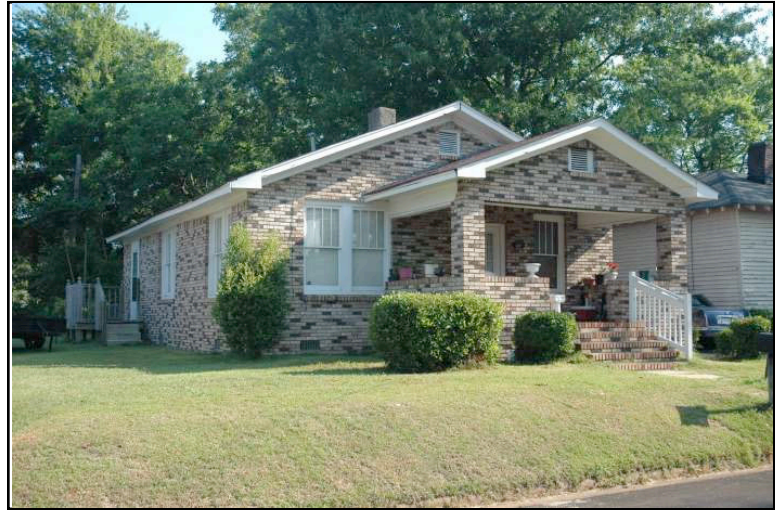
Rectangular 1-story brick veneer dwelling with a front-facing gable composition shingle roof; faces south, 3x1 bay core.

Condition: good _____ Integrity: fair _____ Ownership: private _____ Category: Building _____
 Historic Use: Single Dwelling - Non Farm _____ Current Use: Single Dwelling - Non Farm _____
 Function: Residence _____ Function: Residence _____

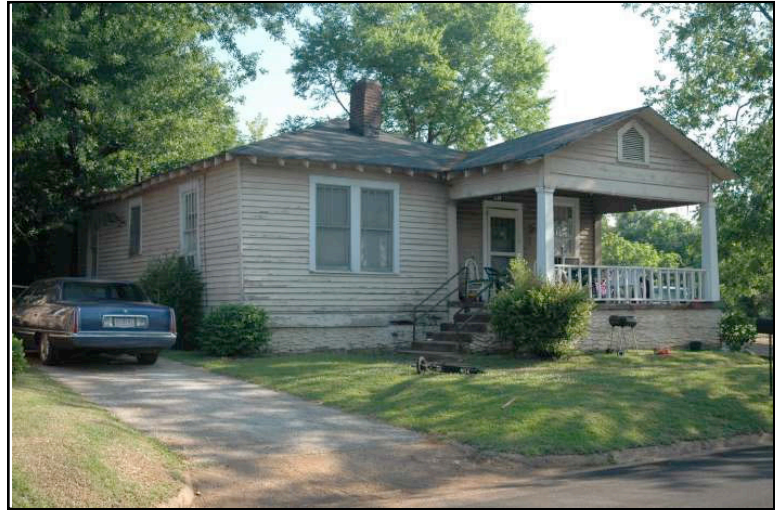
Rectangular 1-story frame dwelling with a hipped composition shingle roof; faces south, 3x3 bay core, eastern 2 bays slightly recessed.

Condition: good _____ Integrity: good _____ Ownership: private _____ Category: Building _____
 Historic Use: Single Dwelling - Non Farm _____ Current Use: Single Dwelling - Non Farm _____
 Function: Residence _____ Function: Residence _____

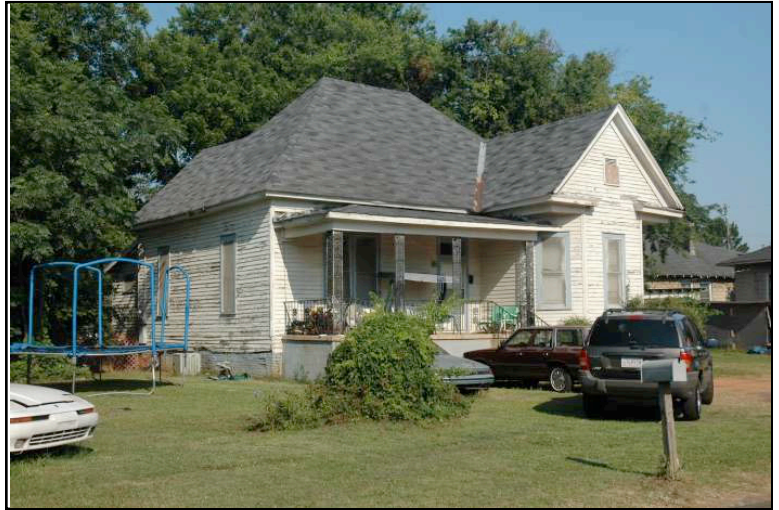
Rectangular 1-story frame dwelling with a hipped composition shingle roof; faces east, 3x2 bay core with a 1-bay wide front-facing gable cutaway bay at the south bay of its facade, rear shed extension.

Condition: good _____ Integrity: good _____ Ownership: private _____ Category: Building _____
 Historic Use: Single Dwelling - Non Farm _____ Current Use: Single Dwelling - Non Farm _____
 Function: Residence _____ Function: Residence _____

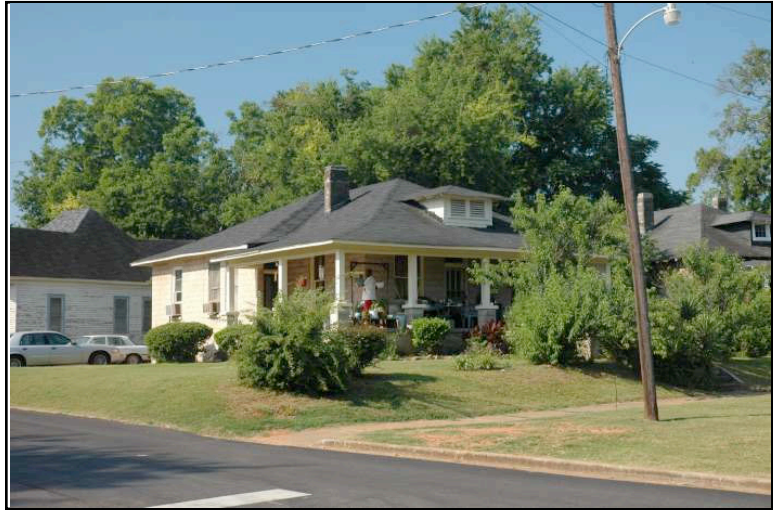
Rectangular 1-story frame dwelling with a hipped composition shingle roof with central hipped decorative dormer; faces east, rectangular 4x4 bay core, front bay slightly narrower than rear bays.

Condition: good _____ Integrity: good _____ Ownership: private _____ Category: Building _____
 Historic Use: Single Dwelling - Non Farm _____ Current Use: Single Dwelling - Non Farm _____
 Function: Residence _____ Function: Residence _____

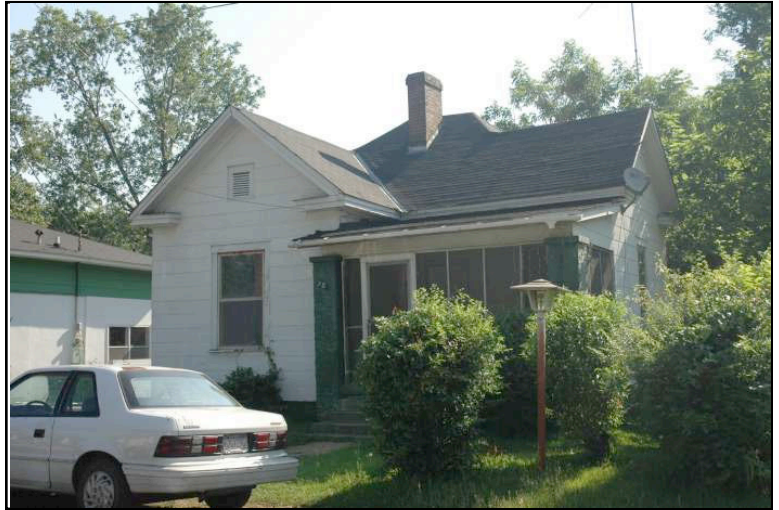
Rectangular 1-story frame dwelling with a hipped composition shingle roof with cross gables; faces west, 3x2 bay core with a 1-bay wide front-facing gable bay at the north bay of its facade, rear extension.

Condition: fair _____ Integrity: fair _____ Ownership: private _____ Category: Building _____
 Historic Use: Single Dwelling - Non Farm _____ Current Use: Single Dwelling - Non Farm _____
 Function: Residence _____ Function: Residence _____

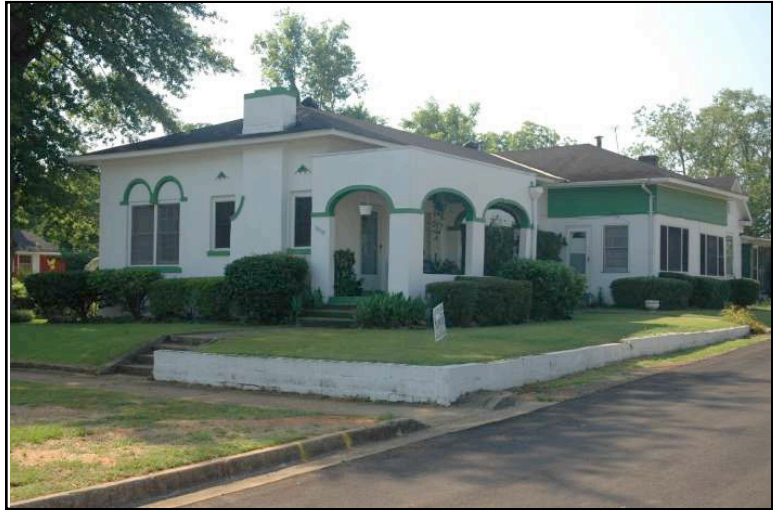
Rectangular 1-story stuccoed masonry dwelling with a hipped composition shingle roof; faces west, 3x2 bay core with a 2x4 bay addition to the south.

Condition: good _____ Integrity: good _____ Ownership: private _____ Category: Building _____
 Historic Use: Single Dwelling - Non Farm _____ Current Use: Single Dwelling - Non Farm _____
 Function: Residence _____ Function: Residence _____

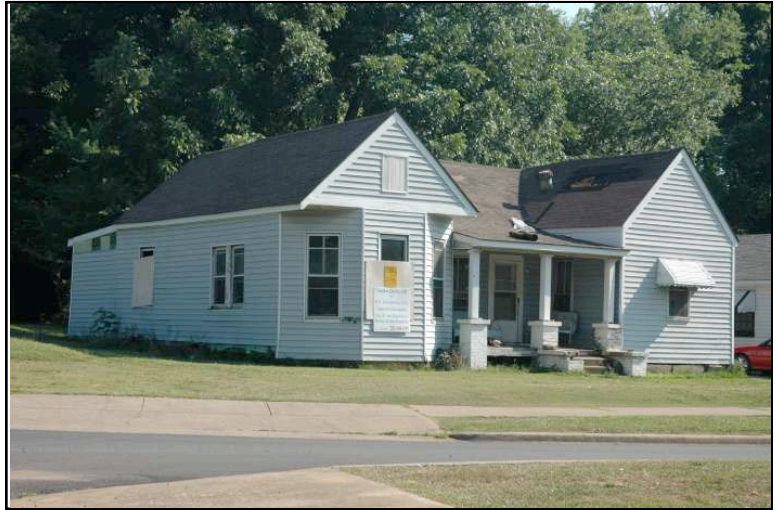
U-shaped 1-story frame dwelling with a cross gable composition shingle roof; faces south, 5x1 bay core with a front-facing gable wings to the east and west, west wing has a cutaway bay.

Condition: good _____ Integrity: fair _____ Ownership: private _____ Category: Building _____
 Historic Use: Single Dwelling - Non Farm _____ Current Use: Single Dwelling - Non Farm _____
 Function: Residence _____ Function: Residence _____

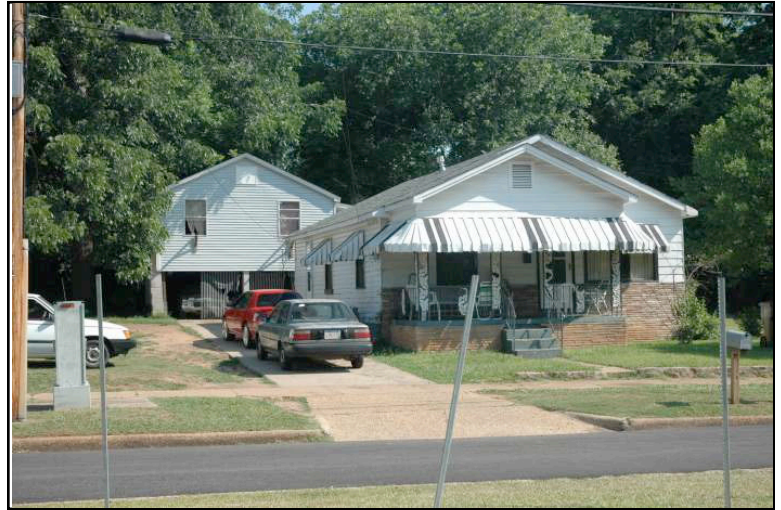
Rectangular 1-story frame dwelling with a front-facing gable composition shingle roof; faces south, 3x3 bay core; ancillary garage with 2nd floor at rear.

Condition: good _____ Integrity: fair _____ Ownership: private _____ Category: Building _____
Historic Use: Single Dwelling - Non Farm _____ Current Use: Single Dwelling - Non Farm _____
Function: Residence _____ Function: Residence _____

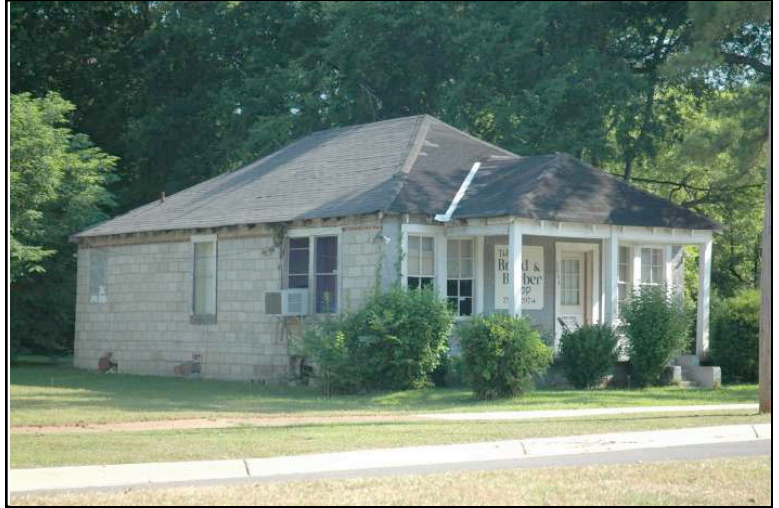
Rectangular 1-story concrete block dwelling with a hipped composition shingle roof; faces south, 3x3 bay core.

Condition: fair _____ Integrity: good _____ Ownership: private _____ Category: Building _____
Historic Use: Single Dwelling - Non Farm _____ Current Use: Single Dwelling - Non Farm _____
Function: Residence _____ Function: Residence _____

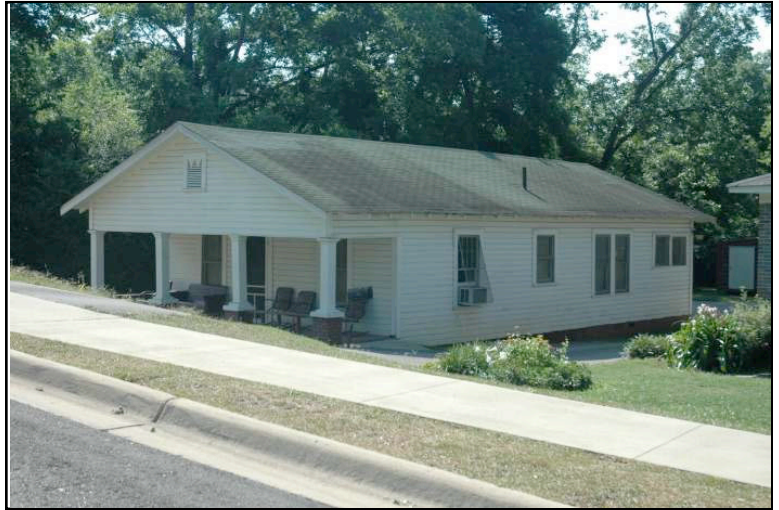
Rectangular 1-story frame dwelling with a front-facing composition shingle roof; faces north, 3x4 bay core.

Condition: good _____ Integrity: good _____ Ownership: private _____ Category: Building _____
 Historic Use: Single Dwelling - Non Farm _____ Current Use: Single Dwelling - Non Farm _____
 Function: Residence _____ Function: Residence _____

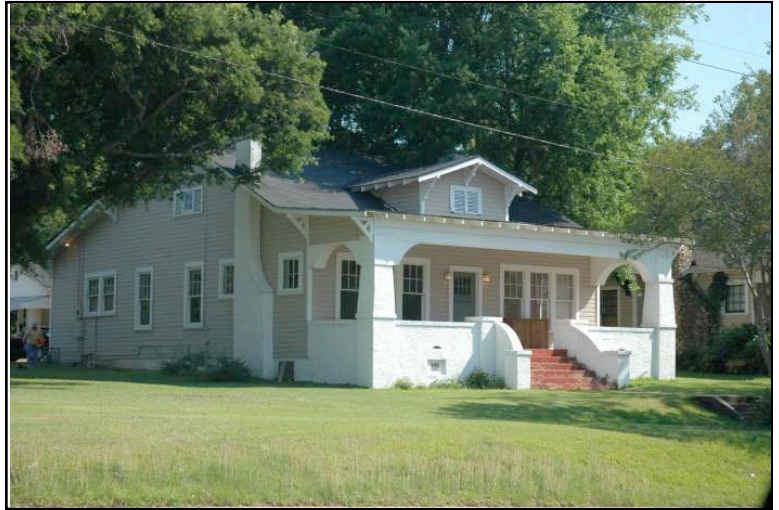
Rectangular 1-story frame dwelling with a side gable composition shingle roof; faces south, 3x5 bay core.

Condition: good _____ Integrity: good _____ Ownership: private _____ Category: Building _____
 Historic Use: Single Dwelling - Non Farm _____ Current Use: Single Dwelling - Non Farm _____
 Function: Residence _____ Function: Residence _____

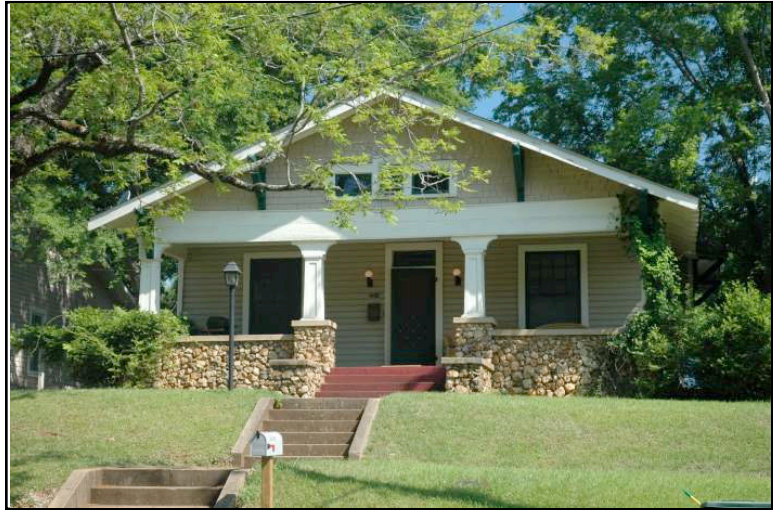
Rectangular 1-story frame dwelling with a front-facing gable composition shingle roof; faces south, 3x3 bay core.

Condition: good _____ Integrity: good _____ Ownership: private _____ Category: Building _____
 Historic Use: Single Dwelling - Non Farm _____ Current Use: Single Dwelling - Non Farm _____
 Function: Residence _____ Function: Residence _____

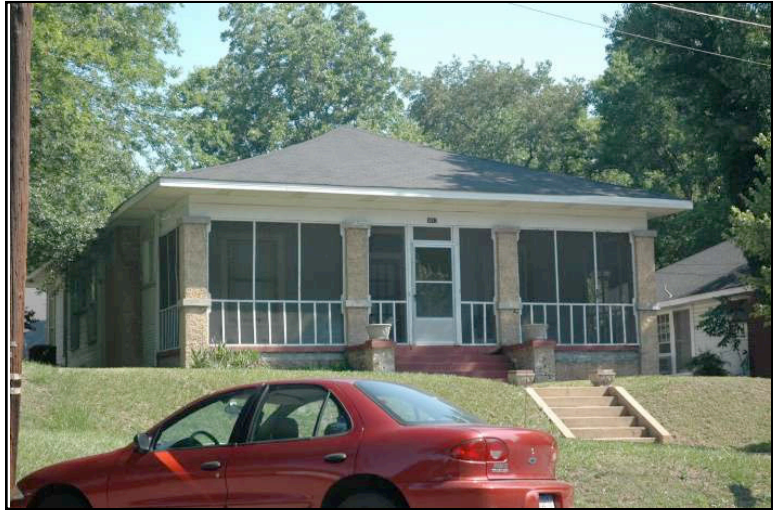
Rectangular 1-story frame dwelling with a hipped composition shingle roof; faces south, 3x3 bay core.

Condition: good _____ Integrity: good _____ Ownership: private _____ Category: Building _____
 Historic Use: Single Dwelling - Non Farm _____ Current Use: Single Dwelling - Non Farm _____
 Function: Residence _____ Function: Residence _____

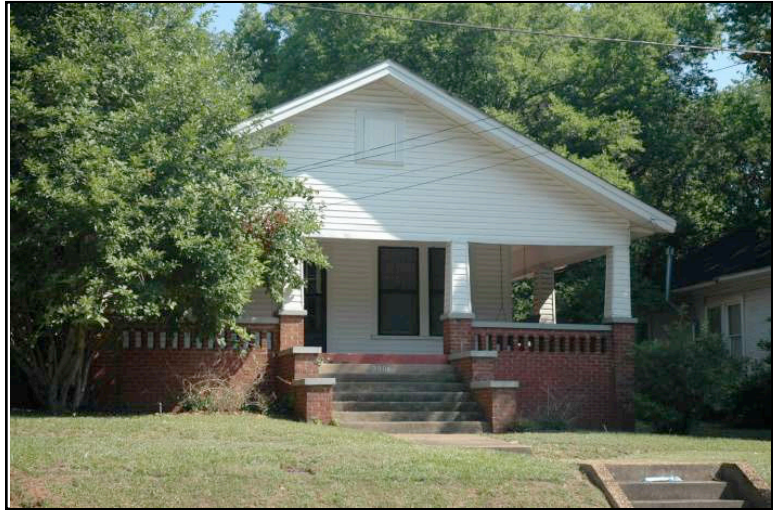
Rectangular 1-story frame dwelling with a front-facing gable composition shingle roof; faces south, 4x4 bay core.

Condition: good _____ Integrity: fair _____ Ownership: private _____ Category: Building _____
 Historic Use: Single Dwelling - Non Farm _____ Current Use: Single Dwelling - Non Farm _____
 Function: Residence _____ Function: Residence _____

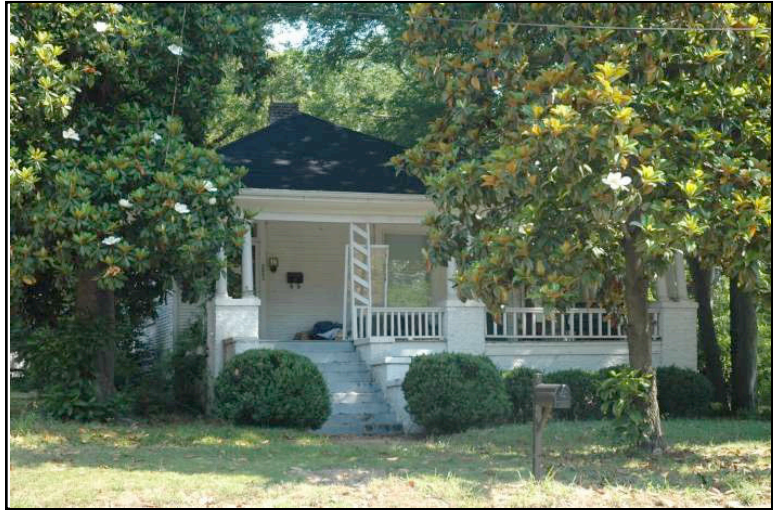
Rectangular 1-story frame dwelling with a hipped composition shingle roof; faces south, 3x3 bay core.

Condition: good _____ Integrity: fair _____ Ownership: private _____ Category: Building _____
 Historic Use: Single Dwelling - Non Farm _____ Current Use: Single Dwelling - Non Farm _____
 Function: Residence _____ Function: Residence _____

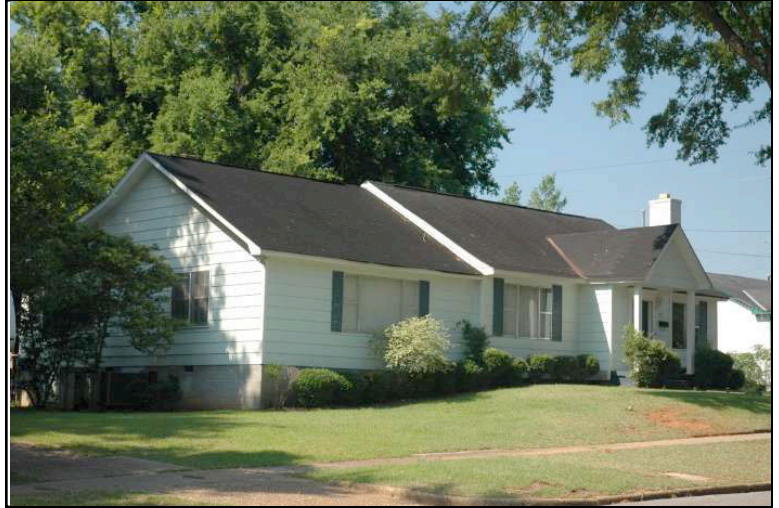
Rectangular 1-story frame dwelling with a side gable composition shingle roof; faces south, 3x2 bay core with gable extension to east.

Condition: good _____ Integrity: fair _____ Ownership: private _____ Category: Building _____
 Historic Use: Single Dwelling - Non Farm _____ Current Use: Single Dwelling - Non Farm _____
 Function: Residence _____ Function: Residence _____

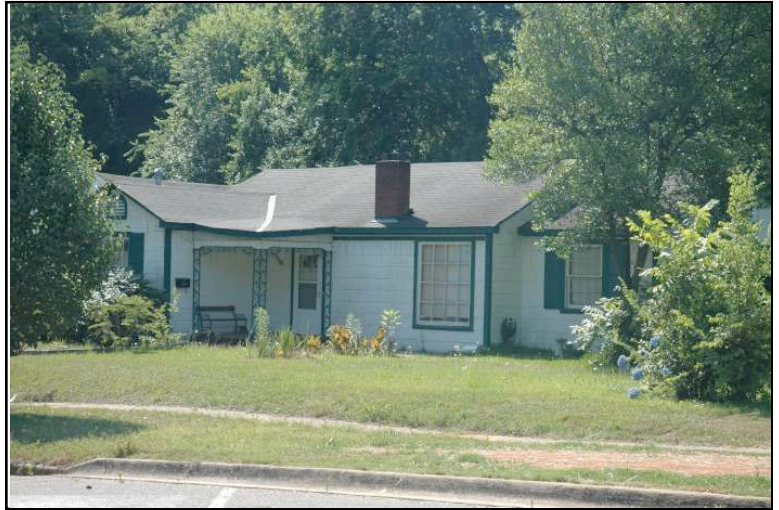
Rectangular 1-story frame dwelling with a cross gable composition shingle roof; faces south, 3x2 bay core with secondary front-facing gable wing to the east.

Condition: fair _____ Integrity: good _____ Ownership: private _____ Category: Building _____
 Historic Use: Single Dwelling - Non Farm _____ Current Use: Single Dwelling - Non Farm _____
 Function: Residence _____ Function: Residence _____

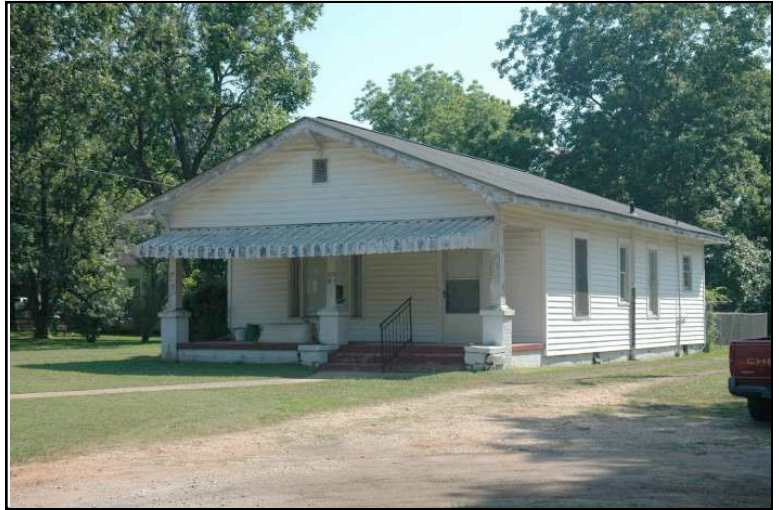
Rectangular 1-story frame dwelling with a front-facing gable composition shingle roof; faces west, 2x4 bay core.

Condition: good _____ Integrity: fair _____ Ownership: private _____ Category: Building _____
 Historic Use: Single Dwelling - Non Farm _____ Current Use: Single Dwelling - Non Farm _____
 Function: Residence _____ Function: Residence _____

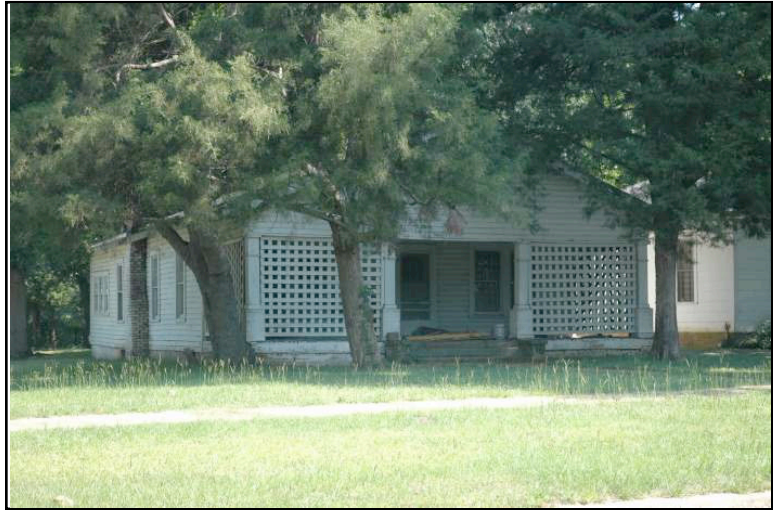
Rectangular 1-story frame dwelling with a front-facing gable composition shingle roof; faces south, 3x3 bay core.

Condition: good _____ Integrity: good _____ Ownership: private _____ Category: Building _____
 Historic Use: Single Dwelling - Non Farm _____ Current Use: Single Dwelling - Non Farm _____
 Function: Residence _____ Function: Residence _____

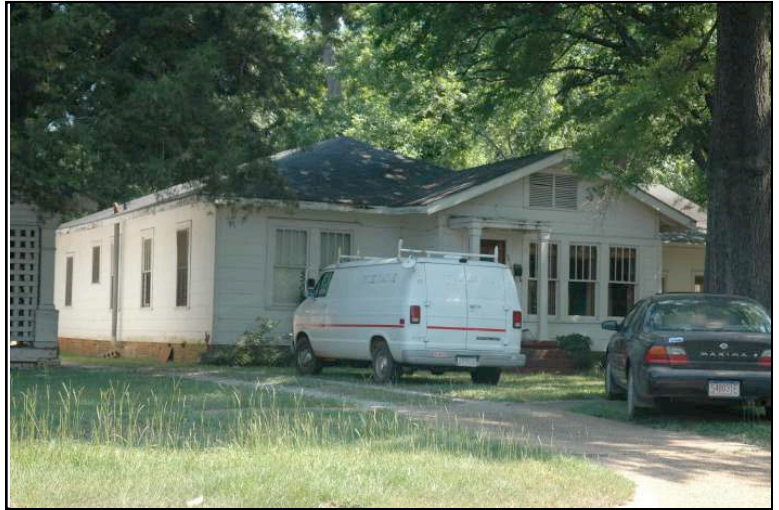
Rectangular 1-story frame dwelling with a hipped composition shingle roof; faces south, 3x4 bay core with a 3-bay wide gable addition to the east.

Condition: good _____ Integrity: fair _____ Ownership: private _____ Category: Building _____
 Historic Use: Single Dwelling - Non Farm _____ Current Use: Single Dwelling - Non Farm _____
 Function: Residence _____ Function: Residence _____

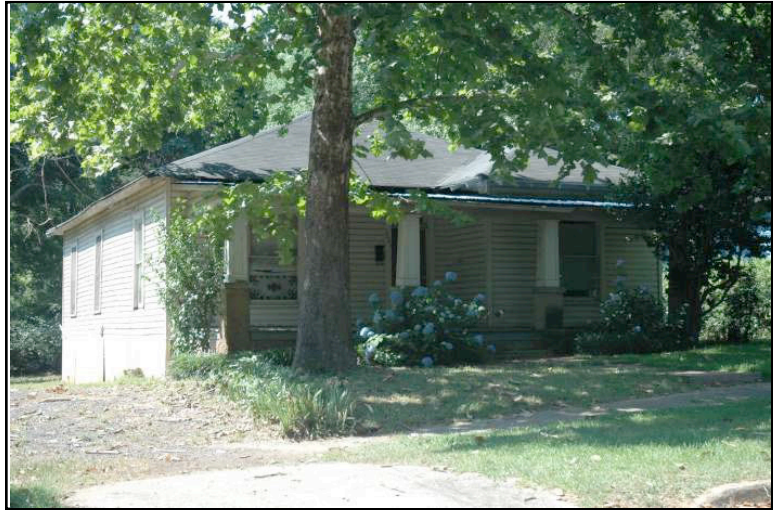
Rectangular 1-story frame dwelling with a hipped composition shingle roof; faces north, 3x3 bay core with slightly projected west bay of façade.

Condition: good _____ Integrity: good _____ Ownership: private _____ Category: Building _____
 Historic Use: Single Dwelling - Non Farm _____ Current Use: Single Dwelling - Non Farm _____
 Function: Residence _____ Function: Residence _____

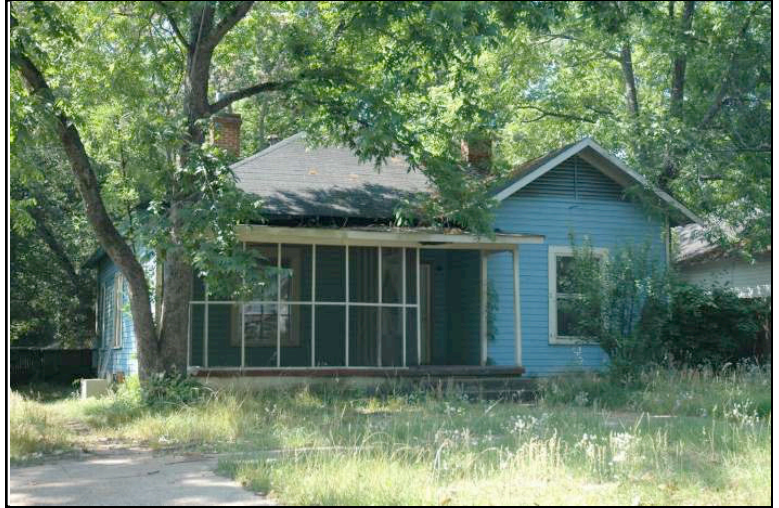
Rectangular 1-story frame dwelling with a hipped composition shingle roof; faces north, 3x3 bay core with front-facing gable projection at west bay of façade.

Condition: good _____ Integrity: fair _____ Ownership: private _____ Category: Building _____
 Historic Use: Single Dwelling - Non Farm _____ Current Use: Single Dwelling - Non Farm _____
 Function: Residence _____ Function: Residence _____

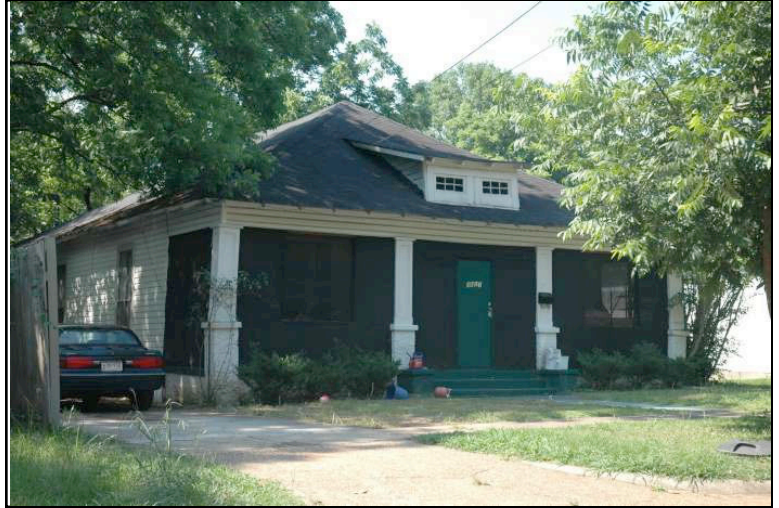
Rectangular 1-story frame dwelling with a hipped composition shingle roof; faces north, 3x3 bay core.

Condition: good _____ Integrity: fair _____ Ownership: private _____ Category: Building _____
 Historic Use: Single Dwelling - Non Farm _____ Current Use: Single Dwelling - Non Farm _____
 Function: Residence _____ Function: Residence _____

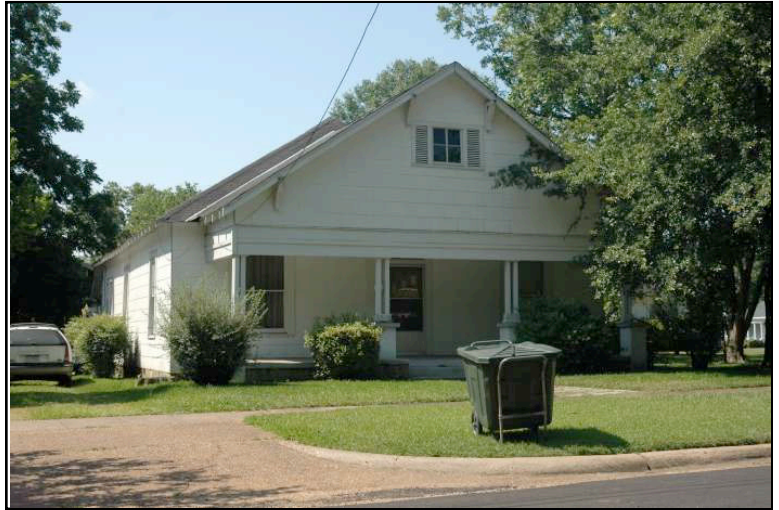
Rectangular 1-story frame dwelling with a hipped composition shingle roof; faces north, 3x3 bay core with rear shed extension.

Condition: good _____ Integrity: fair _____ Ownership: private _____ Category: Building _____
 Historic Use: Single Dwelling - Non Farm _____ Current Use: Single Dwelling - Non Farm _____
 Function: Residence _____ Function: Residence _____

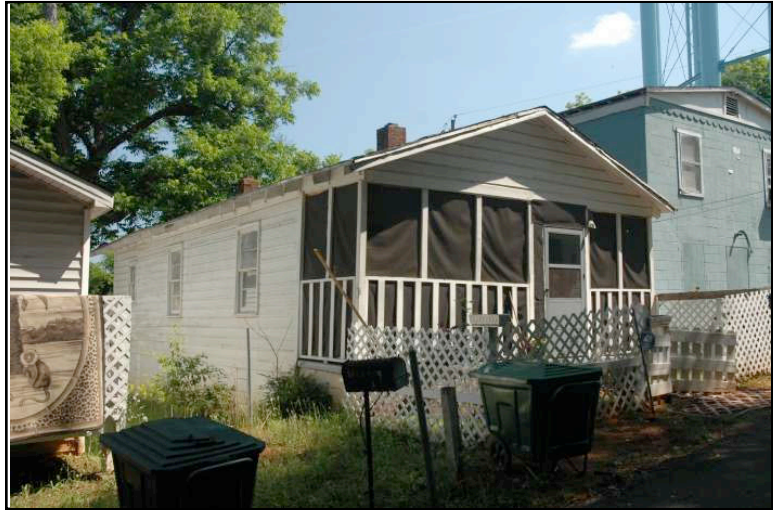
Rectangular 1-story frame dwelling with a front-facing gable composition shingle roof; faces south, 3x3 bay core.

Condition: good _____ Integrity: good _____ Ownership: private _____ Category: Building _____
 Historic Use: Single Dwelling - Non Farm _____ Current Use: Single Dwelling - Non Farm _____
 Function: Residence _____ Function: Residence _____

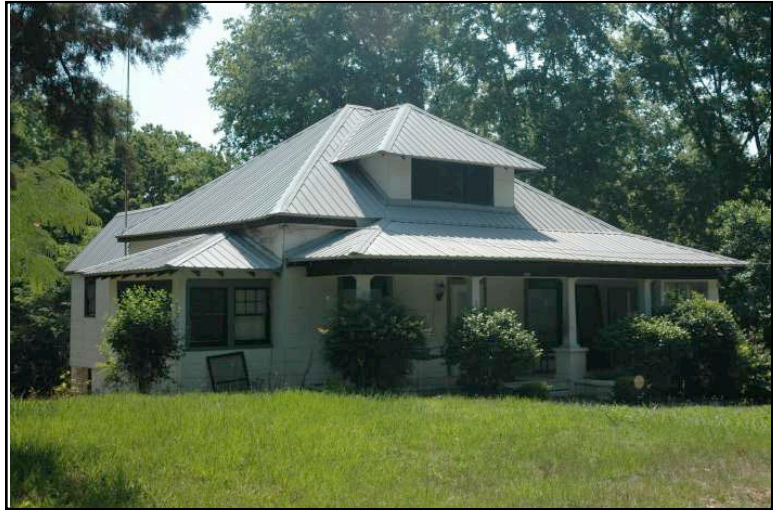
Rectangular 1-story frame dwelling with a hipped industrial metal roof; faces west, 4x2 bay core with rear gable extension, side gable bay at rear bay of south elevation, hipped addition at north elevation.

Condition: good _____ Integrity: fair _____ Ownership: private _____ Category: Building _____
 Historic Use: Single Dwelling - Non Farm _____ Current Use: Single Dwelling - Non Farm _____
 Function: Residence _____ Function: Residence _____

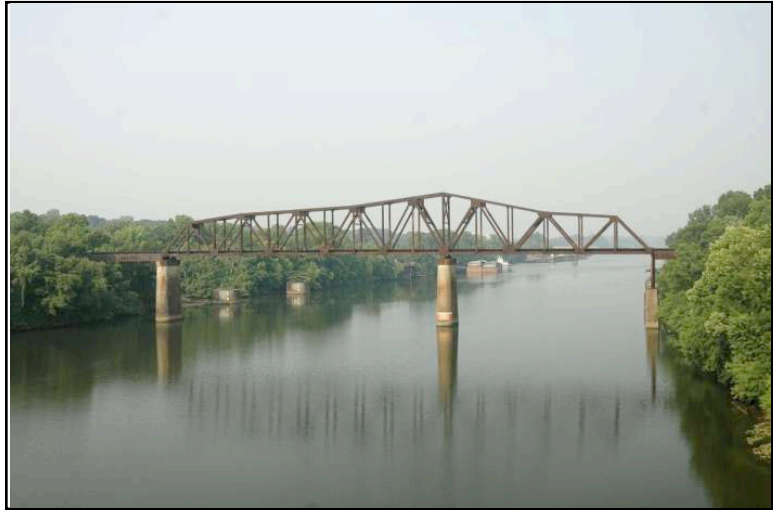
Curved wooden trestle with intermediate steel truss span supported by concrete abutments.

Condition: good _____ Integrity: good _____ Ownership: private _____ Category: Structure _____
 Historic Use: Transportation _____ Current Use: Transportation _____
 Function: Rail Related _____ Function: Rail Related _____

According to a historical marker: "This wooden and steel truss bridge was constructed for the Mobile and Ohio Railroad in 1898 by civil engineer Benjamin Hardaway, an 1887 graduate of The University of Alabama and former Tuscaloosa City Engineer. Originally 135-feet high with a 110-foot clearance, it was once considered by many to be the country's longest trestle at 3600 feet." A steel bridge structure shown in historic postcard views was replaced with the present span in 1924.

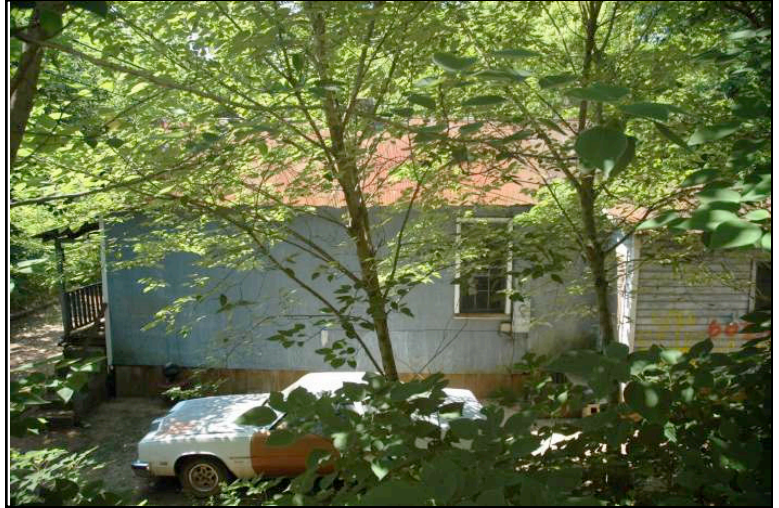
Site not readily accessible. Rectangular 1-story frame shotgun dwelling; faces east.

Condition: fair _____ Integrity: fair _____ Ownership: private _____ Category: Building _____
 Historic Use: Single Dwelling - Non Farm _____ Current Use: Single Dwelling - Non Farm _____
 Function: Residence _____ Function: Residence _____

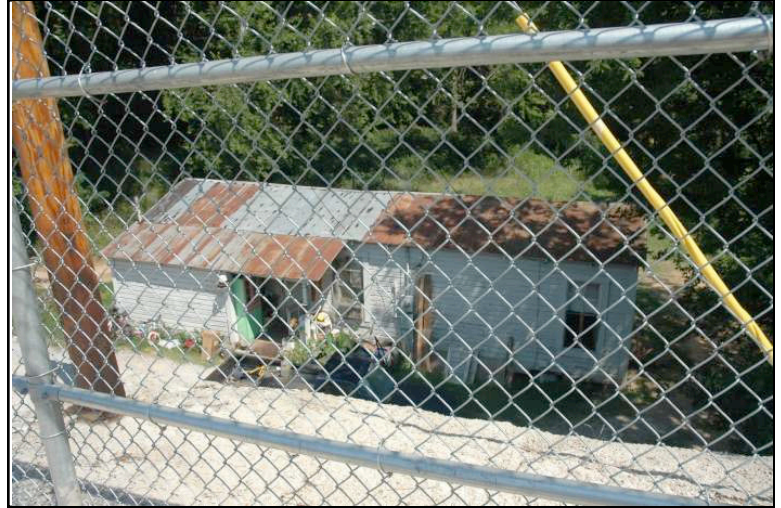
Site not readily accessible. Rectangular 1-story frame shotgun dwelling; faces east, rectangular 1x3 bay core.

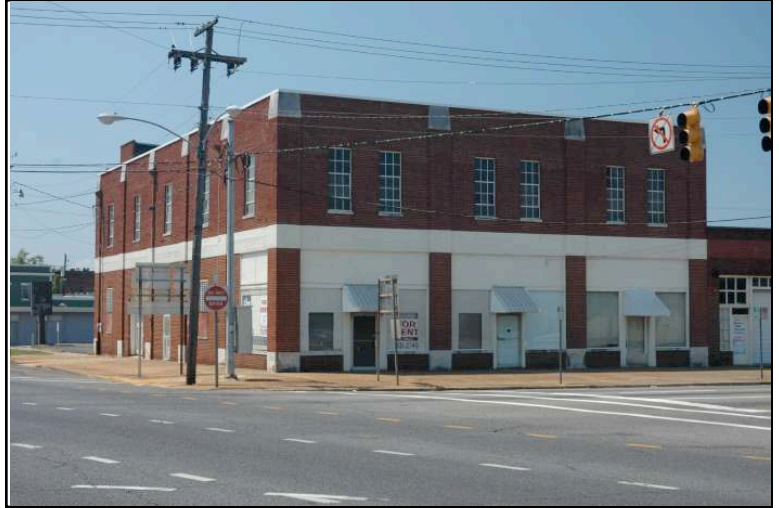
Rectangular 2-story brick commercial building with a flat roof concealed by low flat parapets; faces north, 6x5 bay core.

Condition: good _____ Integrity: good _____ Ownership: private _____ Category: Building _____
 Historic Use: Commerce/Trade _____ Current Use: Commerce/Trade _____
 Function: Specialty Store _____ Function: Specialty Store _____

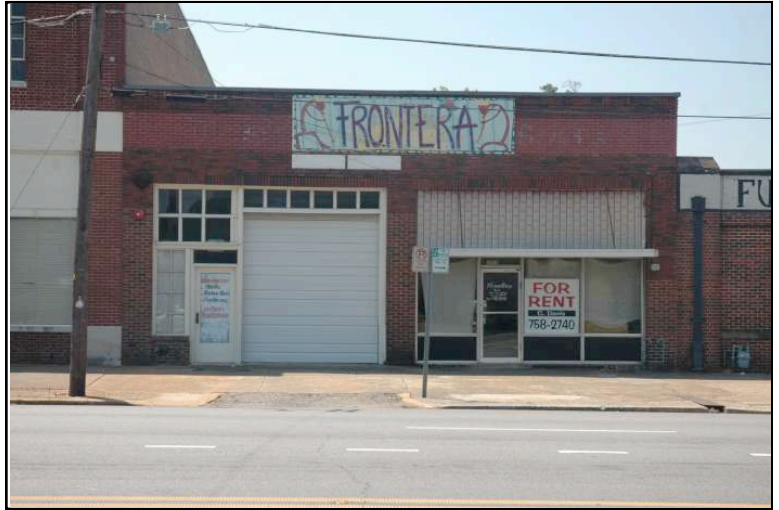
Rectangular 1-story brick commercial building with a flat roof concealed by a low flat parapet; faces north, 3 bays wide.

Condition: good _____ Integrity: good _____ Ownership: private _____ Category: Building _____
 Historic Use: Commerce/Trade _____ Current Use: Commerce/Trade _____
 Function: Specialty Store _____ Function: Specialty Store _____

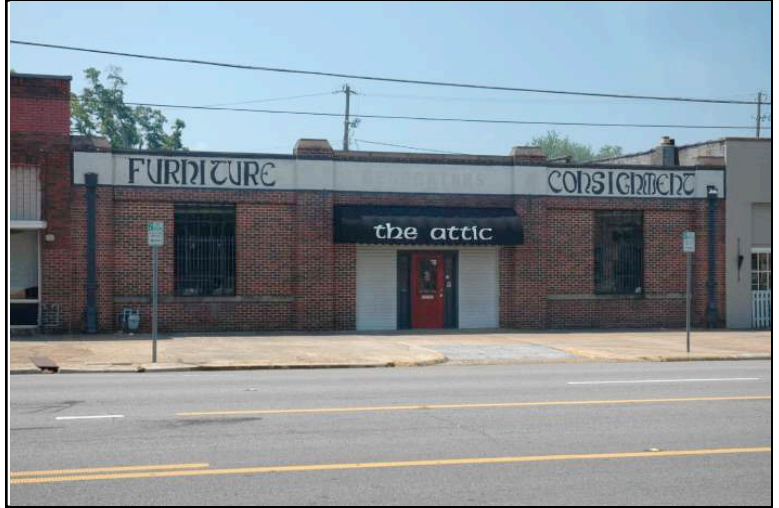
Rectangular 1-story brick commercial building with a flat roof concealed by a low flat parapet; faces north, 4 bays wide.

Condition: good _____ Integrity: good _____ Ownership: private _____ Category: Building _____
Historic Use: Commerce/Trade _____ Current Use: Commerce/Trade _____
Function: Specialty Store _____ Function: Specialty Store _____

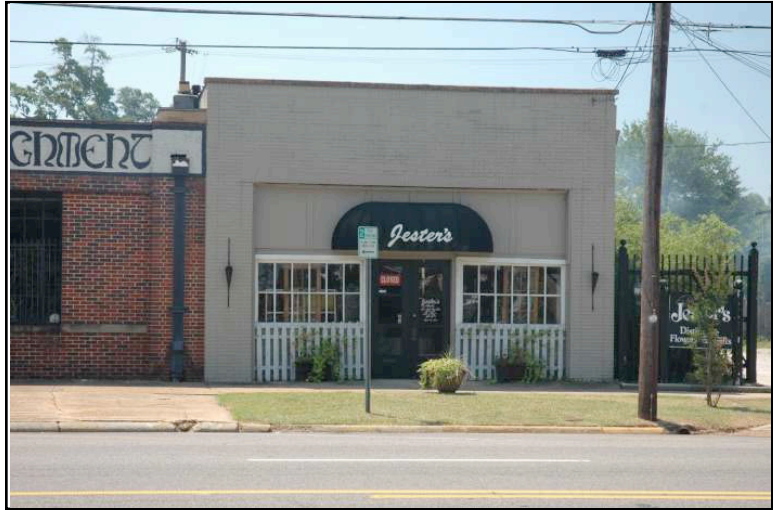
Rectangular 1-story brick commercial building with a flat roof concealed by a flat parapet; faces north, 3 bays wide.

Condition: good _____ Integrity: good _____ Ownership: private _____ Category: Building _____
 Historic Use: Commerce/Trade _____ Current Use: Commerce/Trade _____
 Function: Specialty Store _____ Function: Specialty Store _____

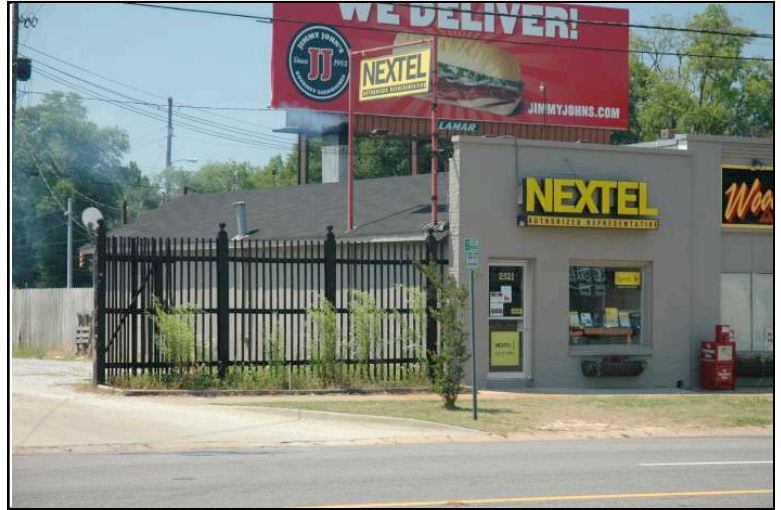
Rectangular 1-story brick commercial building with a gable roof concealed by a tall flat parapet; faces north, 2 bays wide.

Condition: good _____ Integrity: good _____ Ownership: private _____ Category: Building _____
 Historic Use: Commerce/Trade _____ Current Use: Commerce/Trade _____
 Function: Specialty Store _____ Function: Specialty Store _____

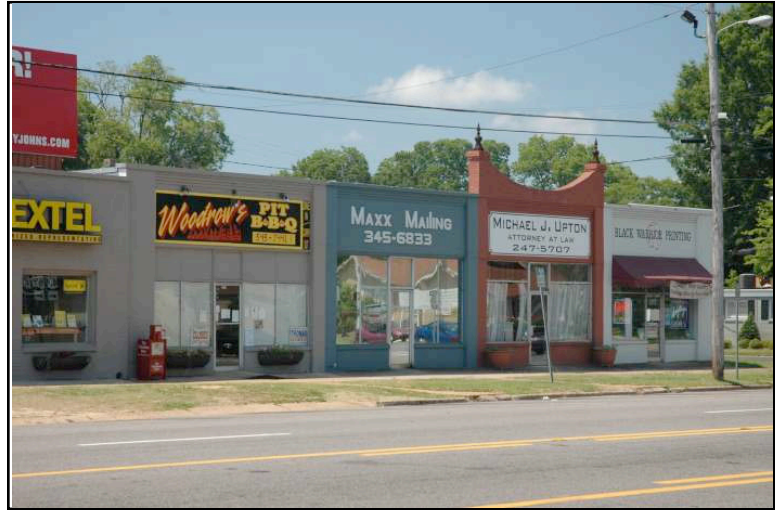
Rectangular 1-story brick 4-unit commercial building with a flat roof concealed by flat parapets at all but the 2nd unit from the west which has a shaped parapet; faces north, 4 bays wide.

Condition: good _____ Integrity: good _____ Ownership: private _____ Category: Building _____
Historic Use: Commerce/Trade _____ Current Use: Commerce/Trade _____
Function: Specialty Store _____ Function: Specialty Store _____
