Tuscaloosa

Greater Downtown Study
Historic Resource Survey - 2006

Survey Number: _____ 1 _____
Historic name(s): House, Not Named
Common name: Southeast Appraisers
Location: University Blvd., 2720

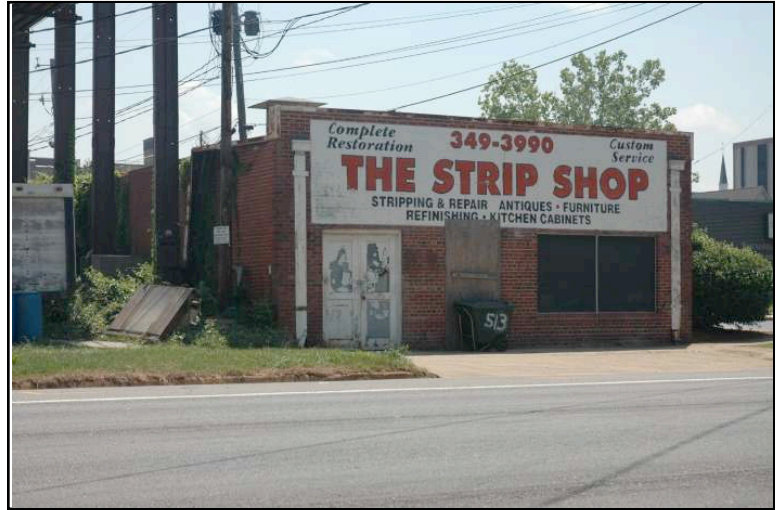
Rectangular 1-story brick commercial building with a flat roof concealed by a flat parapet; faces west, 3 bays wide.

Condition: good _____ Integrity: good _____ Ownership: private _____ Category: Building _____
 Historic Use: Commerce/Trade _____ Current Use: Commerce/Trade _____
 Function: Specialty Store _____ Function: Specialty Store _____

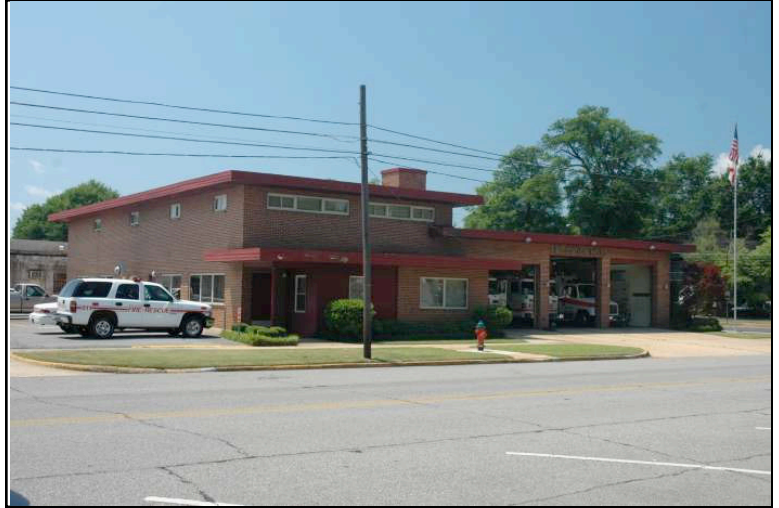
Rectangular split level brick fire station building with a flat roof; faces north, 5x4 bay core.

Condition: good _____ Integrity: good _____ Ownership: private _____ Category: Building _____
 Historic Use: Government _____ Current Use: Government _____
 Function: Fire Station _____ Function: Fire Station _____

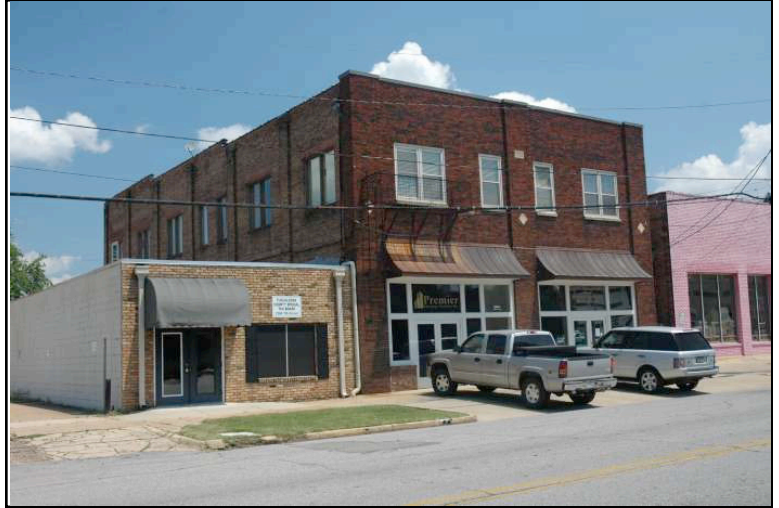
Rectangular 2-story brick commercial building with a flat roof concealed by a low flat parapet at its facade and stepped parapets at its side elevations; faces south, 4x7 bay core.

Condition: good _____ Integrity: good _____ Ownership: private _____ Category: Building _____
 Historic Use: Commerce/Trade _____ Current Use: Commerce/Trade _____
 Function: Specialty Store _____ Function: Business/Professional Office _____

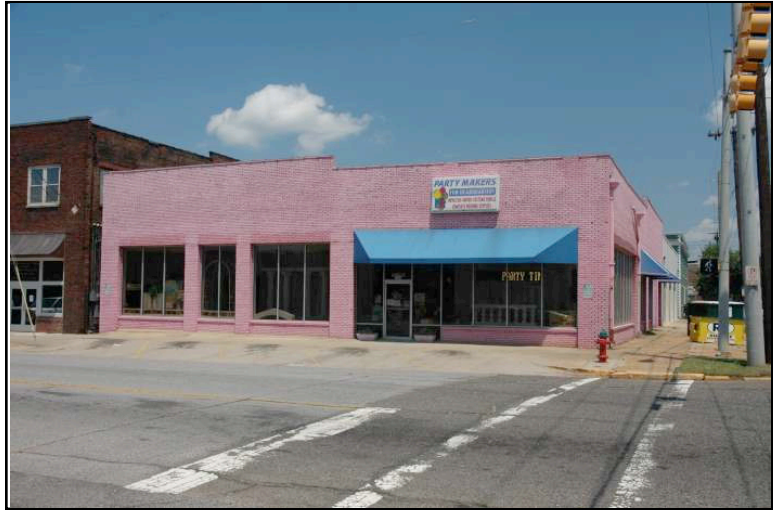
Rectangular 1-story brick 2-unit commercial building with a flat roof concealed by stepped parapets; faces south, 4x3 bay core.

Condition: good _____ Integrity: fair _____ Ownership: private _____ Category: Building _____
 Historic Use: Commerce/Trade _____ Current Use: Commerce/Trade _____
 Function: Specialty Store _____ Function: Specialty Store _____

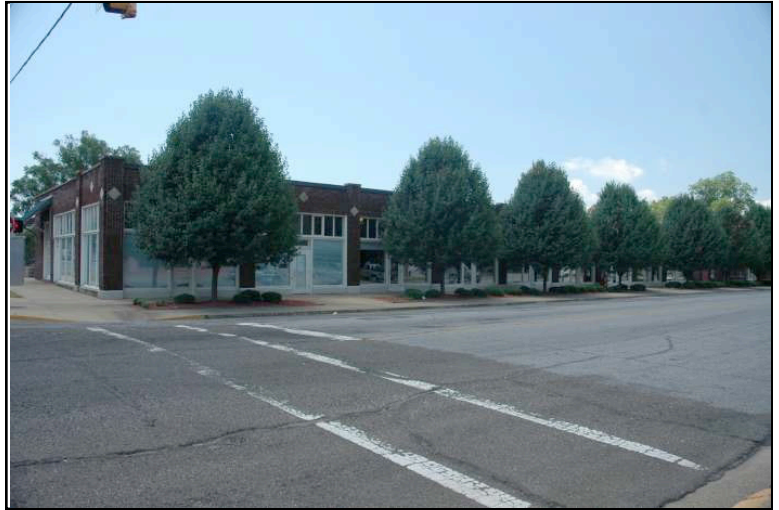
Rectangular 1-story brick 9-unit commercial building with a flat roof concealed by flat parapets; faces north, 9x3 bay core.

Condition: good _____ Integrity: good _____ Ownership: private _____ Category: Building _____
Historic Use: Commerce/Trade _____ Current Use: Commerce/Trade _____
Function: Specialty Store _____ Function: Business/Professional Office _____

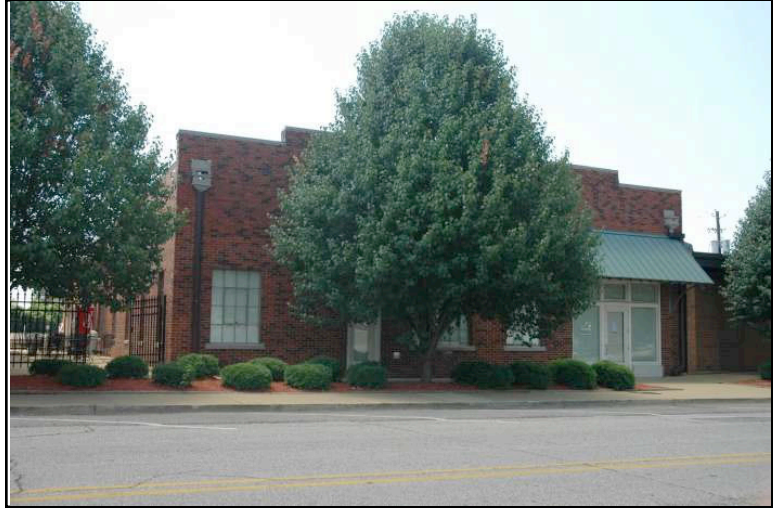
Rectangular 1-story brick commercial building with a flat roof concealed by a stepped parapet; faces north, 5x8 bay core.

Condition: good _____ Integrity: good _____ Ownership: private _____ Category: Building _____
 Historic Use: Commerce/Trade _____ Current Use: Commerce/Trade _____
 Function: Specialty Store _____ Function: Business/Professional Office _____

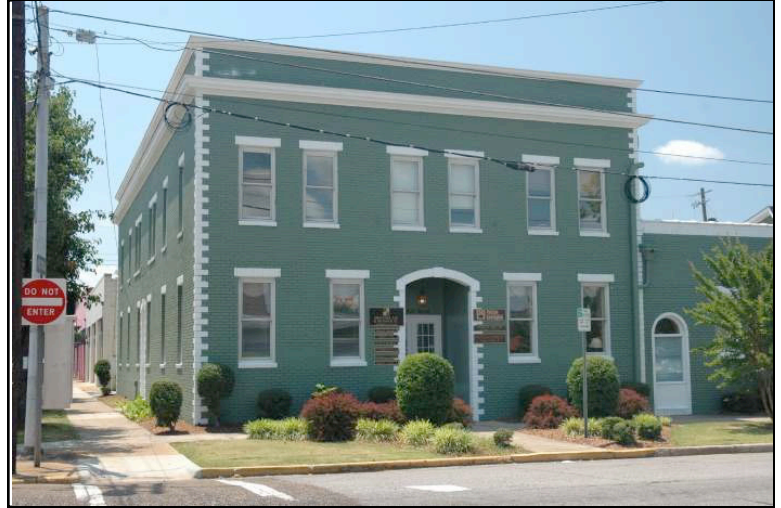
Rectangular 2-story brick commercial building with a flat roof concealed low flat parapets; faces north, 5x5 bay core with 6-bay wide 1-story addition to the west.

Condition: good _____ Integrity: good _____ Ownership: private _____ Category: Building _____
 Historic Use: Commerce/Trade _____ Current Use: Commerce/Trade _____
 Function: Specialty Store _____ Function: Business/Professional Office _____

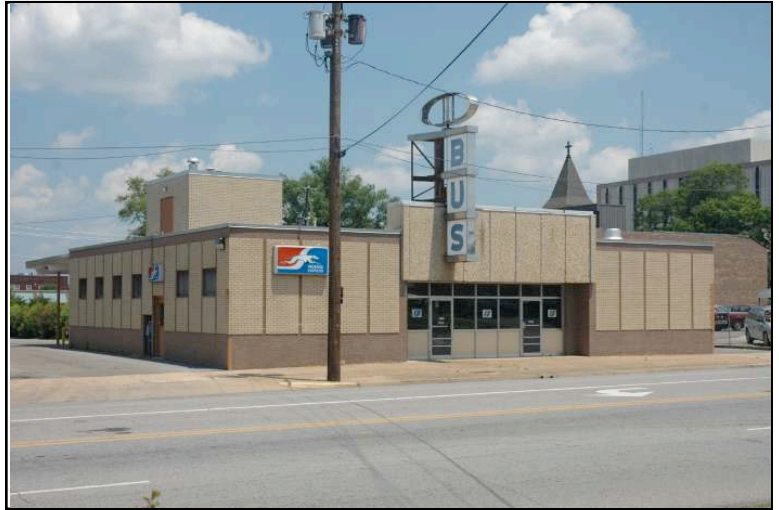
Rectangular 1-story brick bus station with a flat roof; faces south, 1x7 bay core.

Condition: good _____ Integrity: good _____ Ownership: private _____ Category: Building _____
 Historic Use: Transportation _____ Current Use: Transportation _____
 Function: Bus Station _____ Function: Bus Station _____

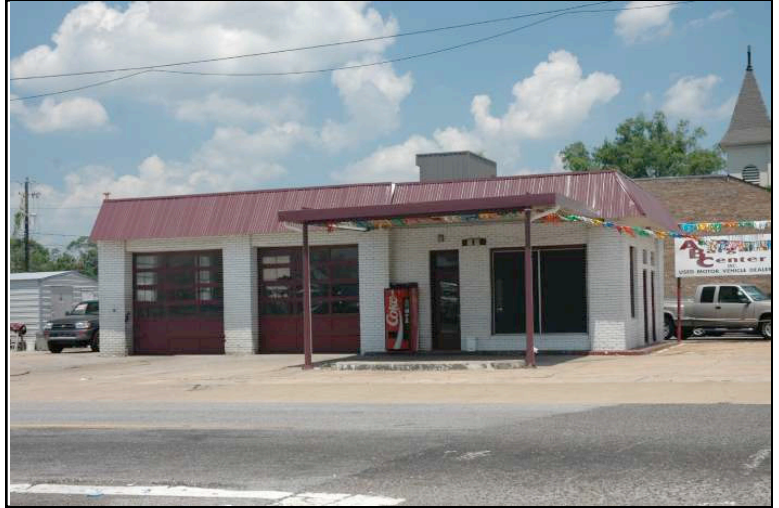
Rectangular 1-story brick gas station with a flat roof with modern mansard extensions; faces south, 4x3 bay core.

Condition: good _____ Integrity: fair _____ Ownership: private _____ Category: Building _____
 Historic Use: Commerce/Trade _____ Current Use: Commerce/Trade _____
 Function: Gas Station _____ Function: Specialty Store _____

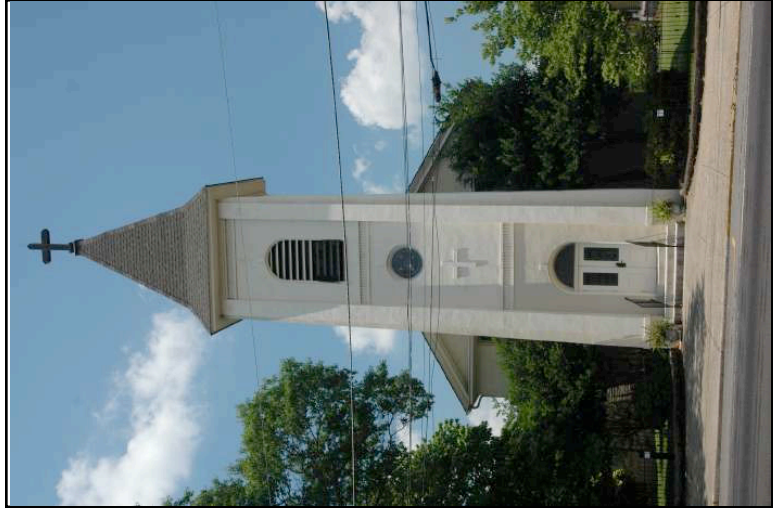
Rectangular 1-story brick church with a front-facing gable composition shingle roof intersecting a central 2-story tower with tall bellcast hipped roof; 3x5 bay core with gable extension to rear; central entrance at 1st level of belltower within round arched opening with stained glass transom & sidelights, round arched louvered bell vent at upper level, tower flanked at core by round arched stained glass windows, similar windows at side elevations; painted stucco exterior walls; stucco foundation.

Condition: good _____ Integrity: good _____ Ownership: private _____ Category: Building _____
Historic Use: Religion _____ Current Use: Religion _____
Function: Religious Facility _____ Function: Religious Facility _____

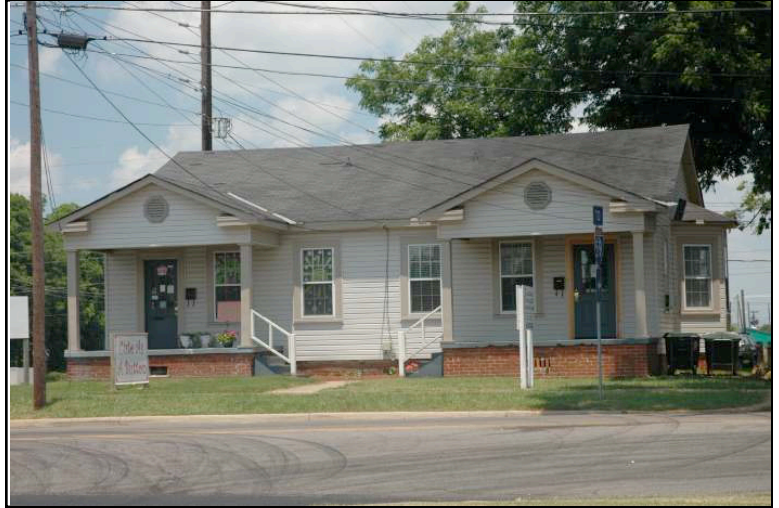
Rectangular 1-story frame duplex dwelling with a side gable composition shingle roof; faces south, 6x3 bay core.

Condition: good _____ Integrity: fair _____ Ownership: private _____ Category: Building _____
 Historic Use: Single Dwelling - Non Farm _____ Current Use: Commerce/Trade _____
 Function: Duplex _____ Function: Business/Professional Office _____

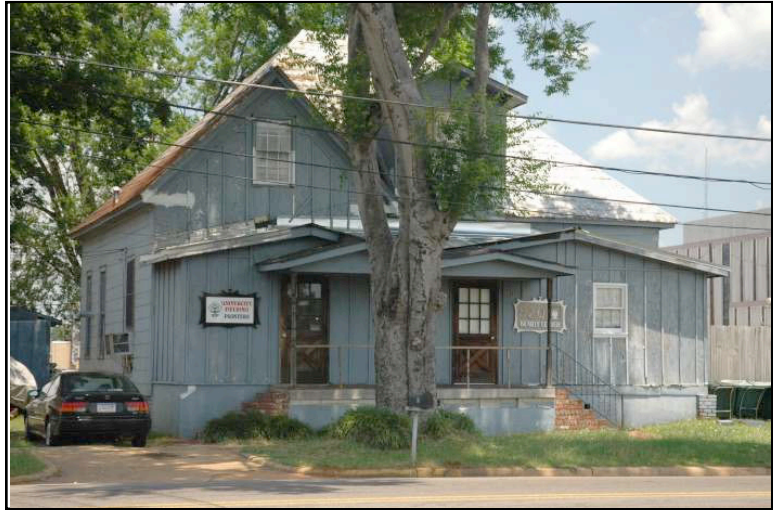
Rectangular 1-story frame pyramidal form dwelling with a hipped pressed metal shingle roof with modern central gable former, historic front-facing gable projection; faces south, 3x2 bay core with front-facing gable projection to west and rear gable wing.

Condition: fair _____ Integrity: fair _____ Ownership: private _____ Category: Building _____
Historic Use: Single Dwelling - Non Farm _____ Current Use: Commerce/Trade _____
Function: Residence _____ Function: Business/Professional Office _____

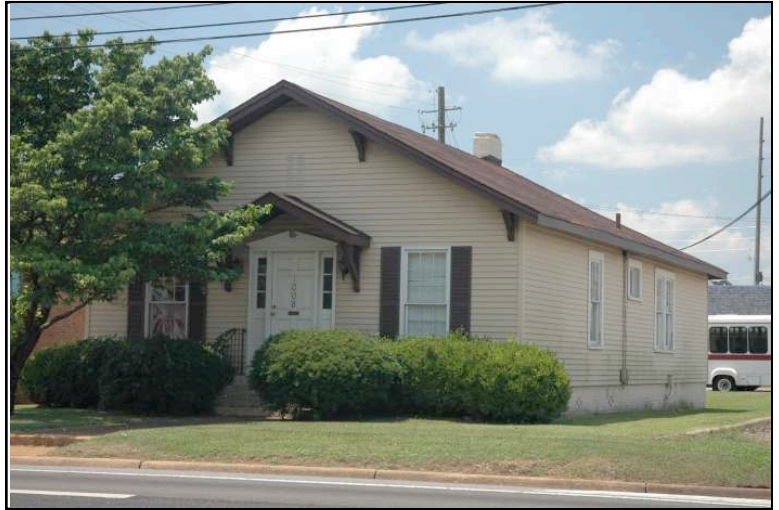
Rectangular 1-story frame gable front form dwelling with a front-facing gable composition shingle roof (hipped at rear) with angle bracketed eaves; faces east, 3x4 bay core.

Condition: good _____ Integrity: fair _____ Ownership: private _____ Category: Building _____
Historic Use: Single Dwelling - Non Farm _____ Current Use: Commerce/Trade _____
Function: Residence _____ Function: Business/Professional Office _____

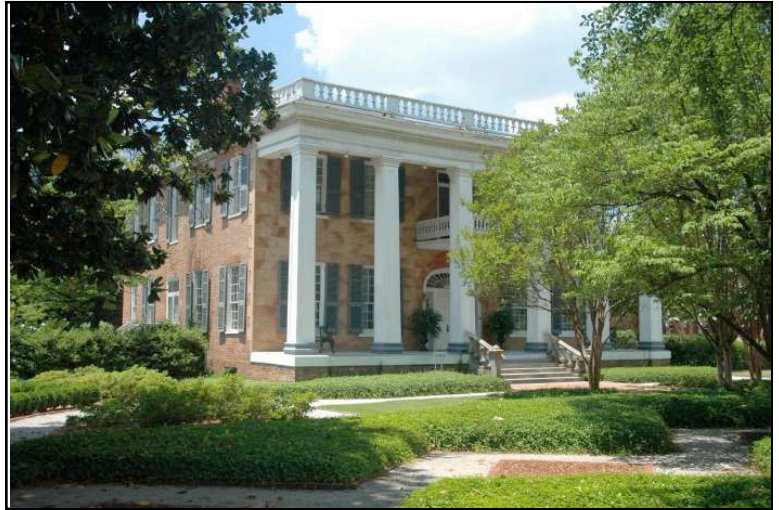
Rectangular 2-story brick dwelling with hipped roof; faces east, 5x2 bay core with 5 bay rear ell wing

Condition: excellent _____ Integrity: good _____ Ownership: private _____ Category: Building _____
 Historic Use: Single Dwelling - Non Farm _____ Current Use: Recreation/Culture _____
 Function: Residence _____ Function: museum _____

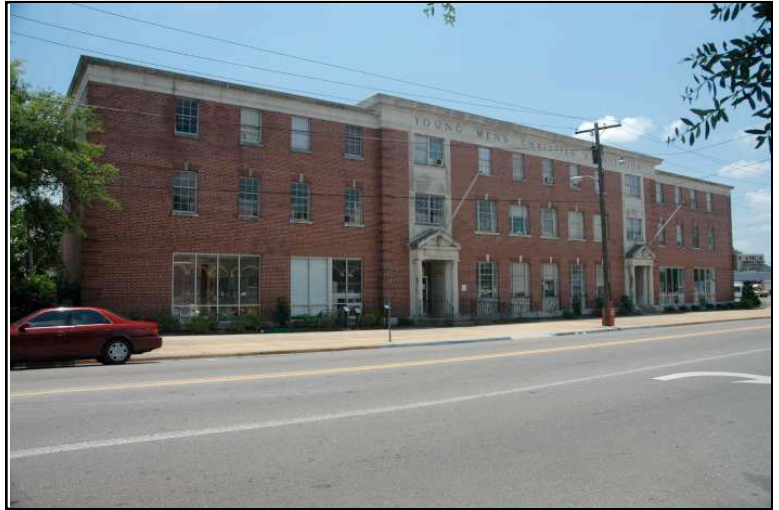
Irregular-shaped 2-story brick veneer YMCA building with a flat hipped roof; faces north, 15x3 bay core with rear extensions.

Condition: good _____ Integrity: good _____ Ownership: private _____ Category: Building _____
Historic Use: Recreation/Culture _____ Current Use: Recreation/Culture _____
Function: Sports Facility _____ Function: Sports Facility _____

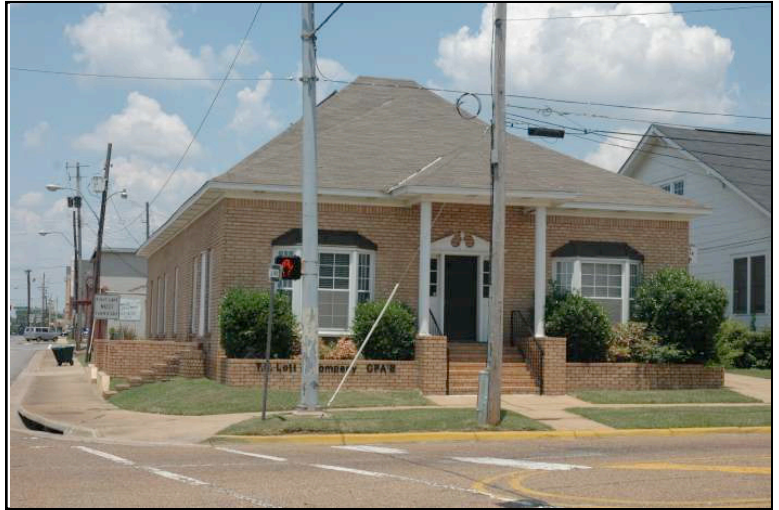
Rectangular 1-story brick veneer dwelling with a hipped composition shingle roof; faces south, 3x5 bay core.

Condition: good _____ Integrity: poor _____ Ownership: private _____ Category: Building _____
 Historic Use: Single Dwelling - Non Farm _____ Current Use: Commerce/Trade _____
 Function: Residence _____ Function: Business/Professional Office _____

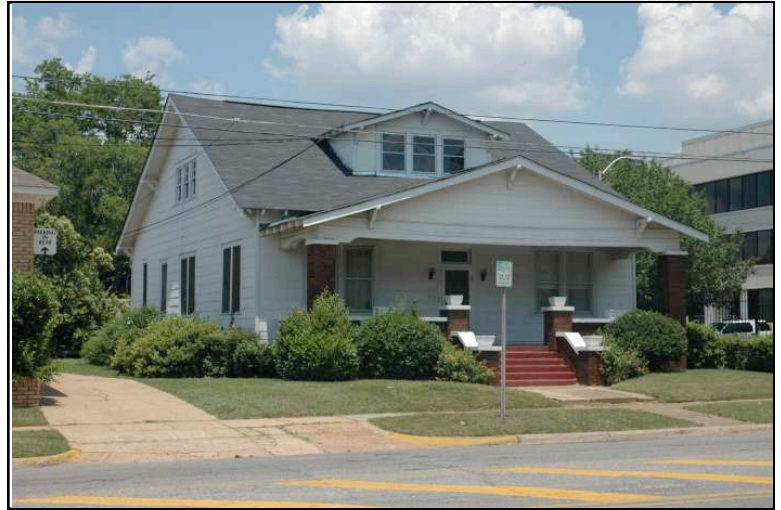
Rectangular 1.5-story frame dwelling with a side gable composition shingle roof with central gable dormer; faces south, 3x4 bay core.

Condition: good _____ Integrity: poor _____ Ownership: private _____ Category: Building _____
 Historic Use: Single Dwelling - Non Farm _____ Current Use: Single Dwelling - Non Farm _____
 Function: Residence _____ Function: Residence _____

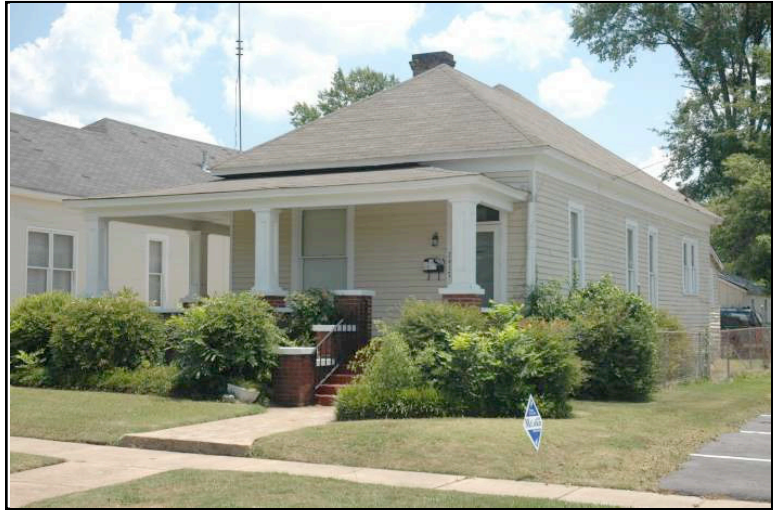
Rectangular 1-story frame dwelling with a hipped composition shingle roof; faces north, 3x4 bay core.

Condition: good _____ Integrity: good _____ Ownership: private _____ Category: Building _____
 Historic Use: Single Dwelling - Non Farm _____ Current Use: Single Dwelling - Non Farm _____
 Function: Residence _____ Function: Residence _____

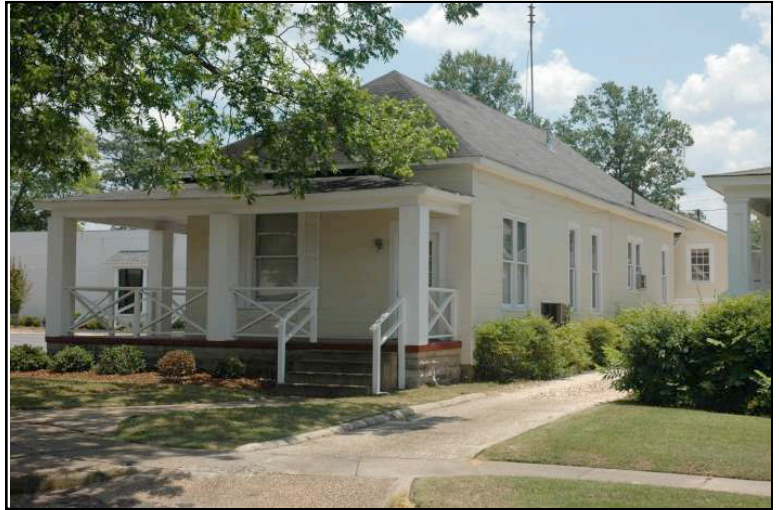
Rectangular 1-story frame dwelling with a hipped composition shingle roof; faces north, 3x3 bay core.

Condition: good _____ Integrity: good _____ Ownership: private _____ Category: Building _____
 Historic Use: Single Dwelling - Non Farm _____ Current Use: Single Dwelling - Non Farm _____
 Function: Residence _____ Function: Residence _____

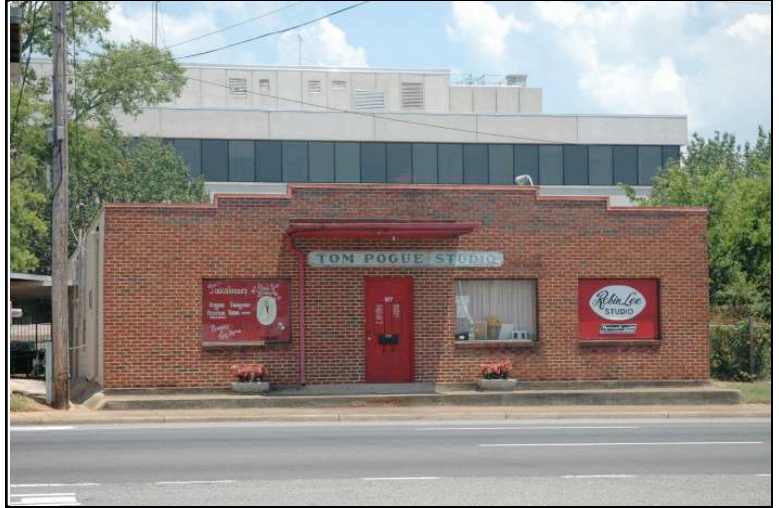
Rectangular 1-story concrete block commercial building with a brick veneer facade and a flat roof concealed by a low stepped parapet with a hipped composition shingle roof; faces west, 3x3 bay core.

Condition: good _____ Integrity: good _____ Ownership: _____ Category: _____
 Historic Use: Commerce/Trade Current Use: Commerce/Trade
 Function: Specialty Store Function: Specialty Store

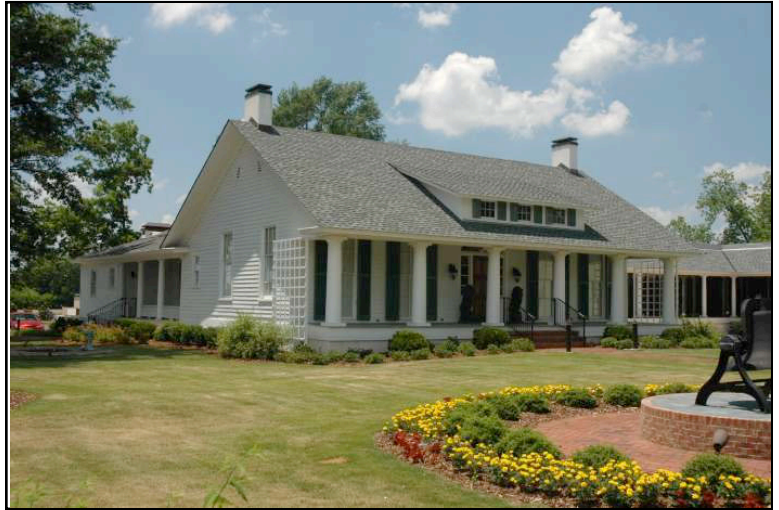
Rectangular 1-story frame dwelling with a side gable composition shingle roof with central shed decorative dormer; faces east, 5x3 bay core with rear wing.

Condition: good _____ Integrity: good _____ Ownership: private _____ Category: Building _____
 Historic Use: Single Dwelling - Non Farm _____ Current Use: Single Dwelling - Non Farm _____
 Function: Residence _____ Function: Residence _____

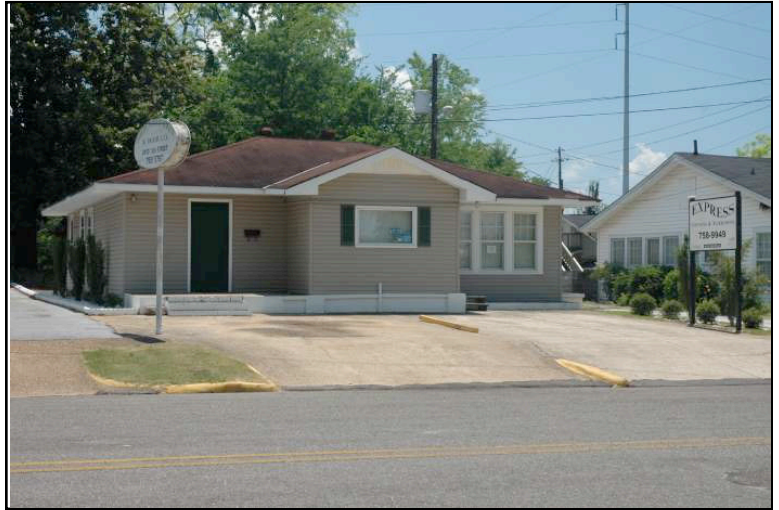
Rectangular 1-story frame dwelling with a hipped composition shingle roof; faces north, 3x3 bay core.

Condition: good _____ Integrity: poor _____ Ownership: private _____ Category: Building _____
 Historic Use: Single Dwelling - Non Farm _____ Current Use: Commerce/Trade _____
 Function: Residence _____ Function: Business/Professional Office _____

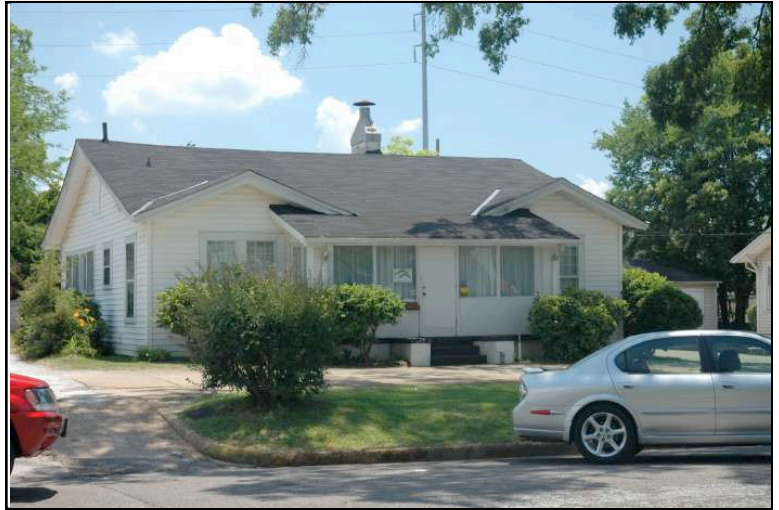
Rectangular 1-story frame dwelling with a side gable composition shingle roof with front-facing gable projections; faces north, 4x3 bay core.

Condition: good _____ Integrity: poor _____ Ownership: private _____ Category: Building _____
 Historic Use: Single Dwelling - Non Farm _____ Current Use: Single Dwelling - Non Farm _____
 Function: Residence _____ Function: Residence _____

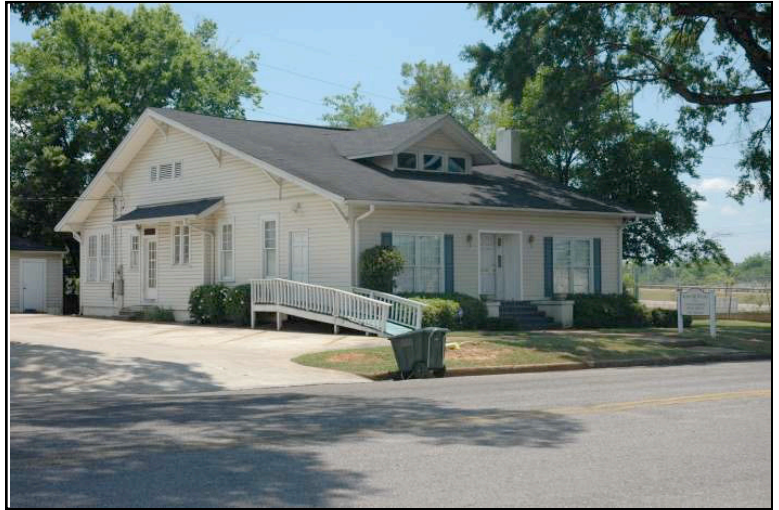
Rectangular 1-story frame dwelling with a side gable composition shingle roof with central decorative gable dormer; faces north, 3x7 bay core.

Condition: good _____ Integrity: poor _____ Ownership: private _____ Category: Building _____
 Historic Use: Single Dwelling - Non Farm _____ Current Use: Commerce/Trade _____
 Function: Residence _____ Function: Business/Professional Office _____

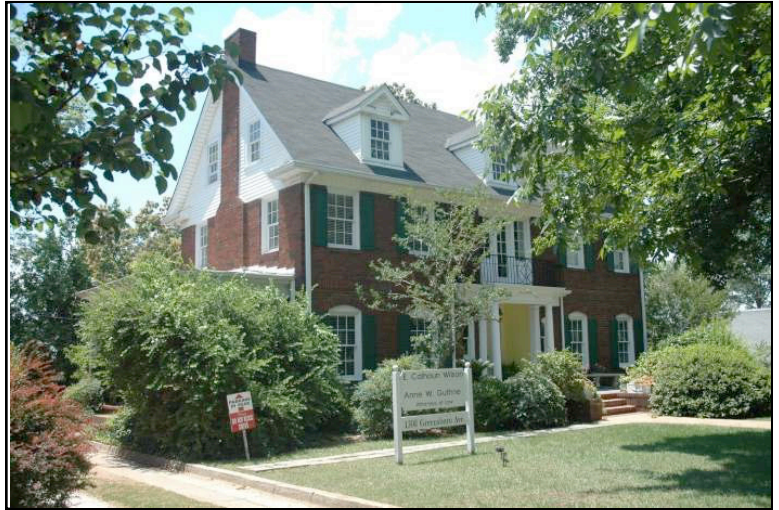
Rectangular 2.5-story brick veneer dwelling with a side gable composition shingle roof with three gable dormer; faces east, 5x2 bay core; replacement entrance bay porch with columns; central entrance at facade with transom & sidelights, entrance w/sidelights at upper level; entrances flanked by single 6/6 double hung sash windows in segmental arched openings, similar windows at side elevations; brick veneer; brick veneer foundation.

Condition: good _____ Integrity: poor _____ Ownership: private _____ Category: Building _____
Historic Use: Single Dwelling - Non Farm _____ Current Use: Commerce/Trade _____
Function: Residence _____ Function: Business/Professional Office _____

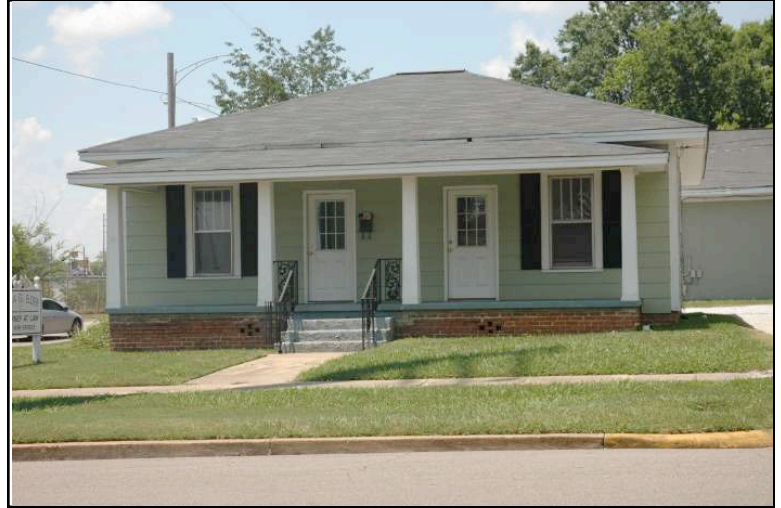
Rectangular 1-story frame dwelling with a hipped composition shingle roof; faces south, 4x2 bay core.

Condition: good _____ Integrity: fair _____ Ownership: private _____ Category: Building _____
 Historic Use: Single Dwelling - Non Farm _____ Current Use: Single Dwelling - Non Farm _____
 Function: Residence _____ Function: Residence _____

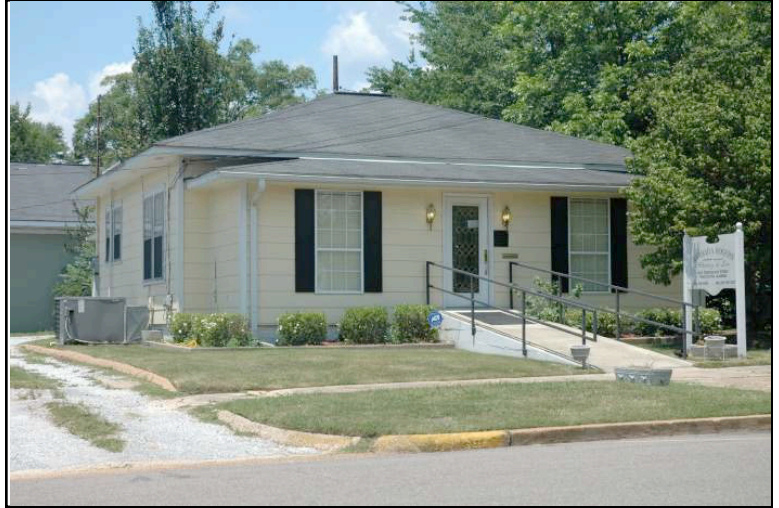
Rectangular 1-story frame dwelling with a hipped composition shingle roof; faces south, 3x2 bay core.

Condition: good _____ Integrity: fair _____ Ownership: private _____ Category: Building _____
 Historic Use: Single Dwelling - Non Farm _____ Current Use: Commerce/Trade _____
 Function: Residence _____ Function: Business/Professional Office _____

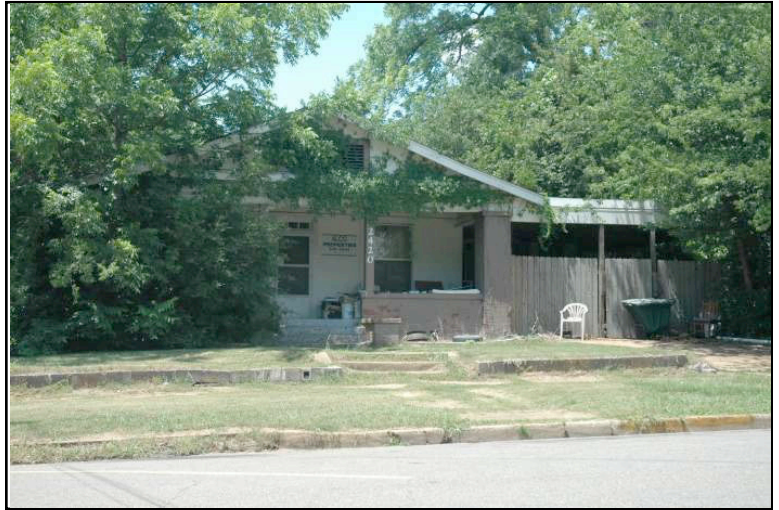
Rectangular 1-story frame dwelling with a front-facing gable composition shingle roof; faces south, 3x3 bay core.

Condition: good _____ Integrity: fair _____ Ownership: private _____ Category: Building _____
 Historic Use: Single Dwelling - Non Farm _____ Current Use: Single Dwelling - Non Farm _____
 Function: Residence _____ Function: Residence _____

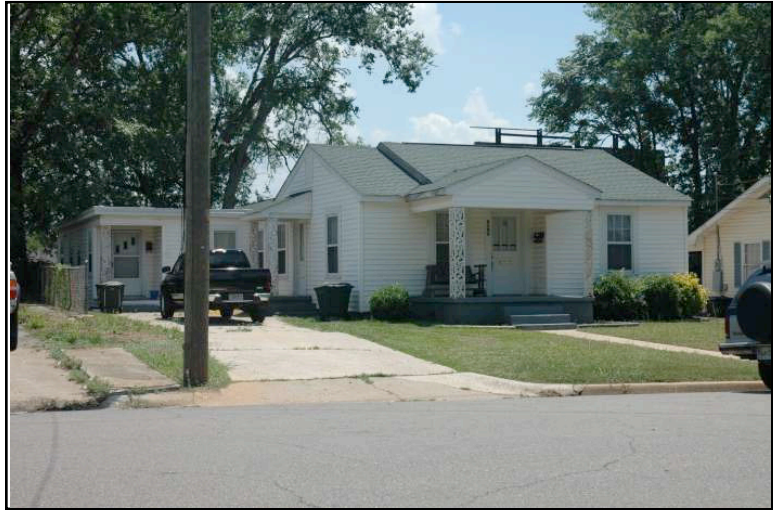
Rectangular 1-story frame dwelling with a side gable composition shingle roof; faces north, 3x3 bay core with rear additions.

Condition: good _____ Integrity: fair _____ Ownership: private _____ Category: Building _____
 Historic Use: Single Dwelling - Non Farm _____ Current Use: Single Dwelling - Non Farm _____
 Function: Residence _____ Function: Residence _____

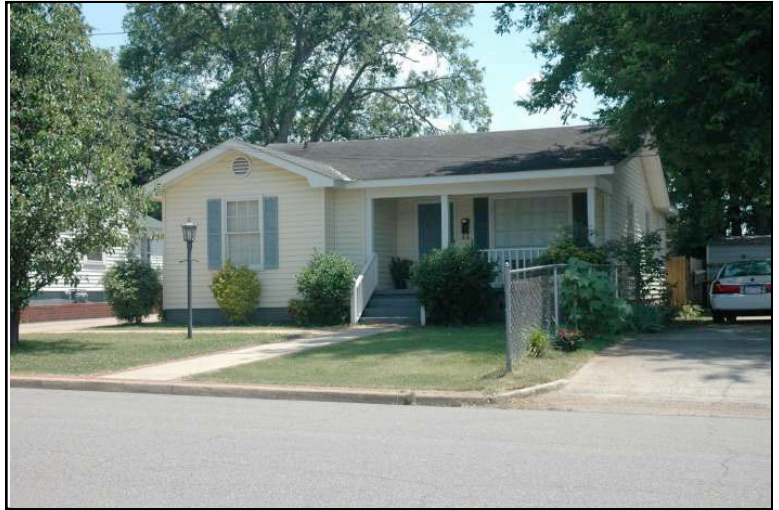
Rectangular 1-story frame dwelling with a side gable composition shingle roof with front-facing gable projection; faces north, 3x2 bay core.

Condition: good _____ Integrity: fair _____ Ownership: private _____ Category: Building _____
 Historic Use: Single Dwelling - Non Farm _____ Current Use: Single Dwelling - Non Farm _____
 Function: Residence _____ Function: Residence _____

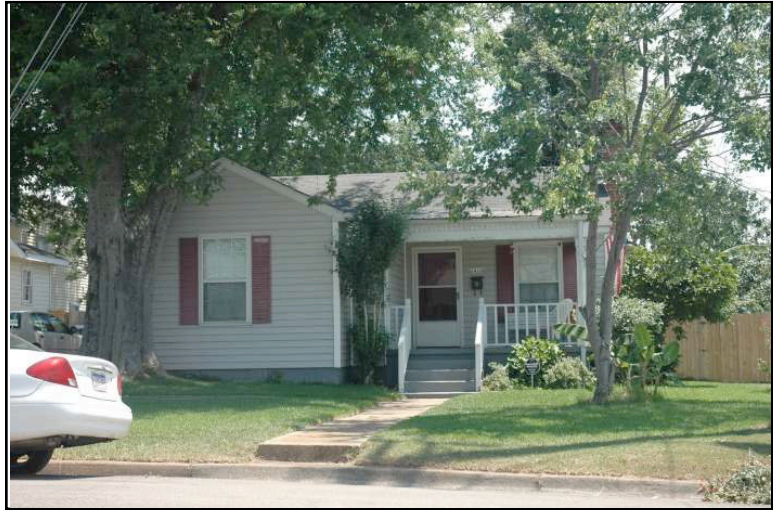
Rectangular 1-story frame dwelling with a side gable composition shingle roof with front-facing gable projection; faces north, 4x2 bay core.

Condition: good _____ Integrity: fair _____ Ownership: private _____ Category: Building _____
 Historic Use: Single Dwelling - Non Farm _____ Current Use: Single Dwelling - Non Farm _____
 Function: Residence _____ Function: Residence _____

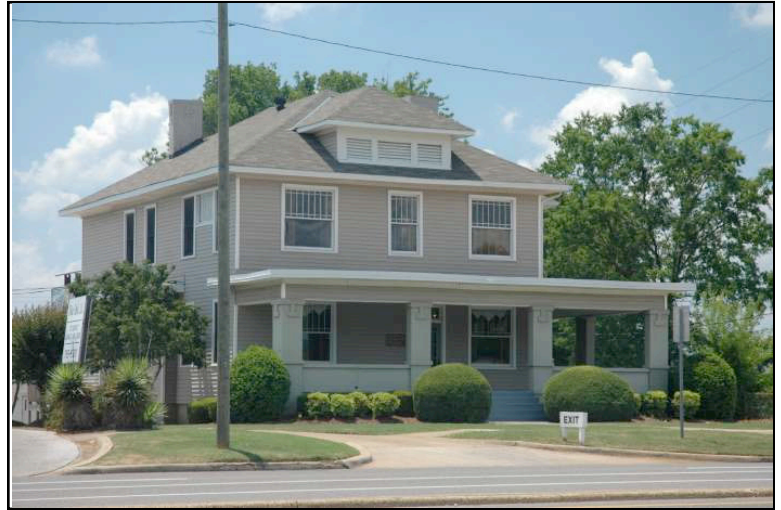
Rectangular 2-story frame dwelling with a hipped composition shingle roof with decorative hipped dormer; faces east, 3x3 bay core.

Condition: good _____ Integrity: fair _____ Ownership: private _____ Category: Building _____
 Historic Use: Single Dwelling - Non Farm _____ Current Use: Single Dwelling - Non Farm _____
 Function: Residence _____ Function: Residence _____

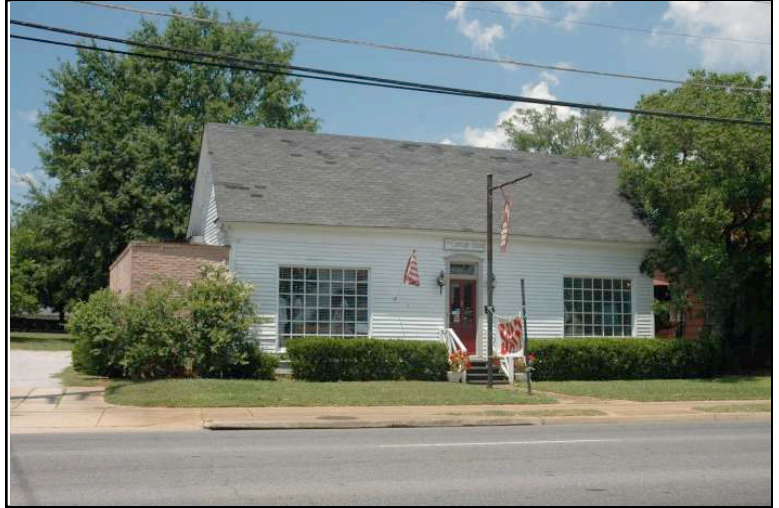
Rectangular 1-story frame dwelling with a side gable composition shingle roof; faces south, 3x2 bay core.

Condition: good _____ Integrity: fair _____ Ownership: private _____ Category: Building _____
 Historic Use: Single Dwelling - Non Farm _____ Current Use: Commerce/Trade _____
 Function: Residence _____ Function: Business/Professional Office _____

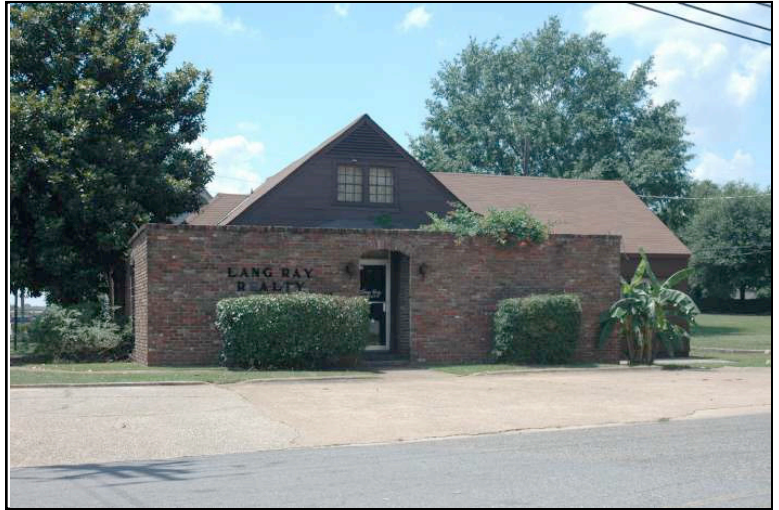
L-shaped 1-story frame dwelling with modern brick veneer and a a cross gable composition shingle roof; faces south.

Condition: good _____ Integrity: poor _____ Ownership: private _____ Category: Building _____
 Historic Use: Single Dwelling - Non Farm _____ Current Use: Commerce/Trade _____
 Function: Residence _____ Function: Business/Professional Office _____

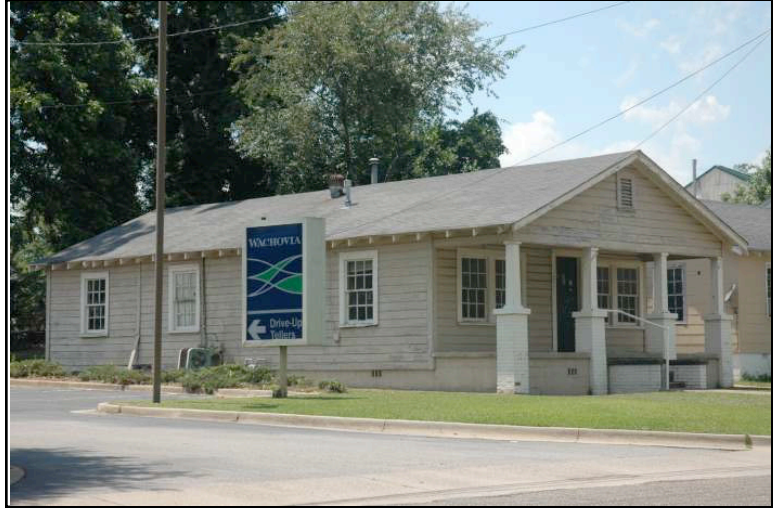
Rectangular 1-story frame dwelling with a front-facing gable composition shingle roof; faces east, 3x3 bay core.

Condition: fair _____ Integrity: good _____ Ownership: private _____ Category: Building _____
 Historic Use: Single Dwelling - Non Farm _____ Current Use: Single Dwelling - Non Farm _____
 Function: Residence _____ Function: Residence _____

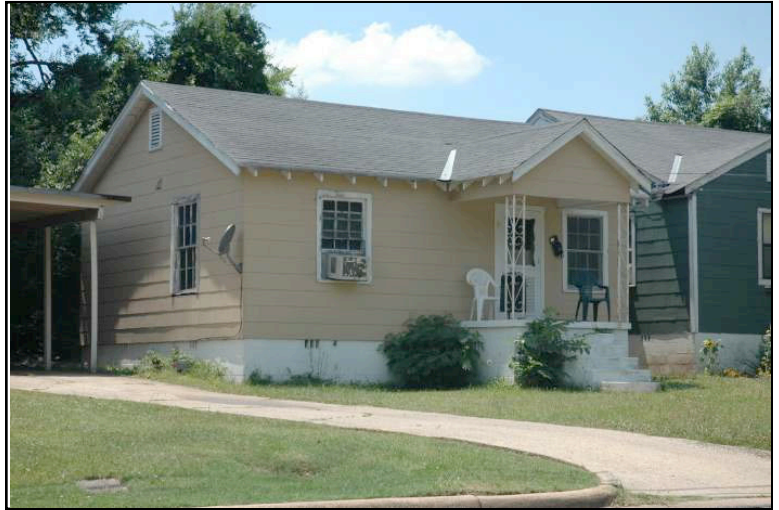
Rectangular 1-story frame dwelling with a side gable composition shingle roof; faces east, 3x1 bay core.

Condition: fair _____ Integrity: good _____ Ownership: private _____ Category: Building _____
 Historic Use: Single Dwelling - Non Farm _____ Current Use: Single Dwelling - Non Farm _____
 Function: Residence _____ Function: Residence _____

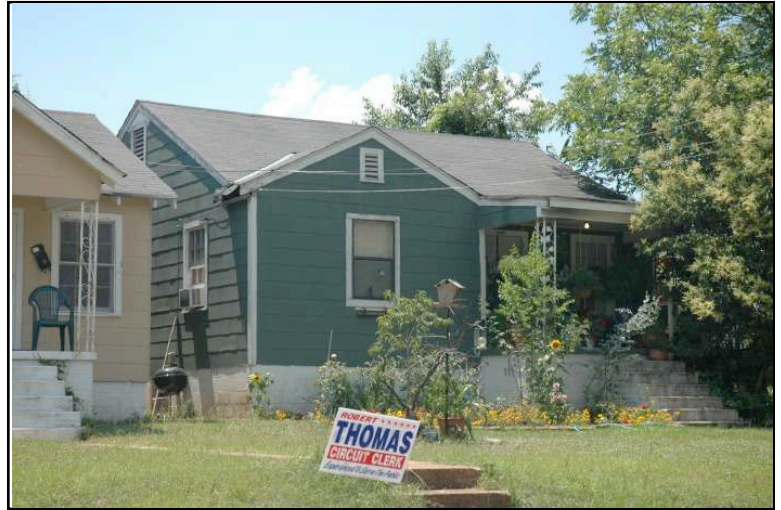
Rectangular 1-story frame dwelling with a side gable composition shingle roof; faces east, 3x1 bay core.

Condition: fair _____ Integrity: good _____ Ownership: private _____ Category: Building _____
 Historic Use: Single Dwelling - Non Farm _____ Current Use: Single Dwelling - Non Farm _____
 Function: Residence _____ Function: Residence _____

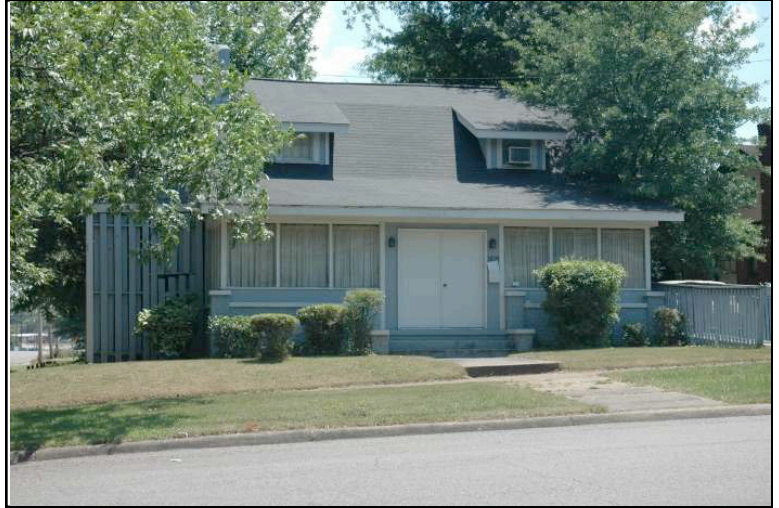
Rectangular 1.5-story frame dwelling with a side gable composition shingle roof with 2 shed dormers; faces north, 3x2 bay core.

Condition: good _____ Integrity: poor _____ Ownership: private _____ Category: Building _____
 Historic Use: Single Dwelling - Non Farm _____ Current Use: Single Dwelling - Non Farm _____
 Function: Residence _____ Function: Residence _____

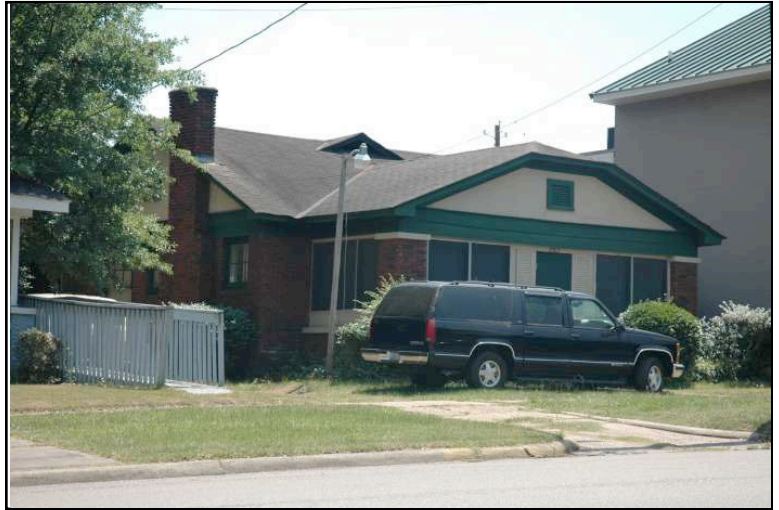
Rectangular 1-story brick veneer dwelling with a side gable composition shingle roof; faces north, 3x3 bay core.

Condition: good _____ Integrity: poor _____ Ownership: private _____ Category: Building _____
 Historic Use: Single Dwelling - Non Farm _____ Current Use: Single Dwelling - Non Farm _____
 Function: Residence _____ Function: Residence _____

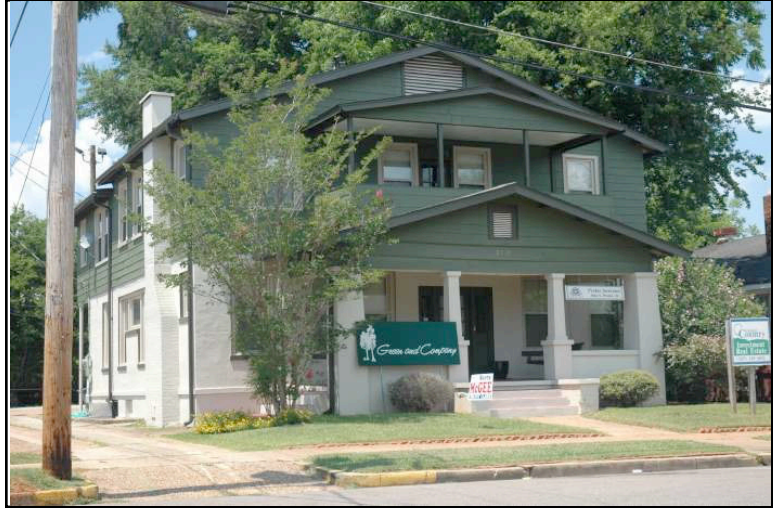
Rectangular 2-story frame dwelling with a front-facing gable composition shingle roof; faces south, 5x4 bay core.

Condition: good _____ Integrity: poor _____ Ownership: private _____ Category: Building _____
Historic Use: Single Dwelling - Non Farm _____ Current Use: Commerce/Trade _____
Function: Residence _____ Function: Business/Professional Office _____

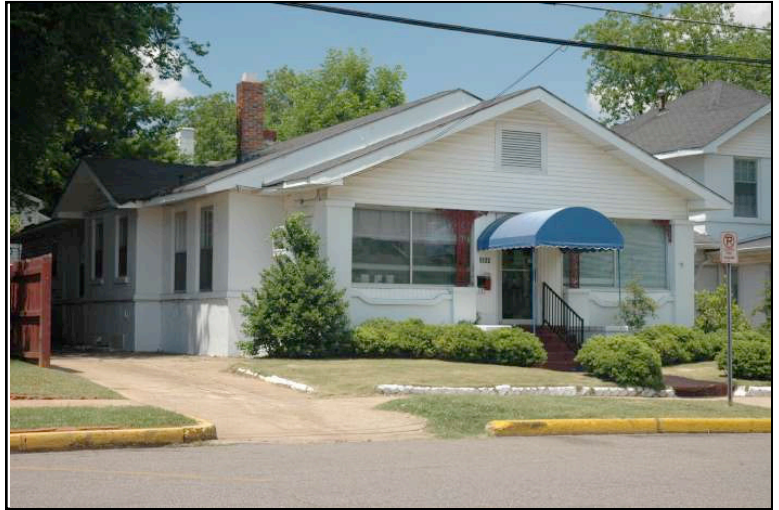
Rectangular 1-story stucco dwelling with a front-facing gable composition shingle roof; faces south, 3x5 bay core.

Condition: good _____ Integrity: poor _____ Ownership: private _____ Category: Building _____
 Historic Use: Single Dwelling - Non Farm _____ Current Use: Commerce/Trade _____
 Function: Residence _____ Function: Business/Professional Office _____

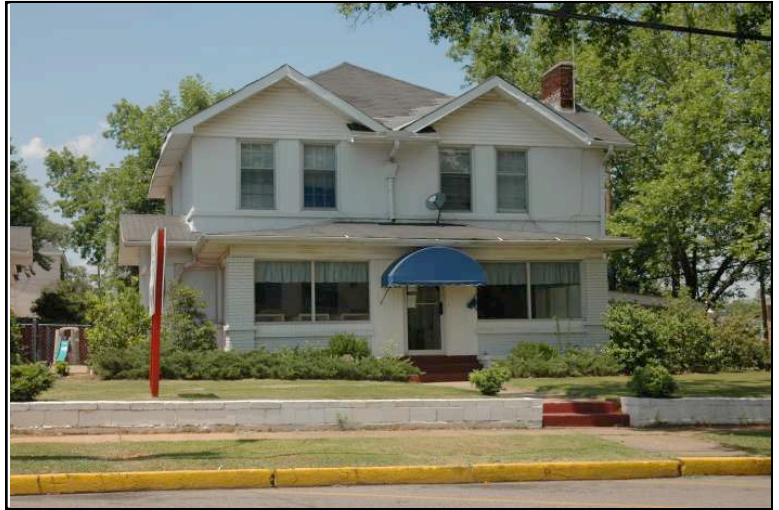
Rectangular 2-story stucco dwelling with a hipped gable composition shingle roof with 2-front facing cross gables; faces south, 3x3 bay core.

Condition: good _____ Integrity: poor _____ Ownership: private _____ Category: Building _____
 Historic Use: Single Dwelling - Non Farm _____ Current Use: Commerce/Trade _____
 Function: Residence _____ Function: Business/Professional Office _____

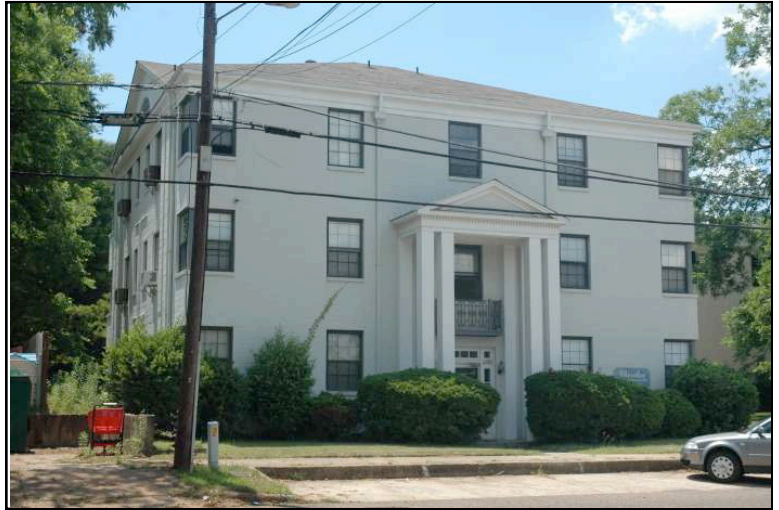
Rectangular 3-story brick apartment building with a hipped composition shingle roof; faces east, 5x6 bay core.

Condition: good _____ Integrity: fair _____ Ownership: _____ Category: _____
 Historic Use: Multiple Dwelling _____ Current Use: Multiple Dwelling _____
 Function: Apartment Building _____ Function: Apartment Building _____

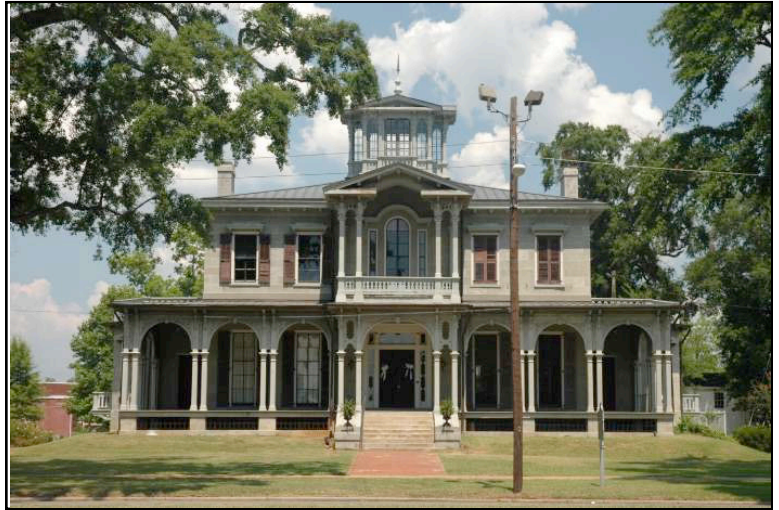
Rectangular 2-story stucco Italianate style dwelling with a hipped raised seam metal roof with cupola; faces west, 5x3 bay core with rear 1-story gable wing.

Condition: good _____ Integrity: fair _____ Ownership: private _____ Category: Building _____
Historic Use: Single Dwelling - Non Farm _____ Current Use: Recreation/Culture _____
Function: Residence _____ Function: Museum _____

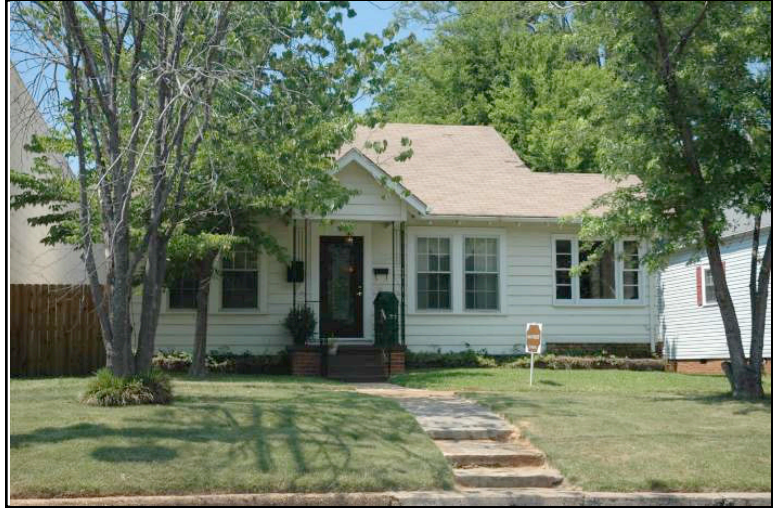
Rectangular 1-story frame dwelling with a side gable composition shingle roof; faces south, 3x2 bay core with secondary gable extension to east.

Condition: good _____ Integrity: fair _____ Ownership: private _____ Category: Building _____
 Historic Use: Single Dwelling - Non Farm _____ Current Use: Single Dwelling - Non Farm _____
 Function: Residence _____ Function: Residence _____
