Tuscaloosa

Greater Downtown Study
Historic Resource Survey - 2006

Survey Number: _____ 1 _____
Historic name(s): House, Not Named
Common name: Southeast Appraisers
Location: University Blvd., 2720

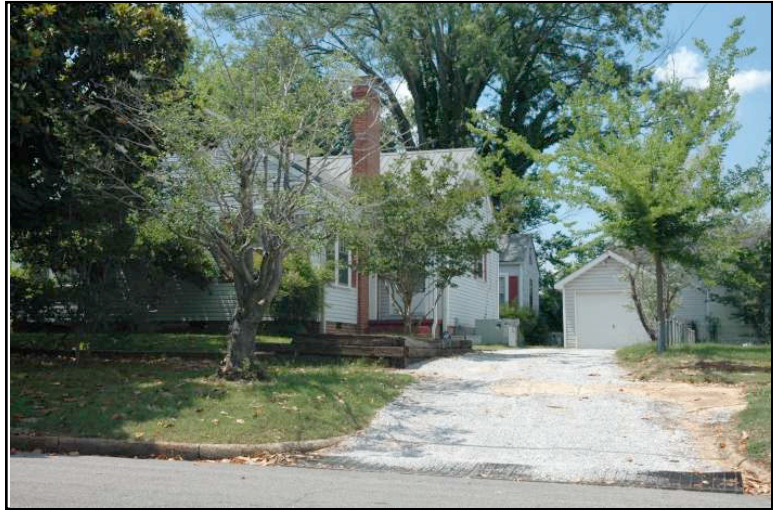
Irregular-shaped 1-story frame dwelling with a cross gable industrial metal roof; faces south, 3x3 bay core, double 6/6 wood double hung sash windows at west bays of facade, east bay of facade is recessed and contains the entrance, similar single and double windows at side elevations; replacement vinyl siding; brick foundation.

Condition: good _____ Integrity: fair _____ Ownership: private _____ Category: Building _____
 Historic Use: Single Dwelling - Non Farm _____ Current Use: Single Dwelling - Non Farm _____
 Function: Residence _____ Function: Residence _____

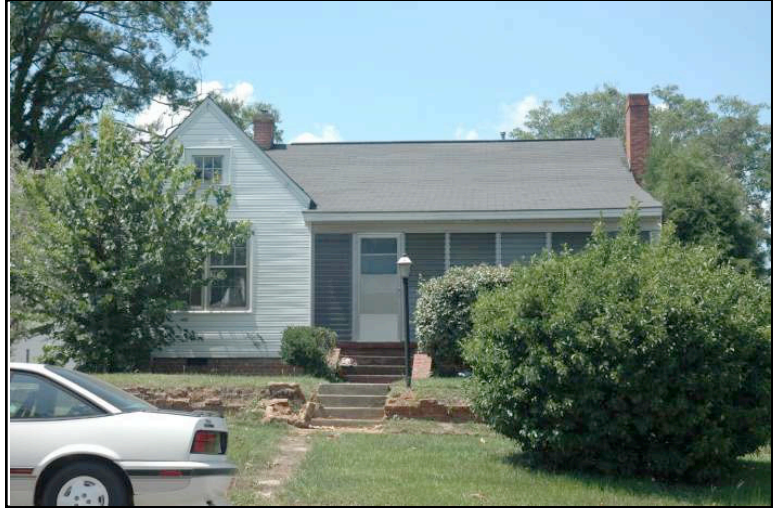
Rectangular 1-story frame dwelling with a cross gable composition shingle roof; faces south, 3x2 bay core with front-facing gable at the west bay of its facade.

Condition: good _____ Integrity: fair _____ Ownership: private _____ Category: Building _____
 Historic Use: Single Dwelling - Non Farm _____ Current Use: Single Dwelling - Non Farm _____
 Function: Residence _____ Function: Residence _____

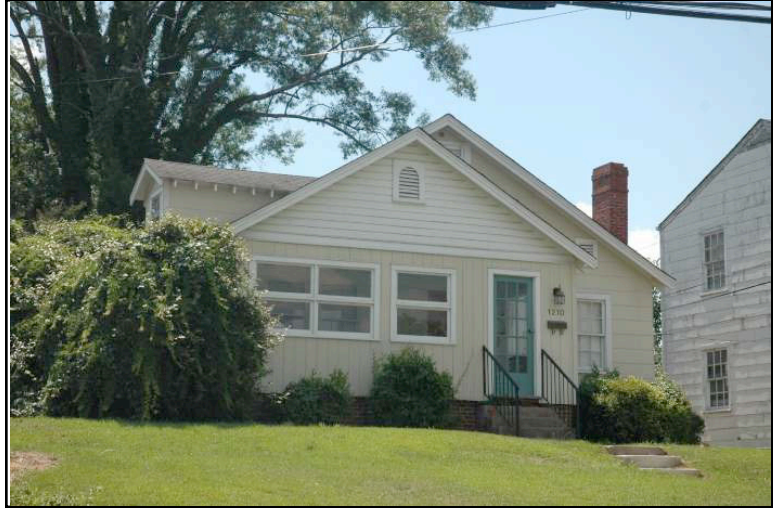
Rectangular 1-story frame dwelling with a front-facing gable composition shingle roof; faces east, 3x3 bay core.

Condition: good _____ Integrity: fair _____ Ownership: private _____ Category: Building _____
 Historic Use: Single Dwelling - Non Farm _____ Current Use: Single Dwelling - Non Farm _____
 Function: Residence _____ Function: Residence _____

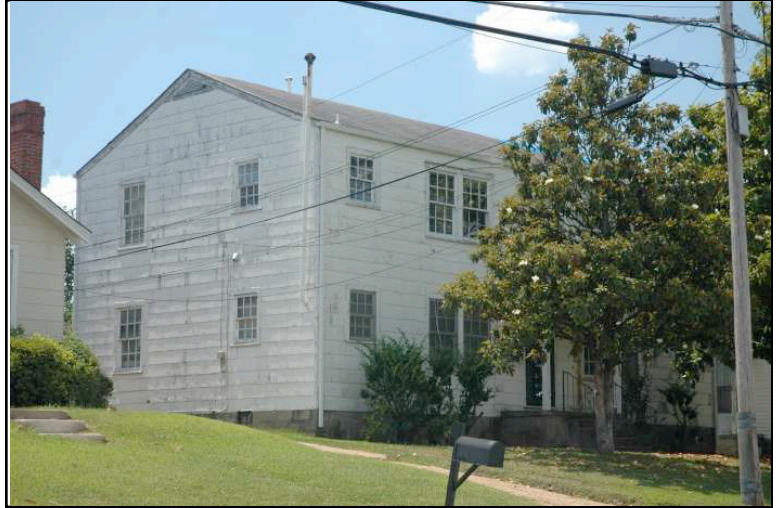
Rectangular 2-story frame duplex dwelling with a side gable composition shingle roof; faces east, 5x2 bay core.

Condition: good _____ Integrity: fair _____ Ownership: private _____ Category: Building _____
 Historic Use: Multiple Dwelling _____ Current Use: Multiple Dwelling _____
 Function: Duplex _____ Function: Duplex _____

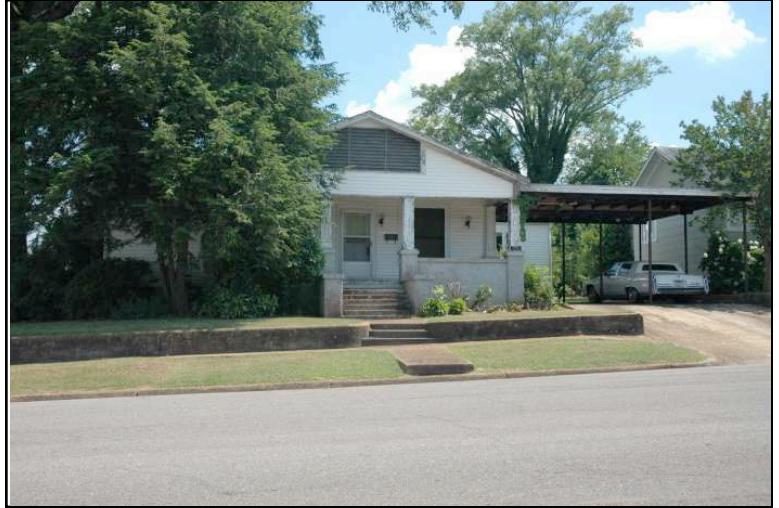
Rectangular 1-story frame dwelling with a front-facing gable composition shingle roof; faces north, 3x3 bay core with side gable additions to east and west, rear gable extension.

Condition: good _____ Integrity: fair _____ Ownership: private _____ Category: Building _____
 Historic Use: Single Dwelling - Non Farm _____ Current Use: Single Dwelling - Non Farm _____
 Function: Residence _____ Function: Residence _____

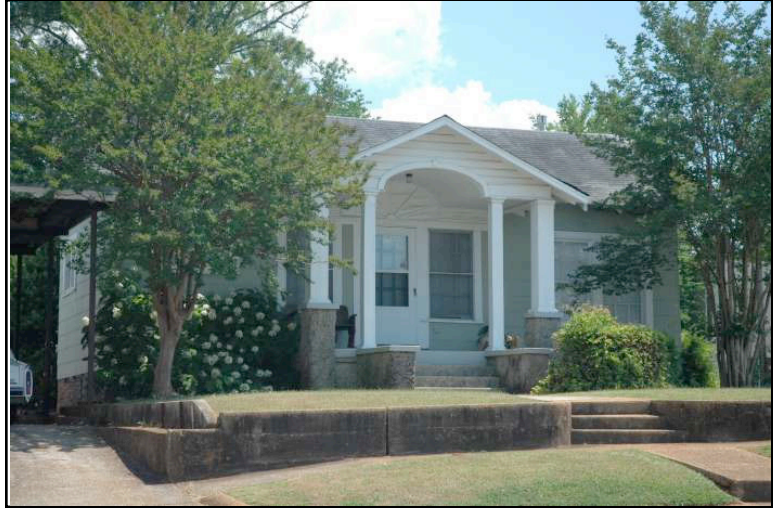
Rectangular 1-story frame dwelling with a side gable composition shingle roof; faces north, 3x1 bay core.

Condition: good _____ Integrity: fair _____ Ownership: private _____ Category: Building _____
 Historic Use: Single Dwelling - Non Farm _____ Current Use: Single Dwelling - Non Farm _____
 Function: Residence _____ Function: Residence _____

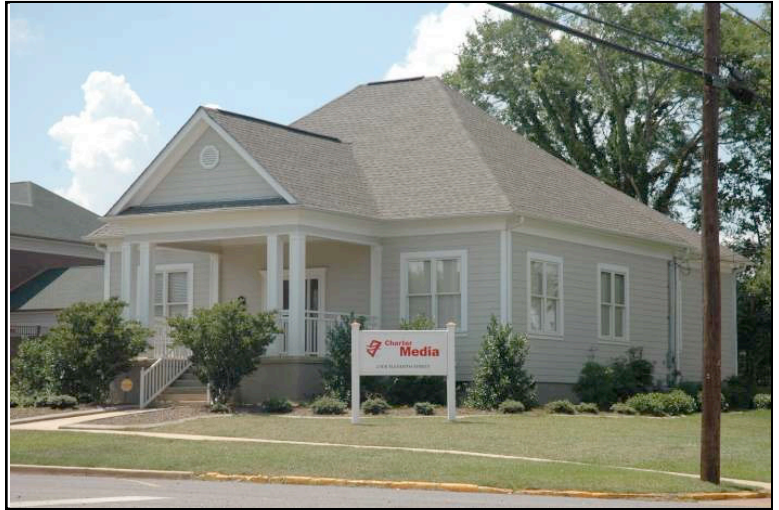
Rectangular 1-story frame dwelling with a hipped composition shingle roof; faces south, 3x3 bay core.

Condition: good _____ Integrity: fair _____ Ownership: private _____ Category: Building _____
 Historic Use: Single Dwelling - Non Farm _____ Current Use: Commerce/Trade _____
 Function: Residence _____ Function: Business/Professional Office _____

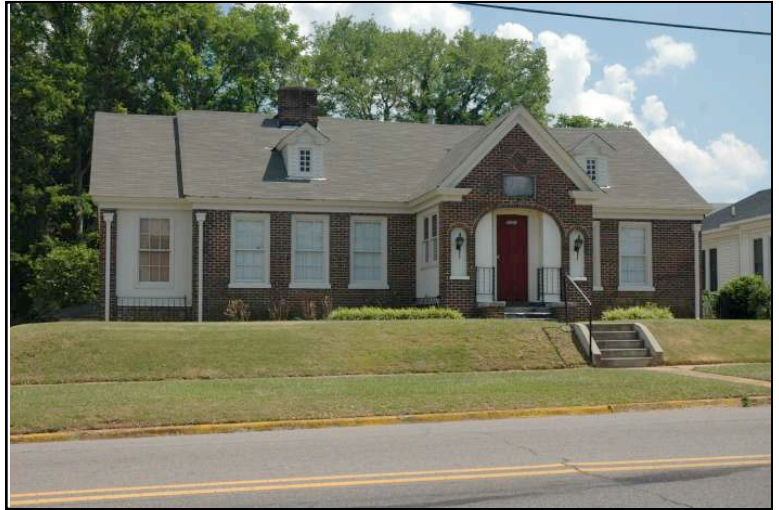
Rectangular 1-story brick veneer dwelling with a side gable composition shingle roof; faces north, 6x2 bay core with enclosed gable porch to east.

Condition: good _____ Integrity: fair _____ Ownership: private _____ Category: Building _____
 Historic Use: Single Dwelling - Non Farm _____ Current Use: Single Dwelling - Non Farm _____
 Function: Residence _____ Function: Residence _____

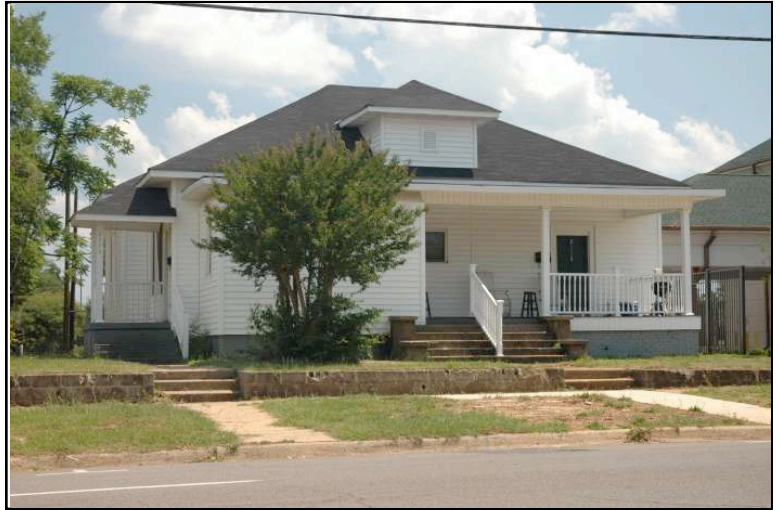
Rectangular 1-story frame dwelling with a hipped composition shingle roof with central decorative hipped dormer; faces north, 3x4 bay core.

Condition: good _____ Integrity: fair _____ Ownership: private _____ Category: Building _____
 Historic Use: Single Dwelling - Non Farm _____ Current Use: Single Dwelling - Non Farm _____
 Function: Residence _____ Function: Residence _____

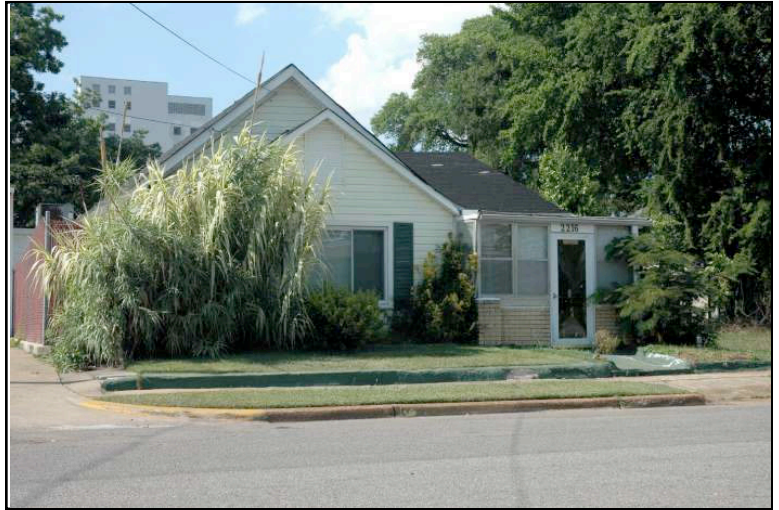
Rectangular 1-story frame dwelling with a cross gable composition shingle roof; faces south, 2x2 bay core.

Condition: good _____ Integrity: fair _____ Ownership: private _____ Category: Building _____
 Historic Use: Single Dwelling - Non Farm _____ Current Use: Single Dwelling - Non Farm _____
 Function: Residence _____ Function: Residence _____

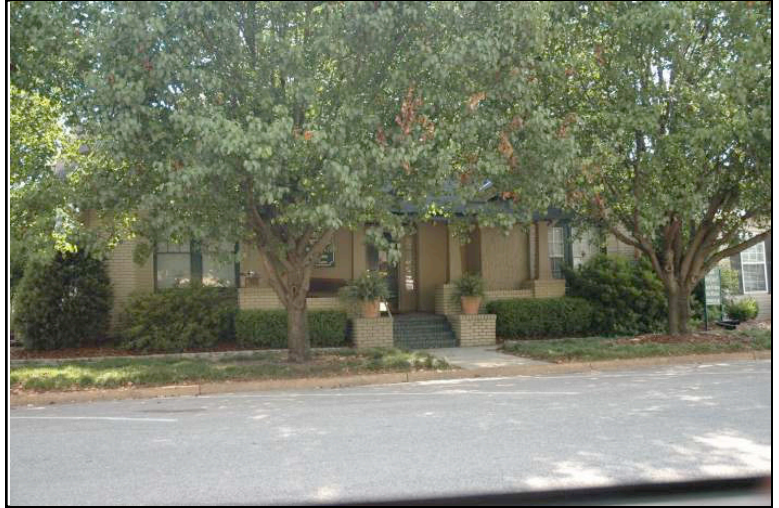
Rectangular 1-story frame dwelling with a side gable composition shingle roof; faces east, 3x2 bay core.

Condition: good _____ Integrity: fair _____ Ownership: private _____ Category: Building _____
 Historic Use: Single Dwelling - Non Farm _____ Current Use: Single Dwelling - Non Farm _____
 Function: Residence _____ Function: Residence _____

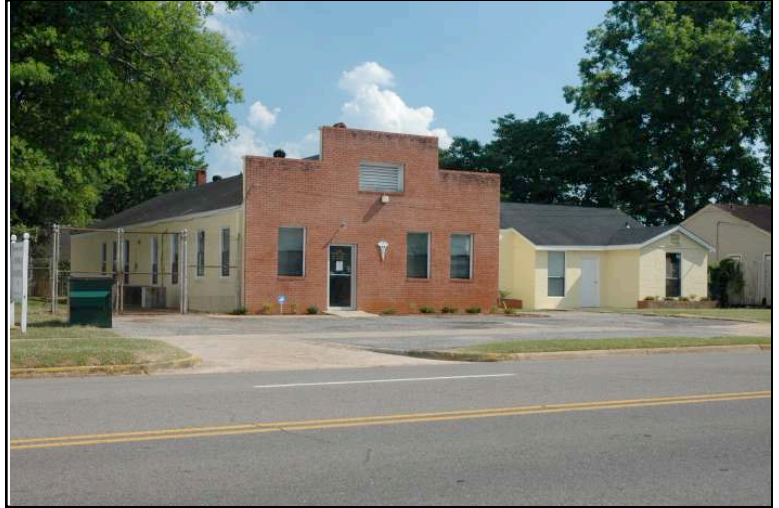
Rectangular 1-story concrete block commercial building with brick veneer facade and front-facing gable composition shingle roof concealed by stepped parapet; faces north, 4x6 bay core with irregular shaped addition to west.

Condition: good _____ Integrity: fair _____ Ownership: _____ Category: _____
 Historic Use: Commerce/Trade Current Use: Commerce/Trade
 Function: Business/Professional Office Function: Business/Professional Office

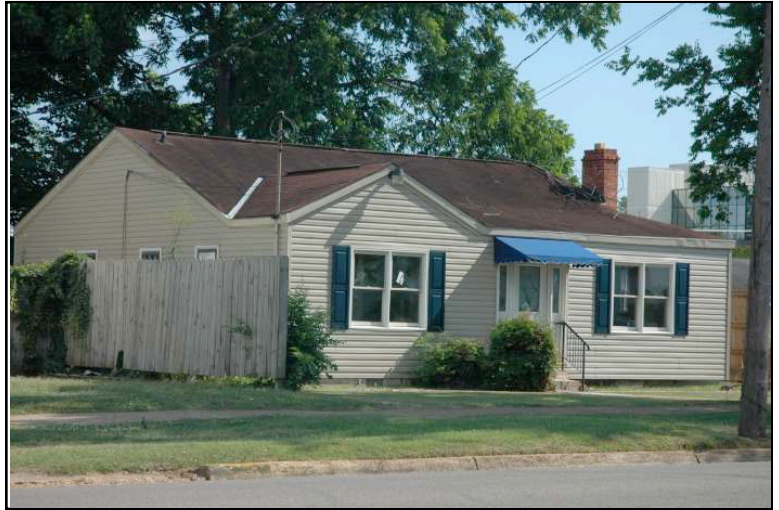
Rectangular 1-story frame dwelling with a side gable composition shingle roof with a secondary front-facing gable to the east; faces north, 3x3 bay core.

Condition: good _____ Integrity: fair _____ Ownership: private _____ Category: Building _____
 Historic Use: Single Dwelling - Non Farm _____ Current Use: Single Dwelling - Non Farm _____
 Function: Residence _____ Function: Residence _____

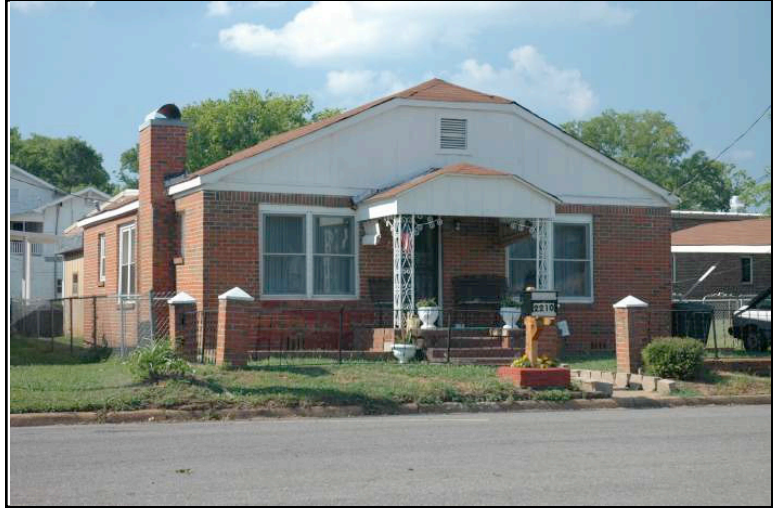
Rectangular 1-story brick veneer dwelling with a front-facing clipped gable composition shingle roof; faces south, 3x4 bay core.

Condition: good _____ Integrity: fair _____ Ownership: private _____ Category: Building _____
 Historic Use: Single Dwelling - Non Farm _____ Current Use: Single Dwelling - Non Farm _____
 Function: Residence _____ Function: Residence _____

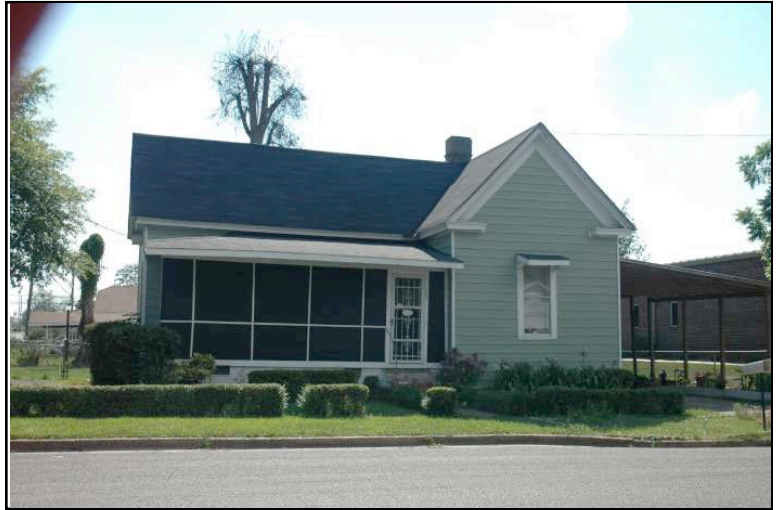
Rectangular 1-story frame dwelling with a cross gable composition shingle roof; faces south, 3x1 bay core with front-facing gable wing to north.

Condition: good _____ Integrity: fair _____ Ownership: private _____ Category: Building _____
 Historic Use: Single Dwelling - Non Farm _____ Current Use: Single Dwelling - Non Farm _____
 Function: Residence _____ Function: Residence _____

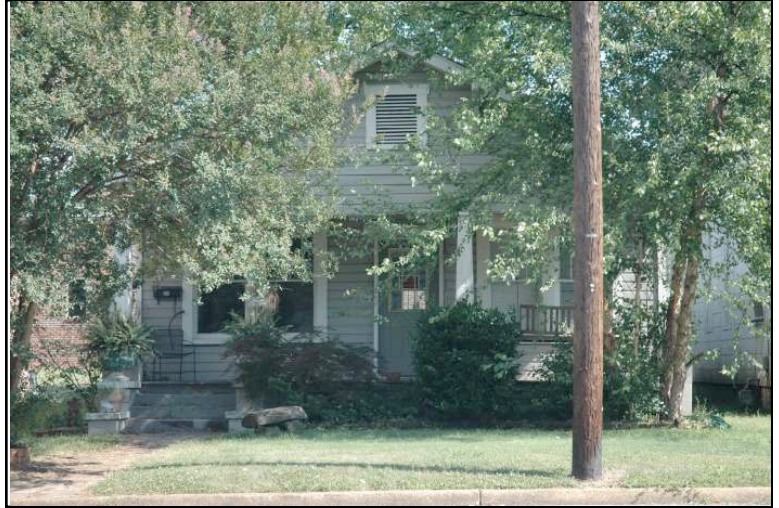
Rectangular 1-story frame dwelling with a front-facing gable composition shingle roof; faces north, 3x2 bay core.

Condition: good _____ Integrity: fair _____ Ownership: private _____ Category: Building _____
 Historic Use: Single Dwelling - Non Farm _____ Current Use: Single Dwelling - Non Farm _____
 Function: Residence _____ Function: Residence _____

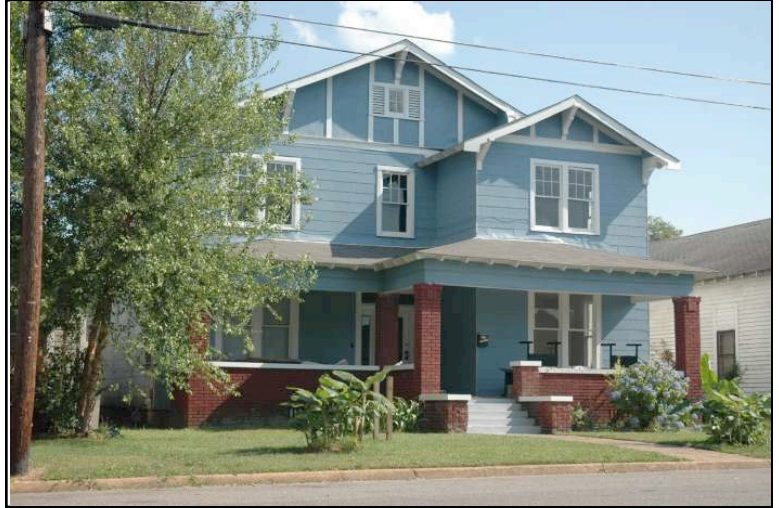
Rectangular 2-story frame dwelling with a front-facing gable composition shingle roof; faces north, 3x2 bay core.

Condition: good _____ Integrity: fair _____ Ownership: private _____ Category: Building _____
 Historic Use: Single Dwelling - Non Farm _____ Current Use: Single Dwelling - Non Farm _____
 Function: Residence _____ Function: Residence _____

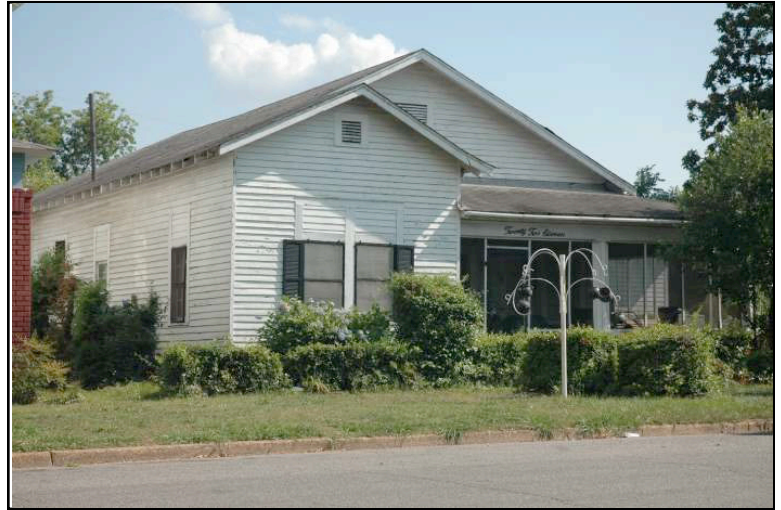
Rectangular 1-story frame dwelling with a front-facing gable composition shingle roof; faces north, 3x3 bay core with secondary front-facing gable projection to east.

Condition: good _____ Integrity: fair _____ Ownership: private _____ Category: Building _____
 Historic Use: Single Dwelling - Non Farm _____ Current Use: Single Dwelling - Non Farm _____
 Function: Residence _____ Function: Residence _____

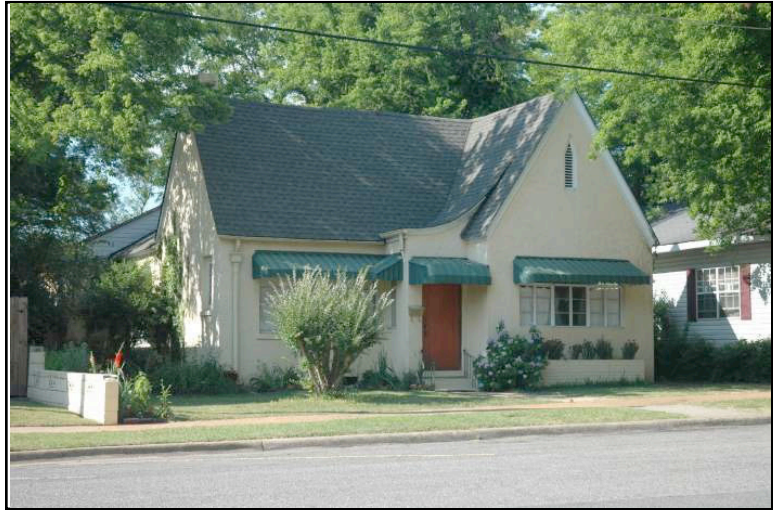
Rectangular 1-story stucco dwelling with a cross gable composition shingle roof; faces south, 3x2 bay core with front-facing gable projection to east.

Condition: good _____ Integrity: fair _____ Ownership: private _____ Category: Building _____
 Historic Use: Single Dwelling - Non Farm _____ Current Use: Single Dwelling - Non Farm _____
 Function: Residence _____ Function: Residence _____

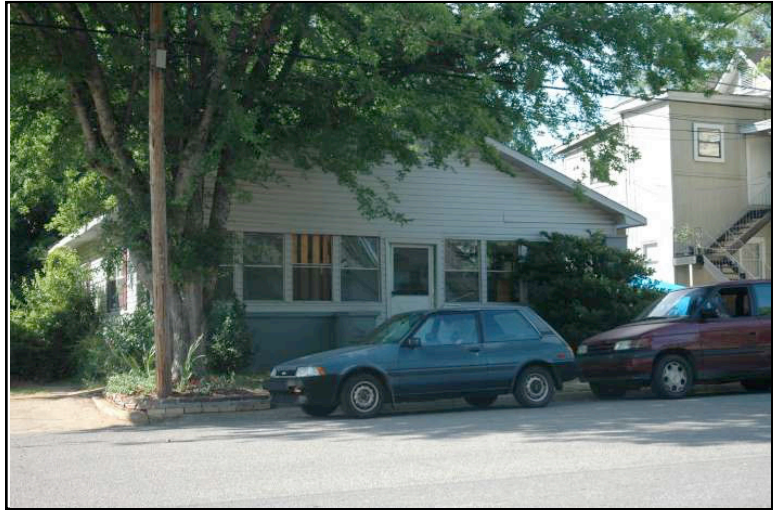
Rectangular 1-story frame dwelling with a front-facing gable composition shingle roof; faces south, 3x3 bay core.

Condition: good _____ Integrity: poor _____ Ownership: private _____ Category: Building _____
 Historic Use: Single Dwelling - Non Farm _____ Current Use: Single Dwelling - Non Farm _____
 Function: Residence _____ Function: Residence _____

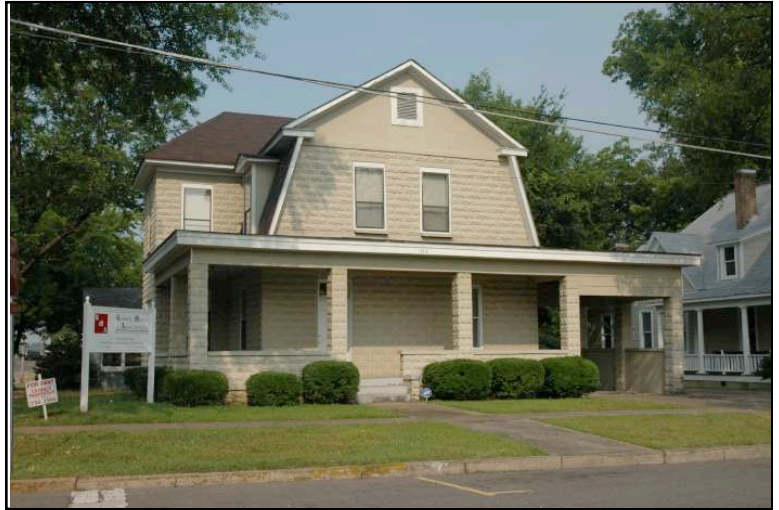
Rectangular 2-story patterned concrete block dwelling with a front-facing gambrel composition shingle roof with rear hip; faces east, 2x2 bay core with hipped wing at rear bay of south elevation, rear additions.

Condition: good _____ Integrity: good _____ Ownership: private _____ Category: Building _____
Historic Use: Single Dwelling - Non Farm _____ Current Use: Single Dwelling - Non Farm _____
Function: Residence _____ Function: Business/Professional Office _____

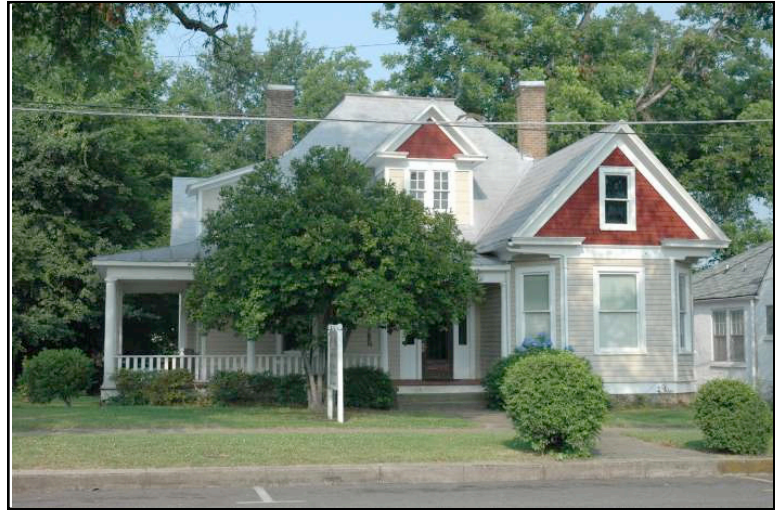
Rectangular 1.5-story frame dwelling with a hipped pressed metal shingle roof with cross gables and a central gable dormer; faces east, 3x3 bay core with front-facing pedimented gable projection at north bay of its facade with cutaway bay, side gable projections to north and south, rear extensions.

Condition: good _____ Integrity: good _____ Ownership: private _____ Category: Building _____
Historic Use: Single Dwelling - Non Farm _____ Current Use: Single Dwelling - Non Farm _____
Function: Residence _____ Function: Residence _____

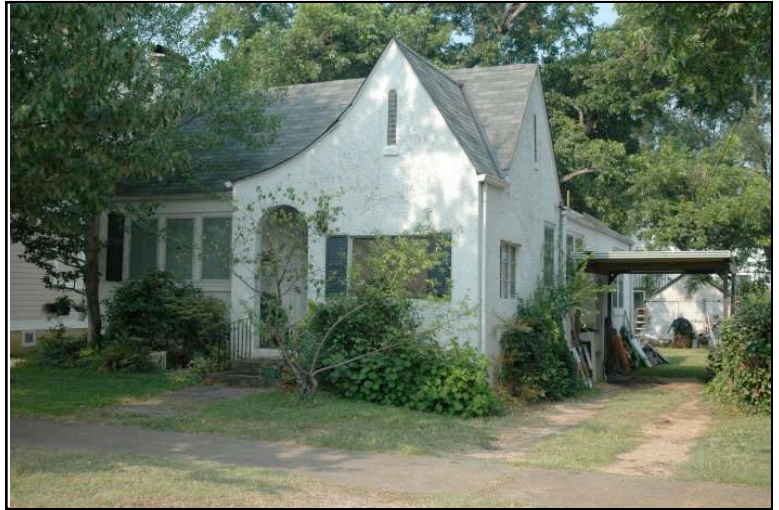
Rectangular 1-story stucco dwelling with a cross gable composition shingle roof; faces east, 3x2 bay core with front-facing gable projection at north bay of its facade.

Condition: good _____ Integrity: fair _____ Ownership: private _____ Category: Building _____
 Historic Use: Single Dwelling - Non Farm _____ Current Use: Single Dwelling - Non Farm _____
 Function: Residence _____ Function: Residence _____

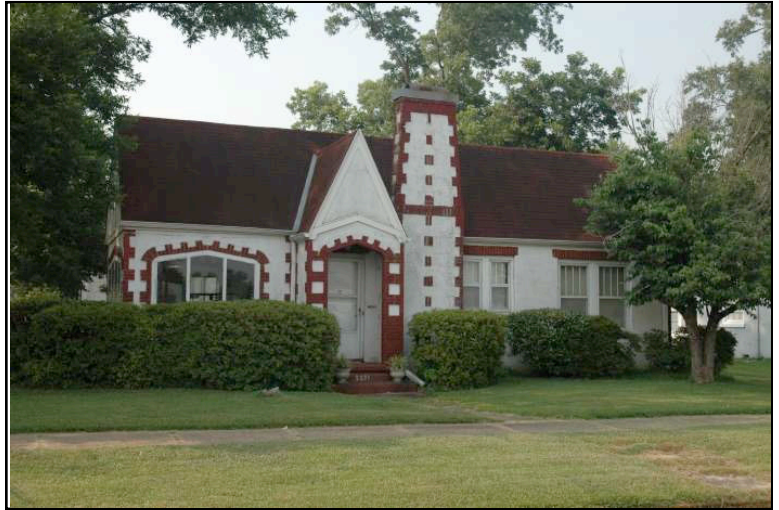
Rectangular 1-story stucco dwelling with a cross gable composition shingle roof; faces north, 4x4 bay core.

Condition: good _____ Integrity: good _____ Ownership: private _____ Category: Building _____
 Historic Use: Single Dwelling - Non Farm _____ Current Use: Single Dwelling - Non Farm _____
 Function: Residence _____ Function: Residence _____

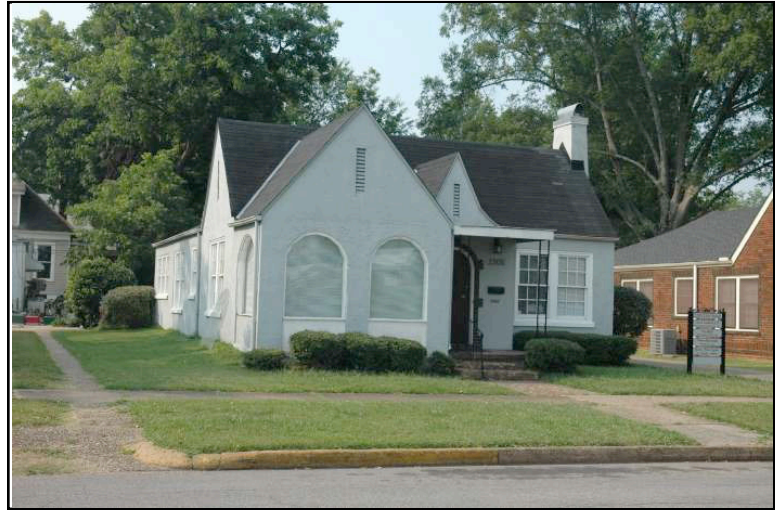
Rectangular 1-story stucco dwelling with a cross gable composition shingle roof; faces north, 3x4 bay core with front-facing gable projection at east bay of its facade.

Condition: good _____ Integrity: good _____ Ownership: private _____ Category: Building _____
 Historic Use: Single Dwelling - Non Farm _____ Current Use: Commerce/Trade _____
 Function: Residence _____ Function: Business/Professional Office _____

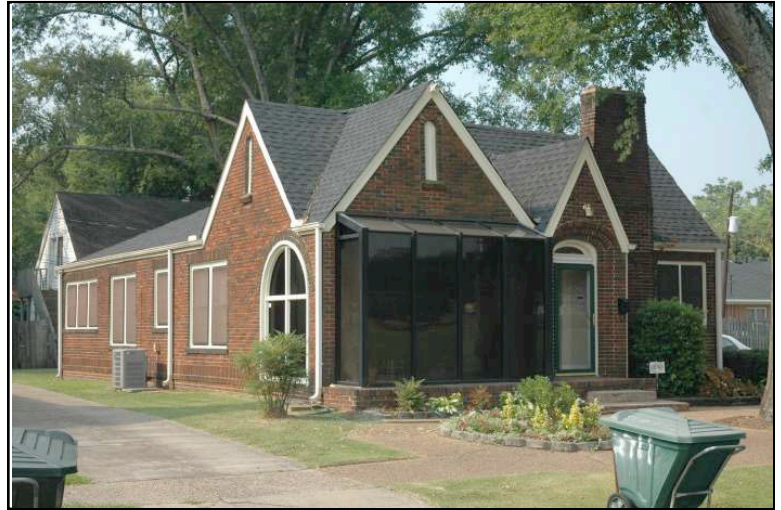
Rectangular 1-story brick veneer dwelling with a cross gable composition shingle roof; faces north, 3x4 bay core with front-facing gable projection at east bay of its facade.

Condition: good _____ Integrity: good _____ Ownership: private _____ Category: Building _____
Historic Use: Single Dwelling - Non Farm _____ Current Use: Commerce/Trade _____
Function: Residence _____ Function: Business/Professional Office _____

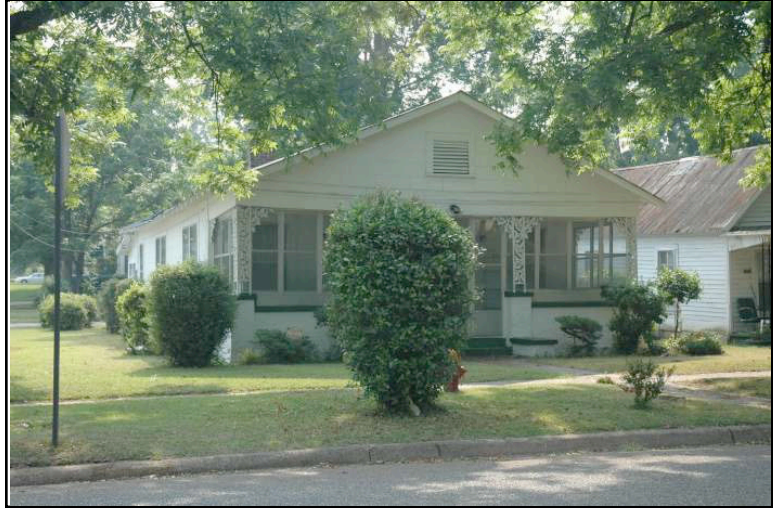
Rectangular 1-story frame dwelling with a front-facing gable composition shingle roof; faces west, 4x3 bay core with rear shed extension.

Condition: good _____ Integrity: good _____ Ownership: private _____ Category: Building _____
 Historic Use: Single Dwelling - Non Farm _____ Current Use: Single Dwelling - Non Farm _____
 Function: Residence _____ Function: Residence _____

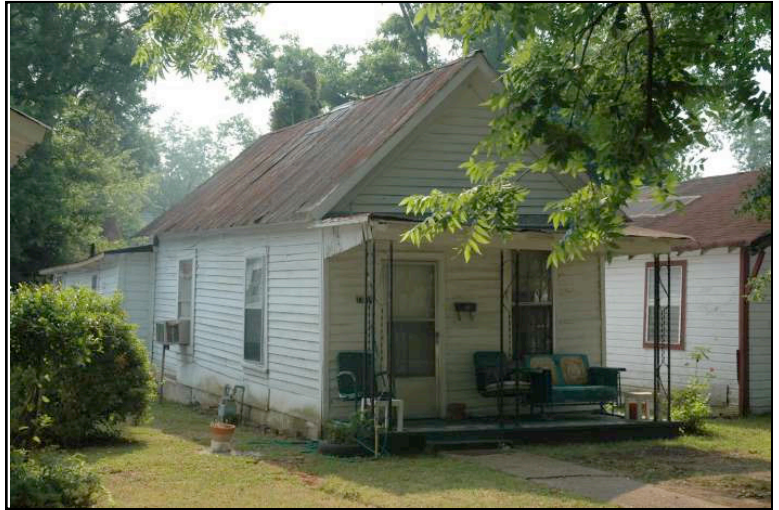
Rectangular 1-story frame shotgun form dwelling with a front-facing gable corrugated metal roof; faces west, 2x2 bay core with rear shed extension.

Condition: good _____ Integrity: good _____ Ownership: private _____ Category: Building _____
 Historic Use: Single Dwelling - Non Farm _____ Current Use: Single Dwelling - Non Farm _____
 Function: Residence _____ Function: Residence _____

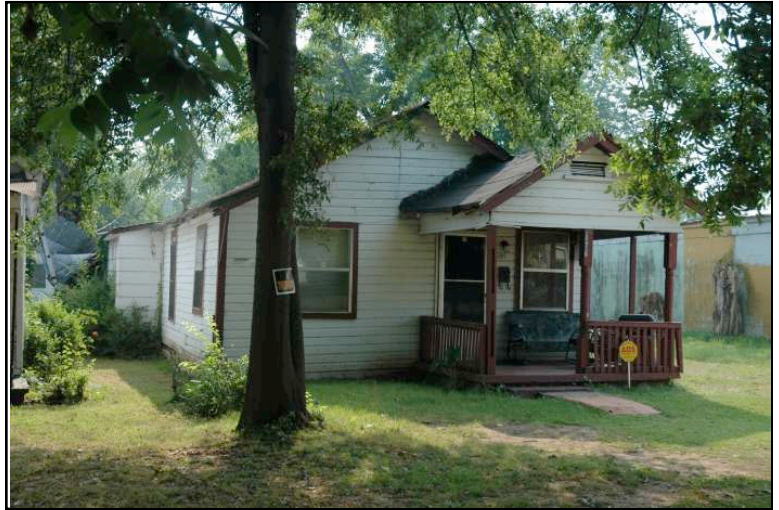
Rectangular 1-story frame dwelling with a front-facing gable composition shingle roof; faces west, 3x3 bay core with rear gable addition.

Condition: good _____ Integrity: fair _____ Ownership: private _____ Category: Building _____
 Historic Use: Single Dwelling - Non Farm _____ Current Use: Single Dwelling - Non Farm _____
 Function: Residence _____ Function: Residence _____

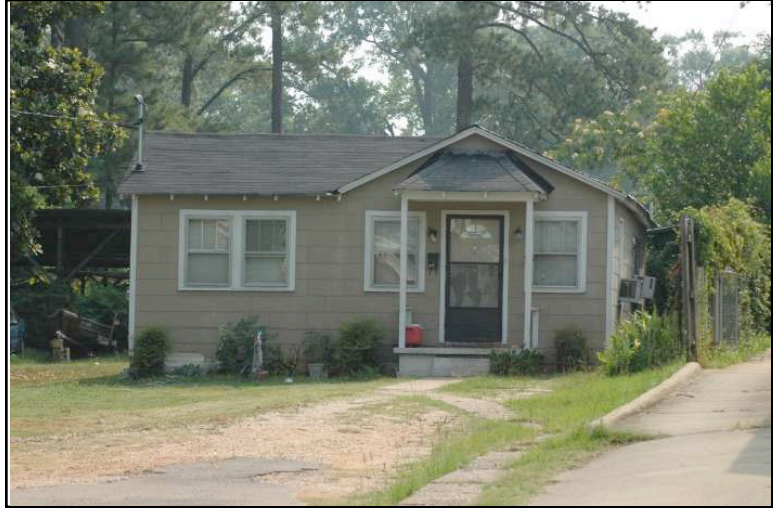
Rectangular 1-story frame dwelling with a front-facing gable composition shingle roof with cross gable at side addition; faces north, 3x2 bay core with side gable addition.

Condition: good _____ Integrity: good _____ Ownership: private _____ Category: Building _____
 Historic Use: Single Dwelling - Non Farm _____ Current Use: Single Dwelling - Non Farm _____
 Function: Residence _____ Function: Residence _____

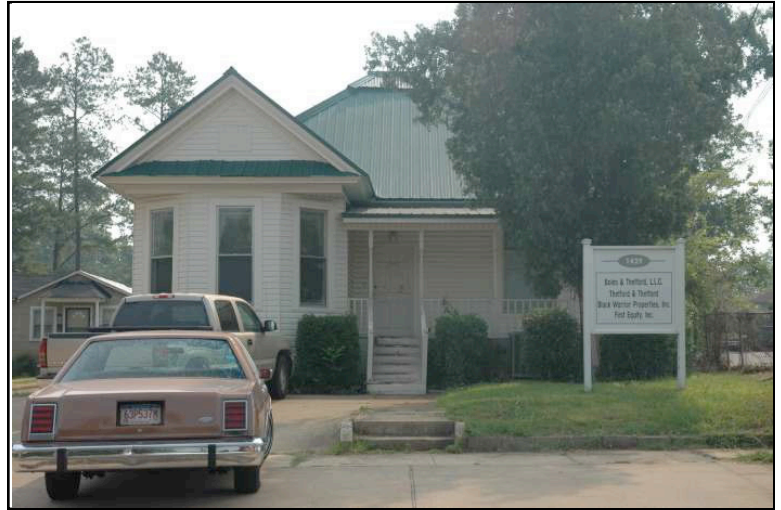
Rectangular 1-story frame dwelling with a hipped industrial metal roof with front-facing pedimented gable to north; faces west, 3x5 bay core with front-facing gable wing with cutaway bay.

Condition: good _____ Integrity: fair _____ Ownership: private _____ Category: Building _____
 Historic Use: Single Dwelling - Non Farm _____ Current Use: Commerce/Trade _____
 Function: Residence _____ Function: Business/Professional Office _____

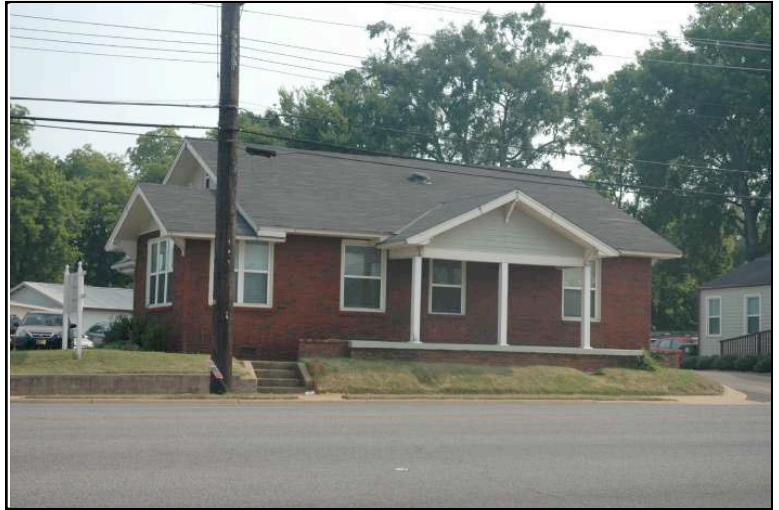
Rectangular 1-story frame dwelling with a side gable composition shingle roof; faces south, 3x3 bay core with secondary rear gable wing with extension.

Condition: good _____ Integrity: fair _____ Ownership: private _____ Category: Building _____
 Historic Use: Single Dwelling - Non Farm _____ Current Use: Single Dwelling - Non Farm _____
 Function: Residence _____ Function: Residence _____

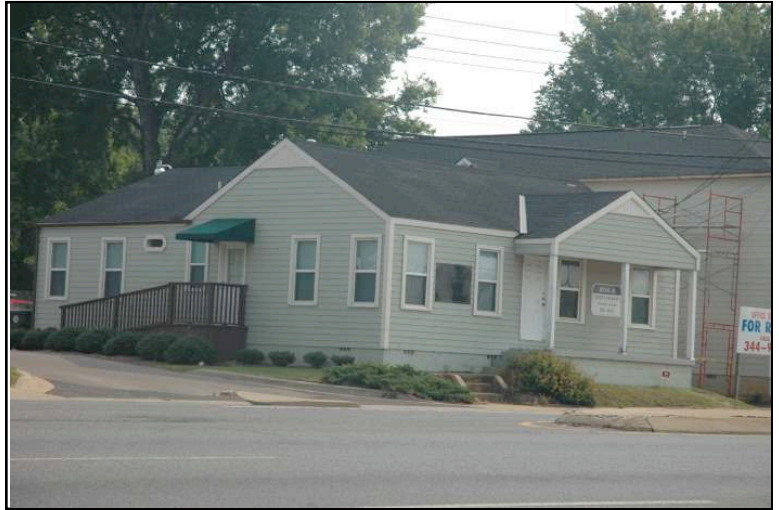
Rectangular 1-story frame dwelling with a side gable composition shingle roof; faces south, 5x3 bay core with rear gable wing.

Condition: good _____ Integrity: fair _____ Ownership: private _____ Category: Building _____
 Historic Use: Single Dwelling - Non Farm _____ Current Use: Single Dwelling - Non Farm _____
 Function: Residence _____ Function: Residence _____

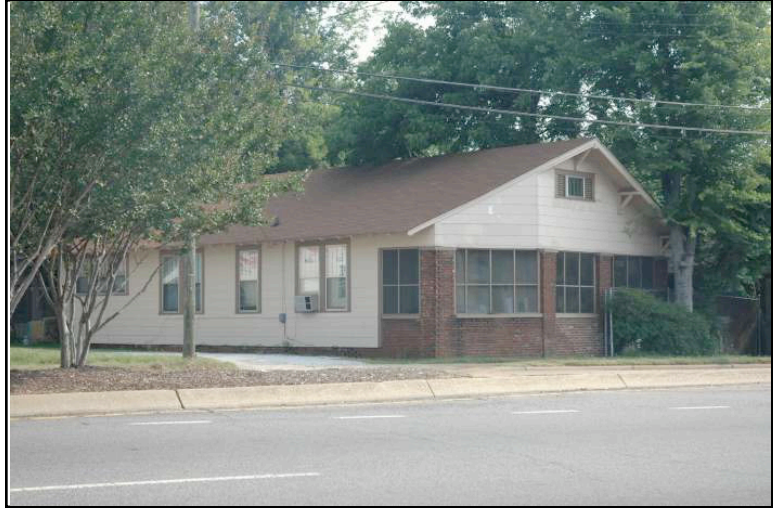
Rectangular 1-story frame dwelling with a front-facing gable composition shingle roof; faces south, 3x4 bay core.

Condition: good _____ Integrity: fair _____ Ownership: private _____ Category: Building _____
 Historic Use: Single Dwelling - Non Farm _____ Current Use: Single Dwelling - Non Farm _____
 Function: Residence _____ Function: Residence _____

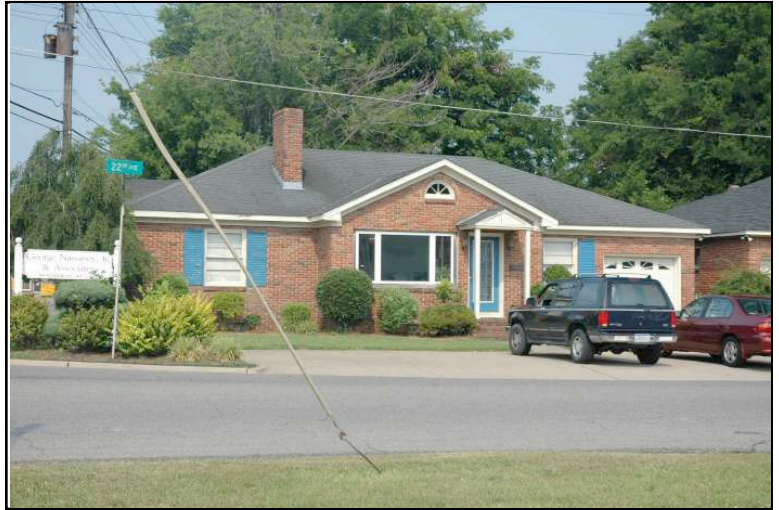
Rectangular 1-story frame dwelling with a hipped composition shingle roof; faces east, 5x2 bay core.

Condition: good _____ Integrity: good _____ Ownership: private _____ Category: Building _____
 Historic Use: Single Dwelling - Non Farm _____ Current Use: Single Dwelling - Non Farm _____
 Function: Residence _____ Function: Residence _____

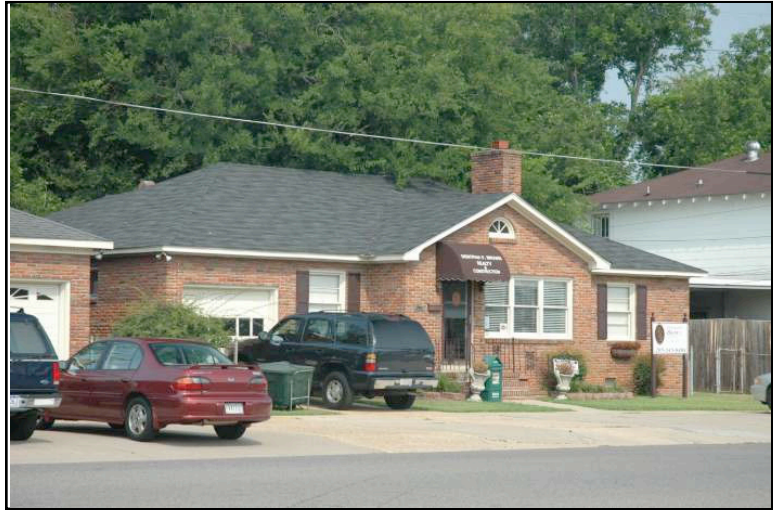
Rectangular 1-story frame dwelling with a hipped composition shingle roof; faces east, 5x2 bay core.

Condition: good _____ Integrity: good _____ Ownership: private _____ Category: Building _____
 Historic Use: Single Dwelling - Non Farm _____ Current Use: Commerce/Trade _____
 Function: Residence _____ Function: Business/Professional Office _____

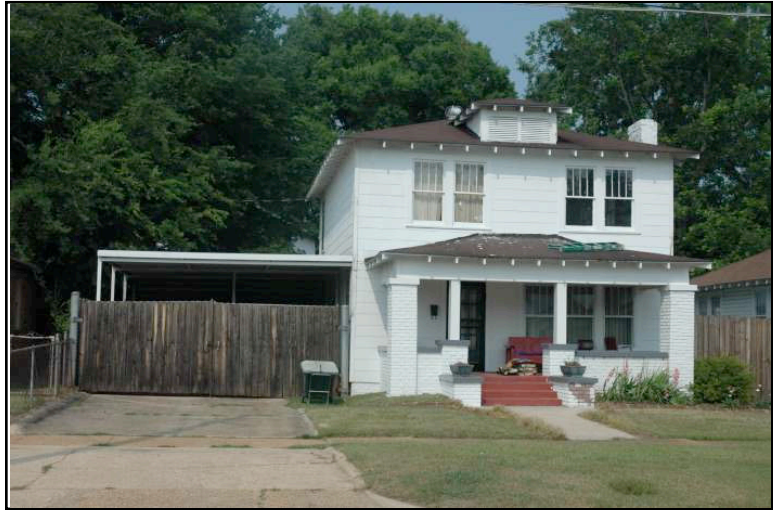
Rectangular 2-story frame dwelling with a hipped composition shingle roof with central hipped decorative dormer and exposed rafter ends; faces east, 2x3 bay core.

Condition: good _____ Integrity: good _____ Ownership: private _____ Category: Building _____
 Historic Use: Single Dwelling - Non Farm _____ Current Use: Single Dwelling - Non Farm _____
 Function: Residence _____ Function: Residence _____

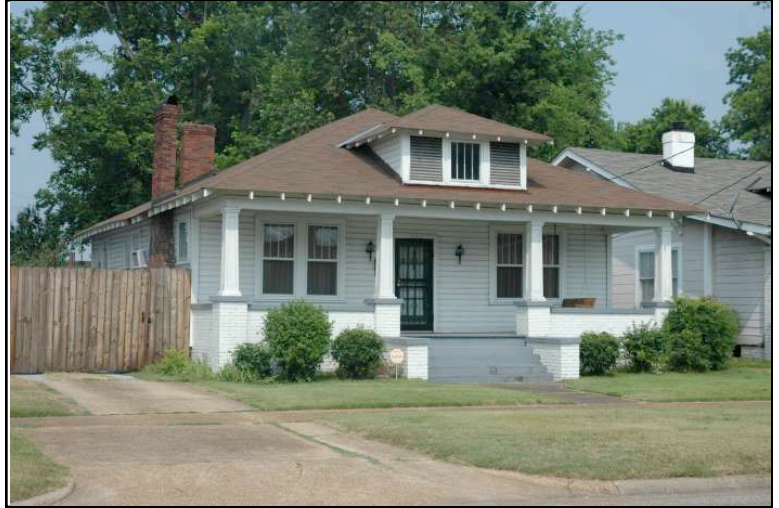
Rectangular 1-story frame dwelling with a hipped composition shingle roof with central hipped decorative dormer and exposed rafter ends; faces east, 3x4 bay core.

Condition: good _____ Integrity: good _____ Ownership: private _____ Category: Building _____
 Historic Use: Single Dwelling - Non Farm _____ Current Use: Single Dwelling - Non Farm _____
 Function: Residence _____ Function: Residence _____

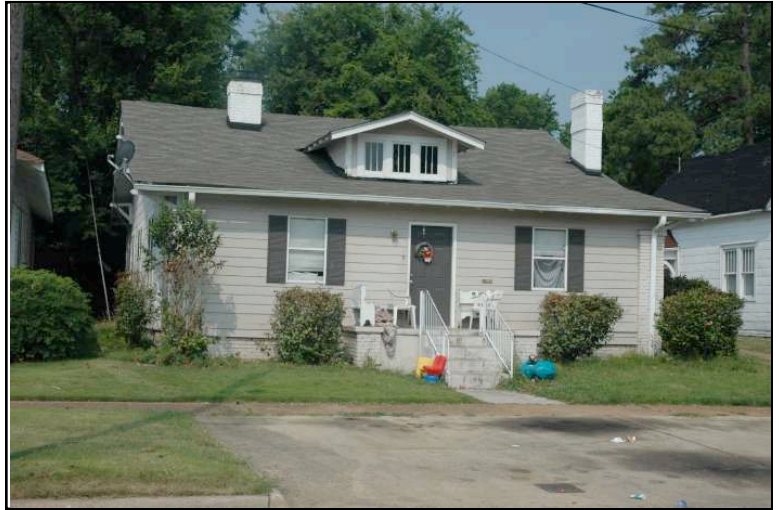
Rectangular 1-story frame dwelling with a side gable composition shingle roof with central gable decorative dormer; faces east, 3x3 bay core.

Condition: good _____ Integrity: fair _____ Ownership: private _____ Category: Building _____
 Historic Use: Single Dwelling - Non Farm _____ Current Use: Single Dwelling - Non Farm _____
 Function: Residence _____ Function: Residence _____

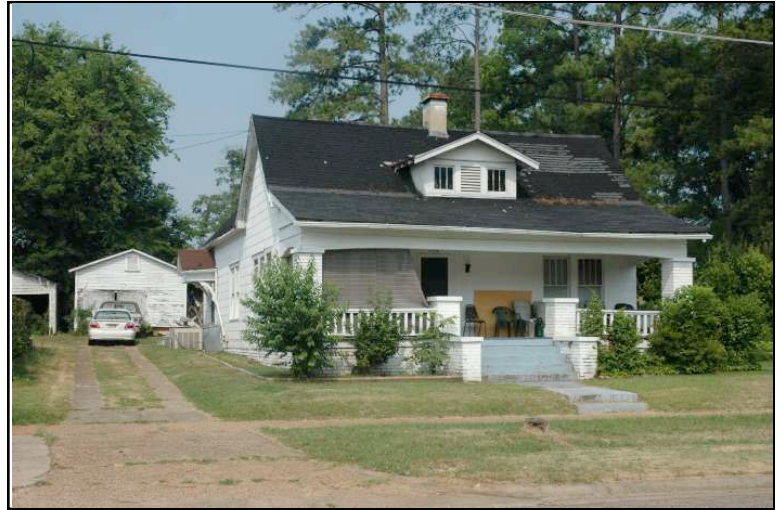
Rectangular 1-story frame dwelling with a cross gable composition shingle roof with central gable decorative dormer ; faces east, 3x2 bay core.

Condition: good _____ Integrity: good _____ Ownership: private _____ Category: Building _____
 Historic Use: Single Dwelling - Non Farm _____ Current Use: Single Dwelling - Non Farm _____
 Function: Residence _____ Function: Residence _____

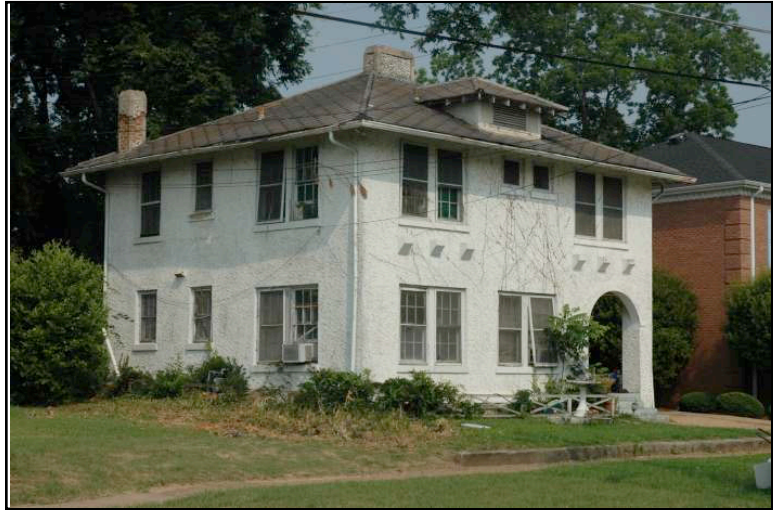
Rectangular 2-story stucco dwelling with a hipped composition shingle roof with central hipped decorative dormer ; faces east, 3x3 bay core.

Condition: good _____ Integrity: good _____ Ownership: private _____ Category: Building _____
 Historic Use: Single Dwelling - Non Farm _____ Current Use: Single Dwelling - Non Farm _____
 Function: Residence _____ Function: Residence _____

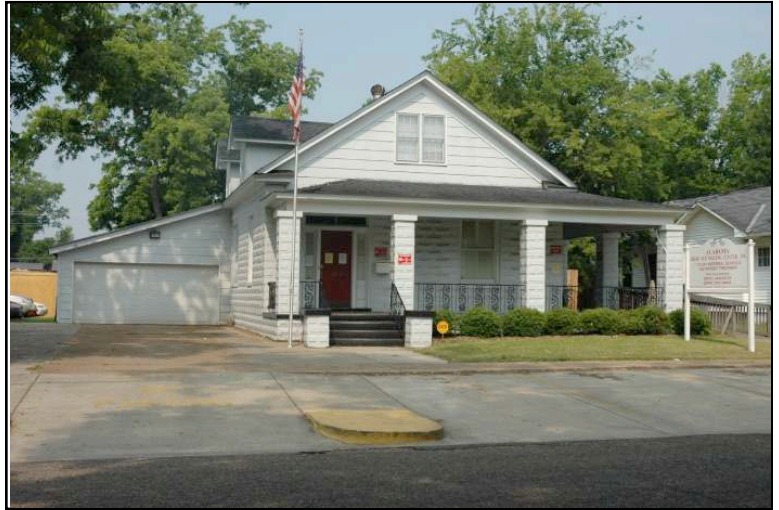
Rectangular 1.5-story patterned concrete block dwelling with a front-facing gable composition shingle roof, dormers added at south slope; faces east, 2x3 bay core.

Condition: good _____ Integrity: good _____ Ownership: private _____ Category: Building _____
 Historic Use: Single Dwelling - Non Farm _____ Current Use: Commerce/Trade _____
 Function: Residence _____ Function: Business/Professional Office _____

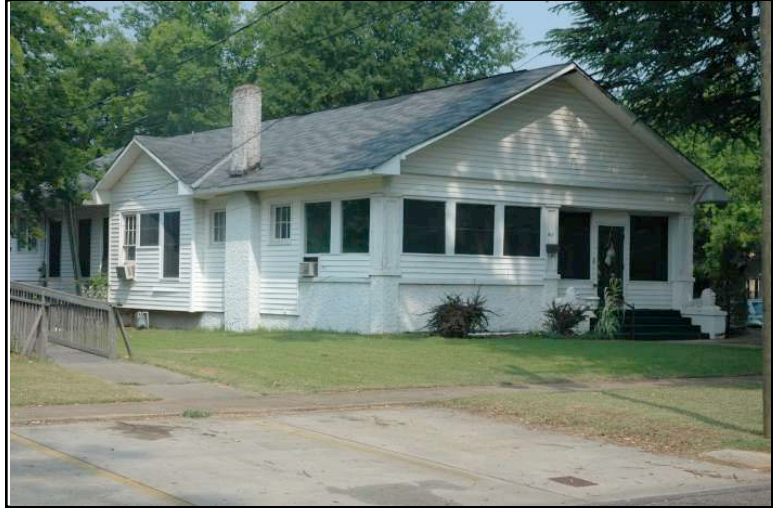
Rectangular 1-story frame dwelling with a front-facing gable composition shingle roof, with secondary side gable projection; faces east, 3x6 bay core.

Condition: good _____ Integrity: fair _____ Ownership: private _____ Category: Building _____
 Historic Use: Single Dwelling - Non Farm _____ Current Use: Single Dwelling - Non Farm _____
 Function: Residence _____ Function: Residence _____

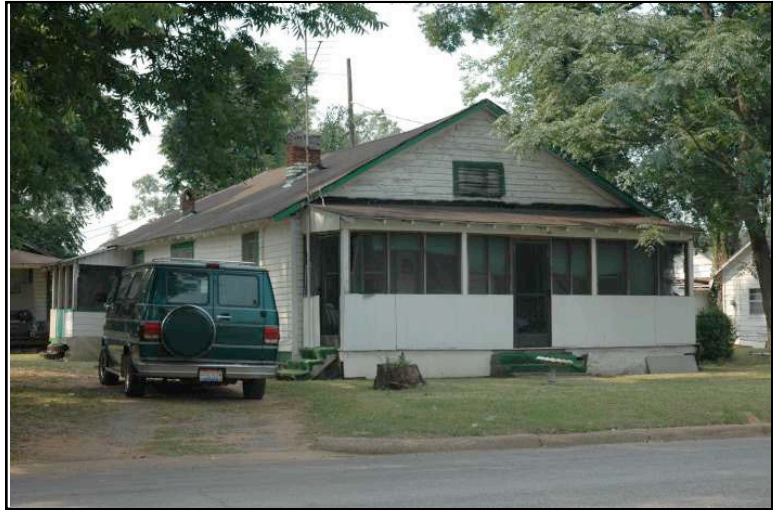
Rectangular 1-story frame dwelling with a front-facing gable composition shingle roof with exposed rafter ends; faces north, 4x4 bay core.

Condition: good _____ Integrity: good _____ Ownership: private _____ Category: Building _____
 Historic Use: Single Dwelling - Non Farm _____ Current Use: Single Dwelling - Non Farm _____
 Function: Residence _____ Function: Residence _____

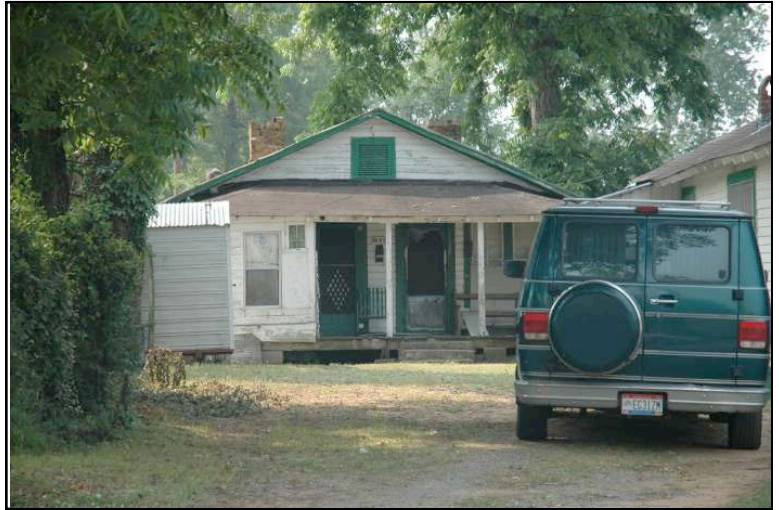
Rectangular 1-story frame dwelling with a front-facing gable composition shingle roof with exposed rafter ends; faces north, 4x4 bay core.

Condition: good _____ Integrity: good _____ Ownership: private _____ Category: Building _____
 Historic Use: Single Dwelling - Non Farm _____ Current Use: Single Dwelling - Non Farm _____
 Function: Residence _____ Function: Residence _____
