Tuscaloosa

Greater Downtown Study
Historic Resource Survey - 2006

Survey Number: _____ 1 _____
Historic name(s): House, Not Named
Common name: Southeast Appraisers
Location: University Blvd., 2720

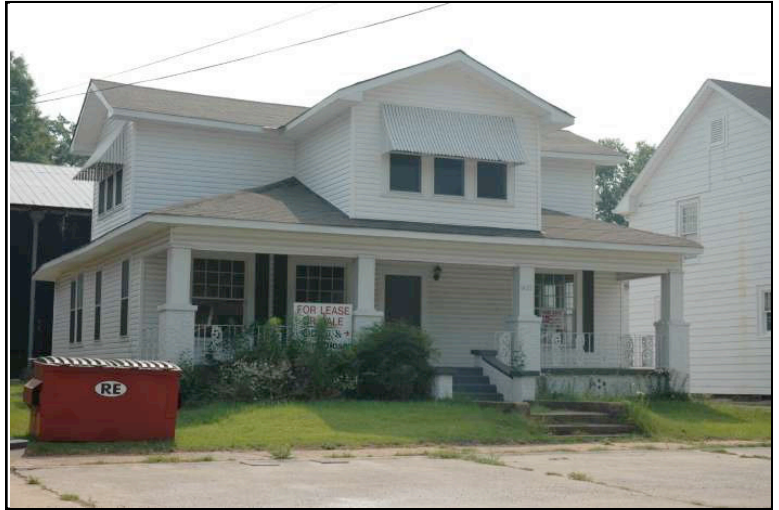
T-shaped 2-story frame dwelling with a cross gable composition shingle roof; faces west, 4x3 bay core.

Condition: good _____ Integrity: fair _____ Ownership: private _____ Category: Building _____
 Historic Use: Single Dwelling - Non Farm _____ Current Use: Single Dwelling - Non Farm _____
 Function: Residence _____ Function: Residence _____

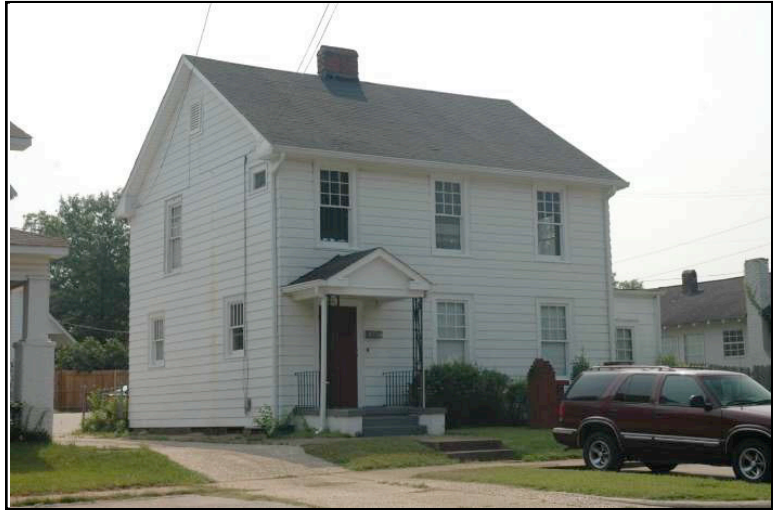
Rectangular 2-story frame dwelling with a side gable composition shingle roof; faces west, 3x2 bay core.

Condition: good _____ Integrity: fair _____ Ownership: private _____ Category: Building _____
 Historic Use: Single Dwelling - Non Farm _____ Current Use: Single Dwelling - Non Farm _____
 Function: Residence _____ Function: Residence _____

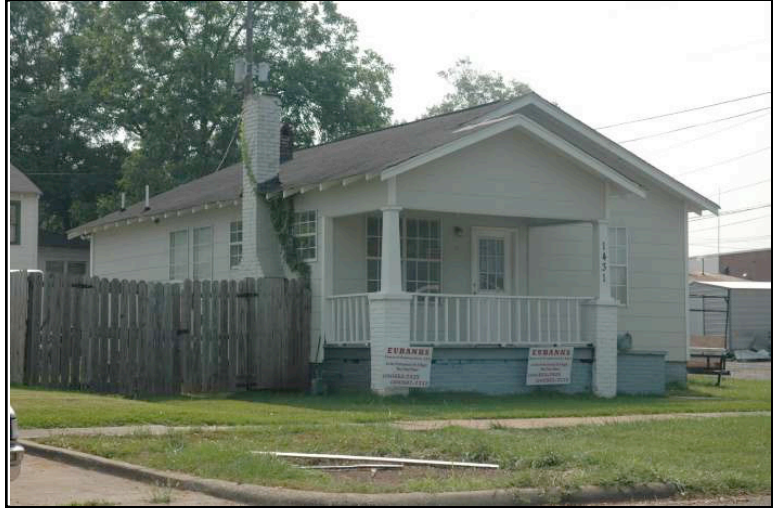
Rectangular 1-story frame dwelling with a front-facing gable composition shingle roof; faces west, 3x3 bay core.

Condition: good _____ Integrity: fair _____ Ownership: private _____ Category: Building _____
 Historic Use: Single Dwelling - Non Farm _____ Current Use: Single Dwelling - Non Farm _____
 Function: Residence _____ Function: Residence _____

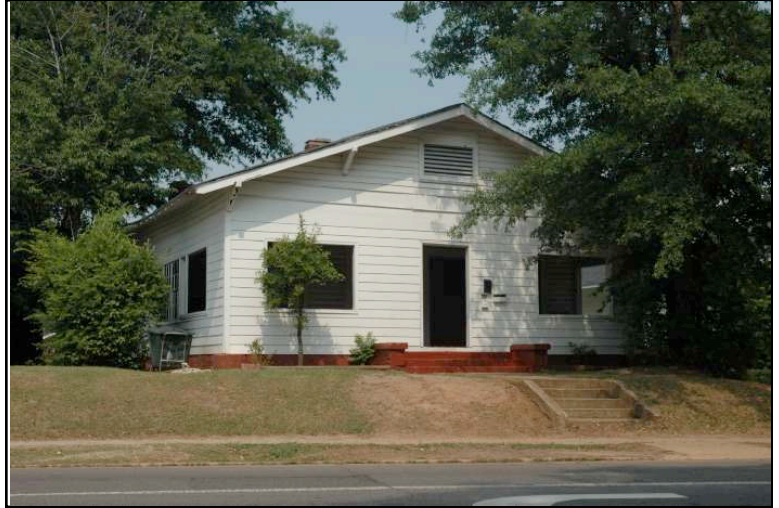
Rectangular 1-story frame dwelling with a front-facing gable composition shingle roof; faces east, 3x3 bay core.

Condition: good _____ Integrity: fair _____ Ownership: private _____ Category: Building _____
 Historic Use: Single Dwelling - Non Farm _____ Current Use: Single Dwelling - Non Farm _____
 Function: Residence _____ Function: Residence _____

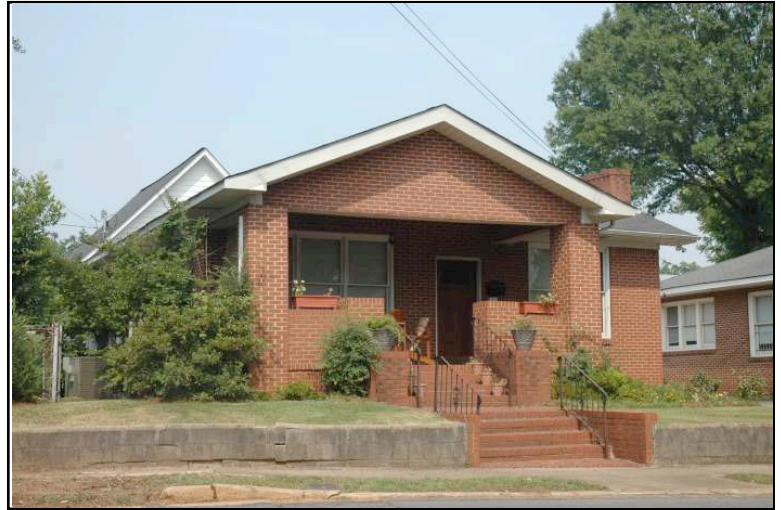
Rectangular 1-story brick veneer dwelling with a front-facing gable composition shingle roof; faces east, 3x3 bay core.

Condition: good _____ Integrity: fair _____ Ownership: private _____ Category: Building _____
 Historic Use: Single Dwelling - Non Farm _____ Current Use: Single Dwelling - Non Farm _____
 Function: Residence _____ Function: Residence _____

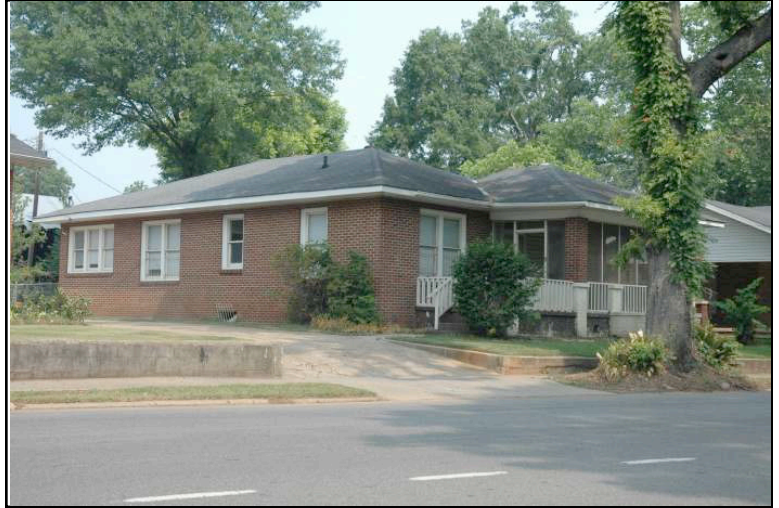
Rectangular 1-story brick veneer dwelling with a hipped gable composition shingle roof; faces east, 3x4 bay core.

Condition: good _____ Integrity: fair _____ Ownership: private _____ Category: Building _____
 Historic Use: Single Dwelling - Non Farm _____ Current Use: Single Dwelling - Non Farm _____
 Function: Residence _____ Function: Residence _____

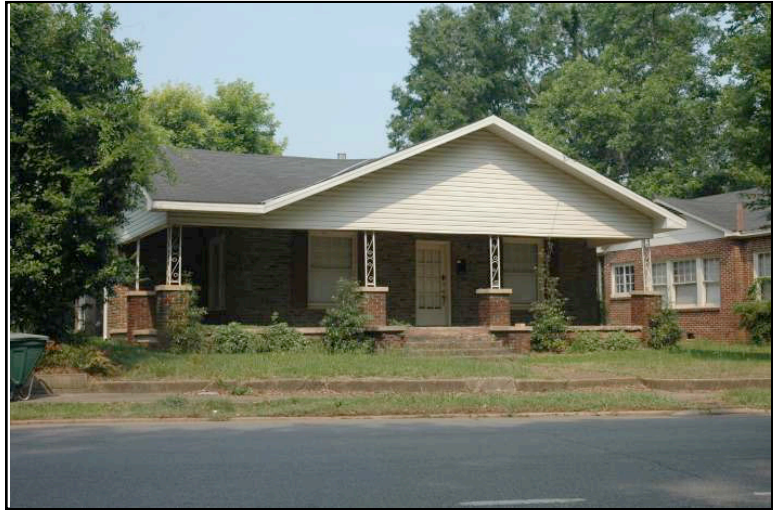
Rectangular 1-story brick veneer dwelling with a side gable composition shingle roof; faces east, 3x4 bay core.

Condition: good _____ Integrity: fair _____ Ownership: private _____ Category: Building _____
 Historic Use: Single Dwelling - Non Farm _____ Current Use: Single Dwelling - Non Farm _____
 Function: Residence _____ Function: Residence _____

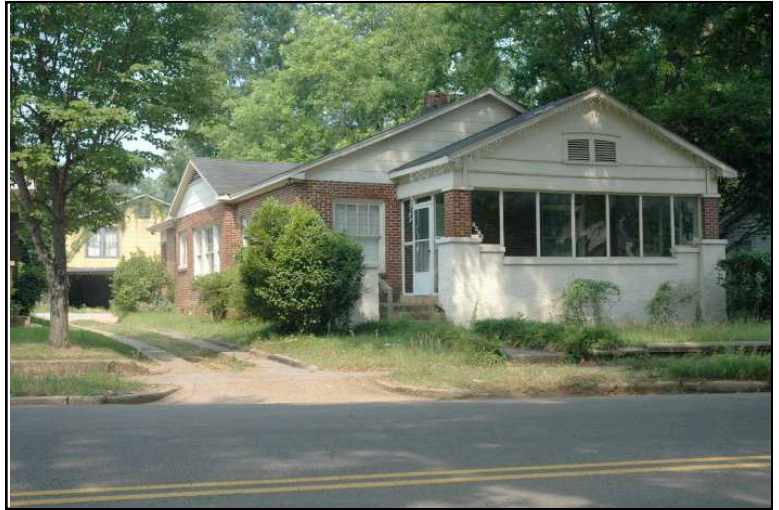
Rectangular 1-story brick veneer dwelling with a front-facing gable composition shingle roof; faces east, 3x5 bay core.

Condition: good _____ Integrity: good _____ Ownership: private _____ Category: Building _____
 Historic Use: Single Dwelling - Non Farm _____ Current Use: Single Dwelling - Non Farm _____
 Function: Residence _____ Function: Residence _____

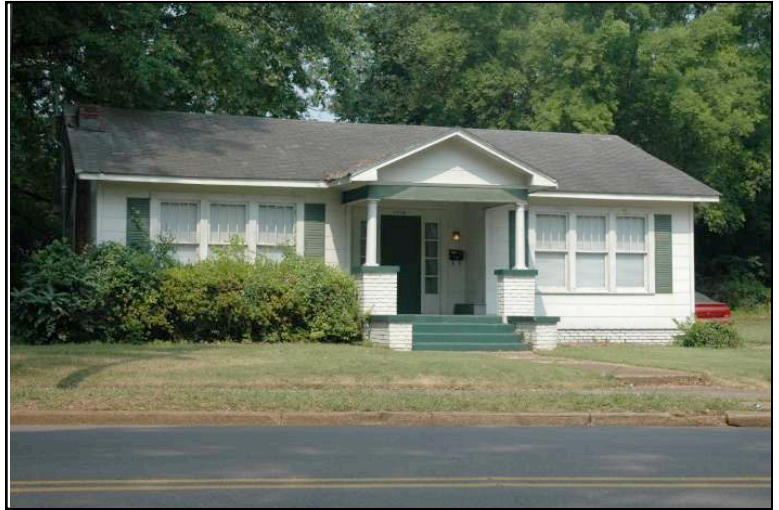
Rectangular 1-story frame dwelling with a side gable composition shingle roof; faces east, 3x2 bay core.

Condition: good _____ Integrity: good _____ Ownership: private _____ Category: Building _____
 Historic Use: Single Dwelling - Non Farm _____ Current Use: Single Dwelling - Non Farm _____
 Function: Residence _____ Function: Residence _____

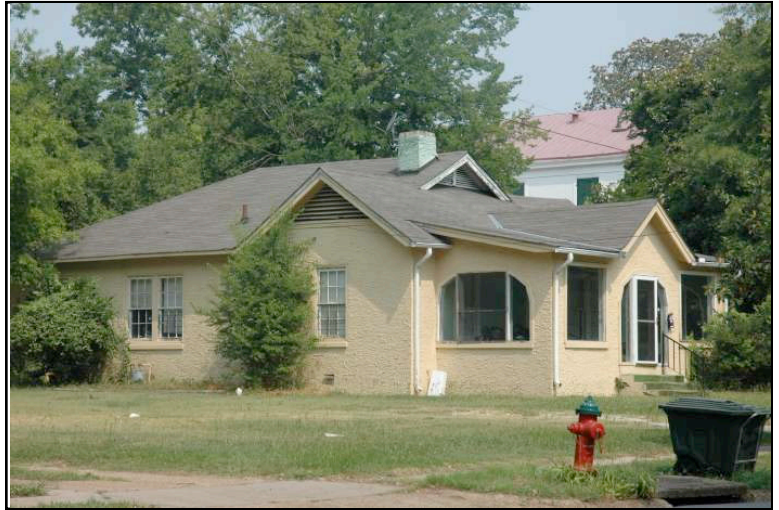
Rectangular 1-story stucco dwelling with a cross gable composition shingle roof; faces east, 3x3 bay core.

Condition: good _____ Integrity: good _____ Ownership: private _____ Category: Building _____
 Historic Use: Single Dwelling - Non Farm _____ Current Use: Single Dwelling - Non Farm _____
 Function: Residence _____ Function: Residence _____

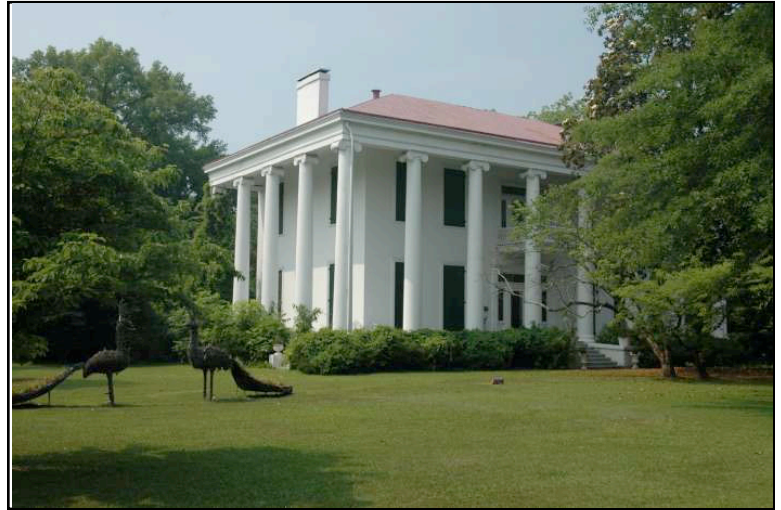
Rectangular 2-story stucco dwelling with a hipped raised seam metal roof; faces north, 5x2 bay core with secondary rear extension; full-height recessed portico along facade and side elevation with Ionic columns; central entrance at facade with transom & sidelights flanked by single windows concealed by closed shutters, similar windows at side elevations, similar entrance at upper level of facade accesses a balcony; stucco exterior walls; foundation not visible; a small frame shed and rear ancillary dwelling were not accessible for survey.

Condition: good _____ Integrity: good _____ Ownership: private _____ Category: Building _____
Historic Use: Single Dwelling - Non Farm _____ Current Use: Single Dwelling - Non Farm _____
Function: Residence _____ Function: Residence _____

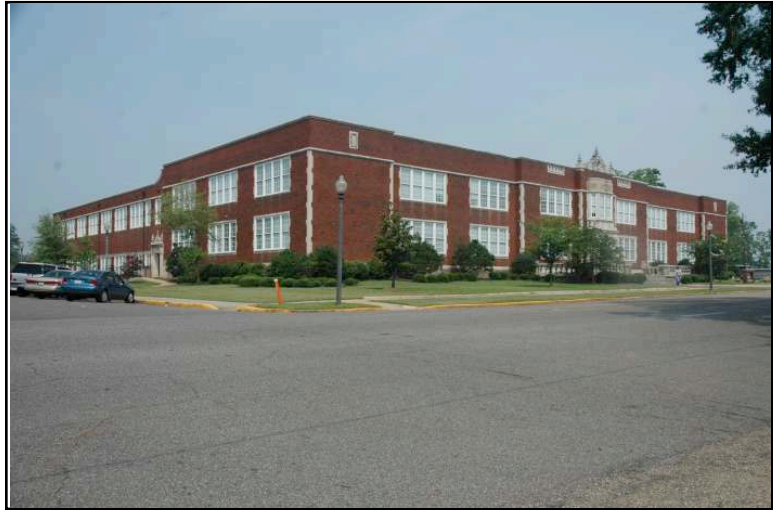
E-shaped 2-story brick veneer school with a flat roof concealed by low parapets; faces east, 7x3 bay core with rear wings to the east and west and central rear auditorium wing; central entrance bay has elaborate cast stone veneer and decorative highlights atop parapet; principal entrance recessed within arched opening flanked on either side by 3 4-unit grouped replacement windows (ca. 1995), similar windows at upper level and side elevations at core, similar single and double windows at wings; exposed brick veneer exterior walls; brick veneer foundation .

Condition: good _____ Integrity: good _____ Ownership: city _____ Category: Building _____
Historic Use: Education _____ Current Use: Education _____
Function: School _____ Function: School _____

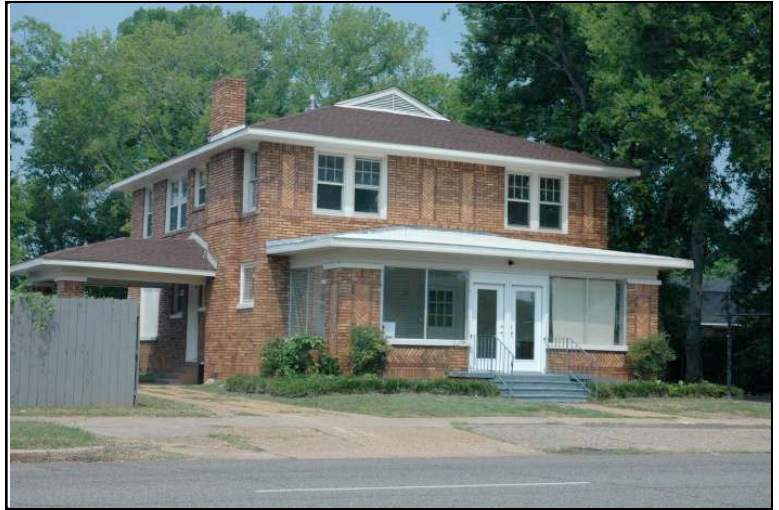
Rectangular 2-story brick veneer dwelling with a hipped composition shingle roof; faces east, 2x4 bay core.

Condition: good _____ Integrity: good _____ Ownership: private _____ Category: Building _____
 Historic Use: Single Dwelling - Non Farm _____ Current Use: Single Dwelling - Non Farm _____
 Function: Residence _____ Function: Residence _____

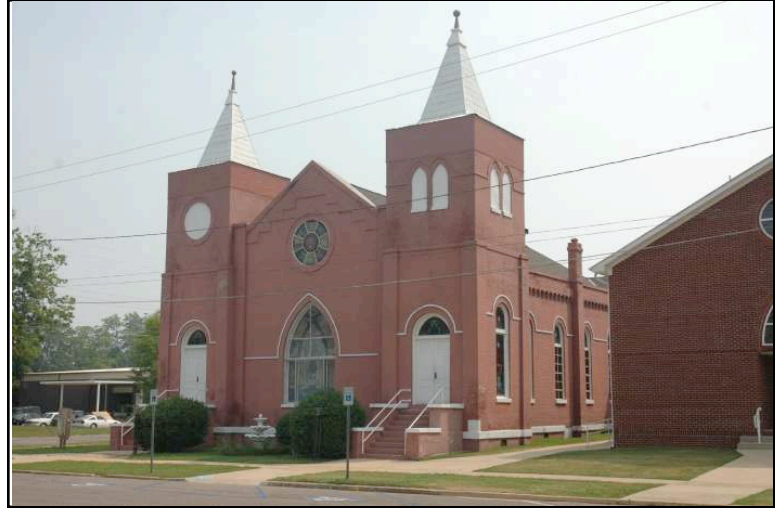
T-shaped 1-story brick church building with a principal front-facing gable composition shingle roof concealed at the building's facade by a gable parapet, secondary side gable at rear; faces west, 1x5 bay core with flanking corner towers at front bays and T-wings at rear bays of side elevations, modern ancillary building to south connected by hyphen at south T wing; single entrances within round arched openings at towers flank central oversized pointed arched stained glass window, round stained glass window above, louvered openings at upper level of towers, tall round arched window openings at 4 front bays of side elevation with stained glass transoms and replacement windows, single entrance flanked by similar arched windows in tripartite grouping at north elevation of rear T wing; exposed brick exterior walls; brick

Condition: good _____ Integrity: good _____ Ownership: private _____ Category: Building _____
Historic Use: Religion _____ Current Use: Religion _____
Function: Religious Facility _____ Function: Religious Facility _____

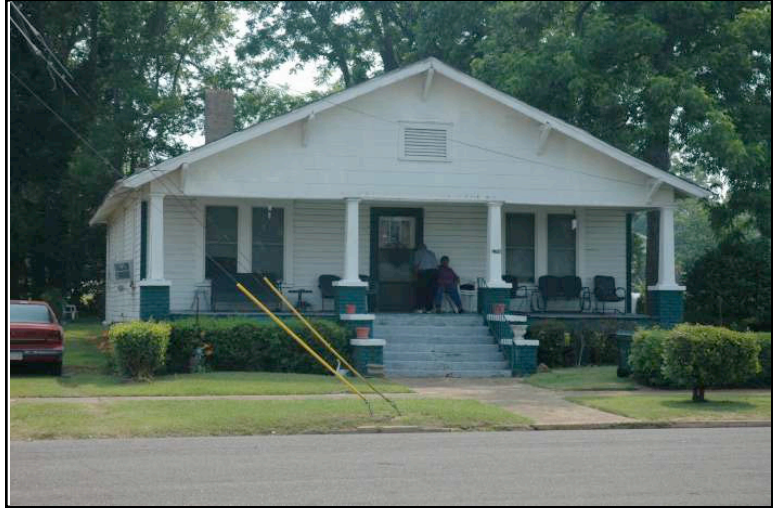
Rectangular 1-story frame dwelling with a front-facing gable composition shingle roof; faces west, 3x4 bay core.

Condition: good _____ Integrity: good _____ Ownership: private _____ Category: Building _____
 Historic Use: Single Dwelling - Non Farm _____ Current Use: Single Dwelling - Non Farm _____
 Function: Residence _____ Function: Residence _____

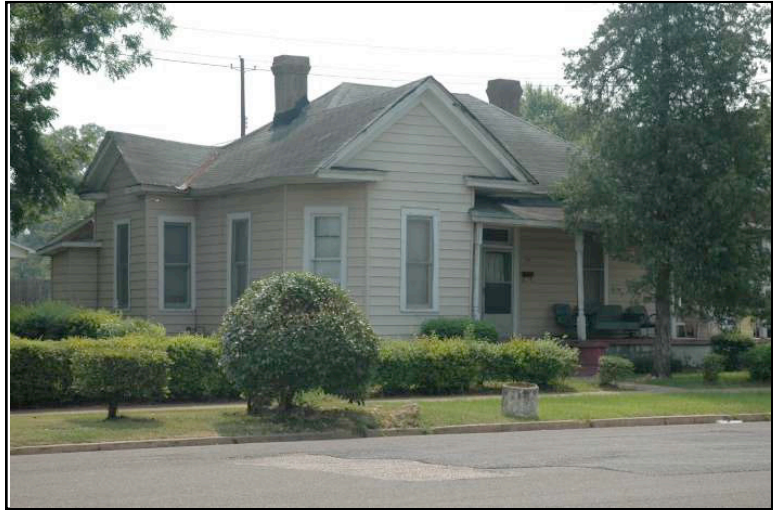
Rectangular 1-story frame dwelling with a hipped composition shingle roof with cross gables; faces west, 3x3 bay core with front-facing gable projection with cutaway bay to north, side gable projection.

Condition: good _____ Integrity: fair _____ Ownership: private _____ Category: Building _____
 Historic Use: Single Dwelling - Non Farm _____ Current Use: Single Dwelling - Non Farm _____
 Function: Residence _____ Function: Residence _____

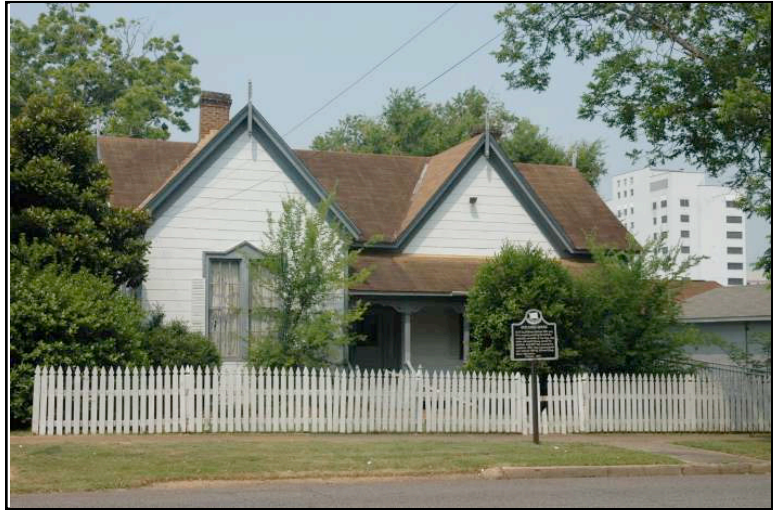
Rectangular 1-story frame dwelling with a side gable composition shingle roof with 2 front-facing cross gables; faces east, 3x2 bay core with front-facing gable projection to south, rear extensions.

Condition: good _____ Integrity: good _____ Ownership: private _____ Category: Building _____
Historic Use: Single Dwelling - Non Farm _____ Current Use: Unknown _____
Function: Residence _____ Function: _____

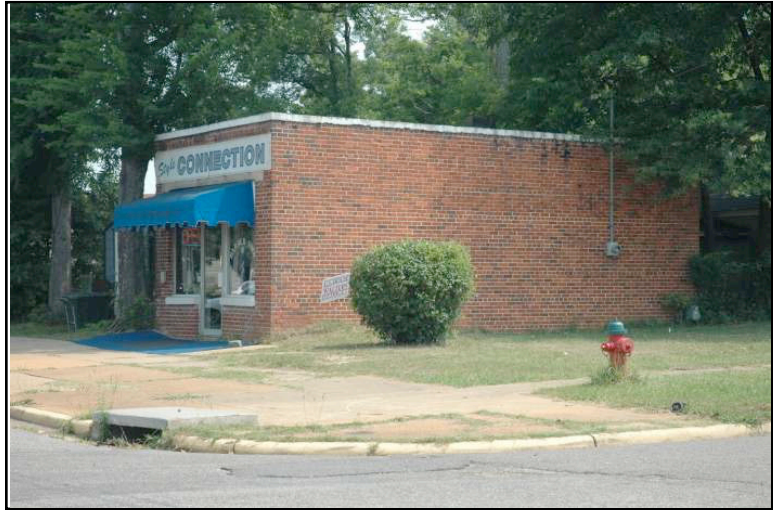
Rectangular 1-story brick commercial building with a flat roof; faces west, 1 bay wide core with replacement aluminum frame storefront.

Condition: good _____ Integrity: good _____ Ownership: private _____ Category: Building _____
 Historic Use: Commerce/Trade Current Use: Commerce/Trade
 Function: Specialty Store Function: Specialty Store

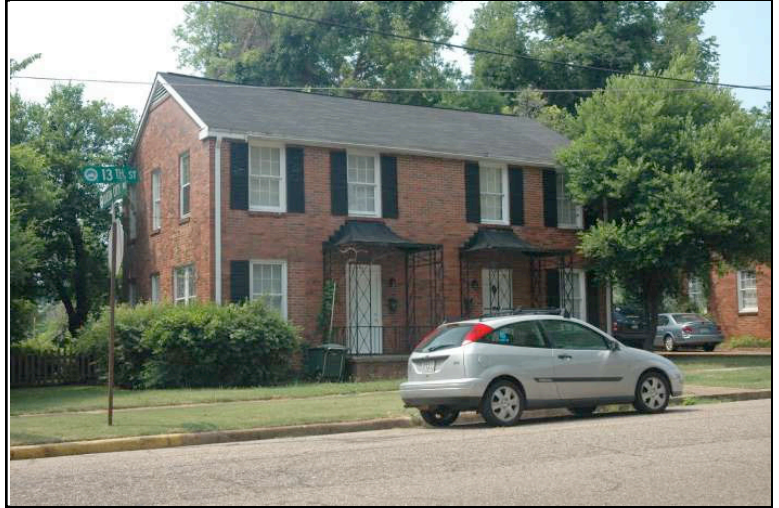
Rectangular 2-story brick veneer duplex with a side gable composition shingle roof; faces north, 4x3 bay core.

Condition: good _____ Integrity: good _____ Ownership: private _____ Category: Building _____
 Historic Use: Multiple Dwelling _____ Current Use: Multiple Dwelling _____
 Function: Duplex _____ Function: Duplex _____

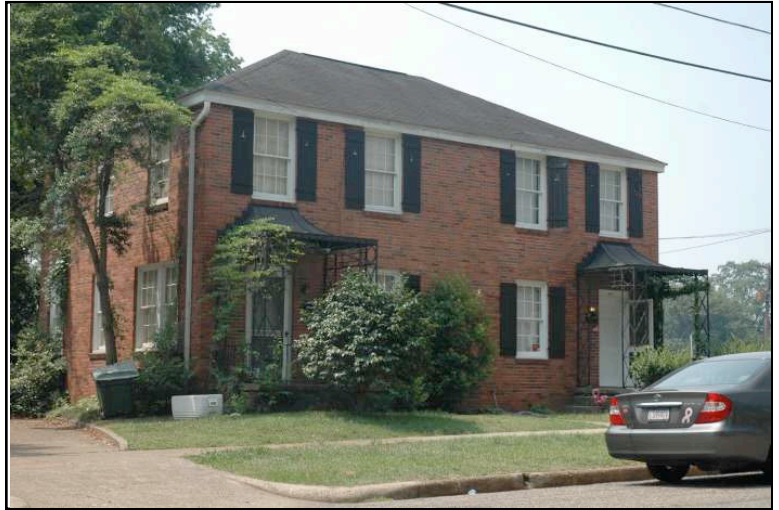
Rectangular 2-story brick veneer duplex with a side gable composition shingle roof; faces north, 4x3 bay core.

Condition: good _____ Integrity: good _____ Ownership: private _____ Category: Building _____
 Historic Use: Multiple Dwelling _____ Current Use: Multiple Dwelling _____
 Function: Duplex _____ Function: Duplex _____

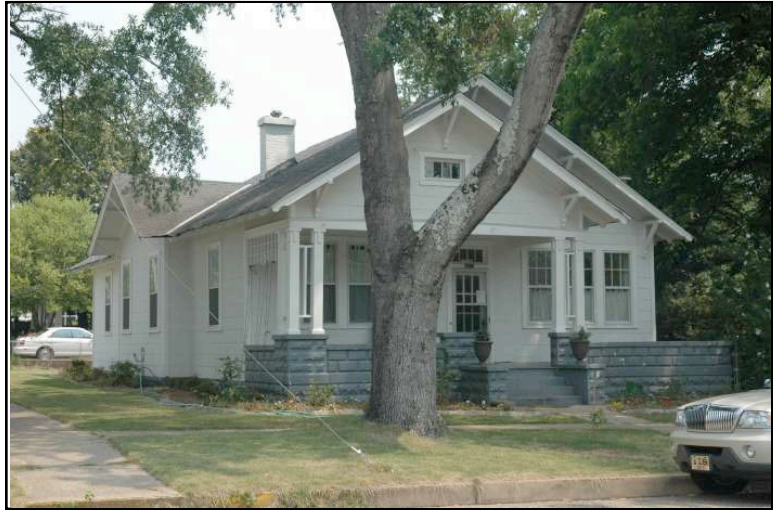
Rectangular 1-story frame dwelling with a front-facing gable composition shingle roof; faces south, 3x5 bay core with side gable projection at west elevation.

Condition: good _____ Integrity: good _____ Ownership: private _____ Category: Building _____
 Historic Use: Single Dwelling - Non Farm _____ Current Use: Single Dwelling - Non Farm _____
 Function: Residence _____ Function: Residence _____

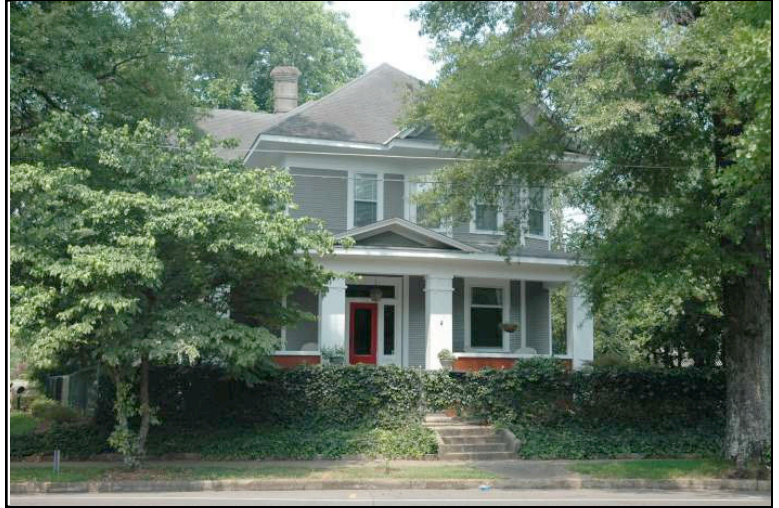
Rectangular 2-story frame dwelling with a hipped gable composition shingle roof; faces east, 2x2 bay core with cutaway bay at north bay of facade, side cutaway wing.

Condition: good _____ Integrity: good _____ Ownership: private _____ Category: Building _____
Historic Use: Single Dwelling - Non Farm _____ Current Use: Single Dwelling - Non Farm _____
Function: Residence _____ Function: Residence _____

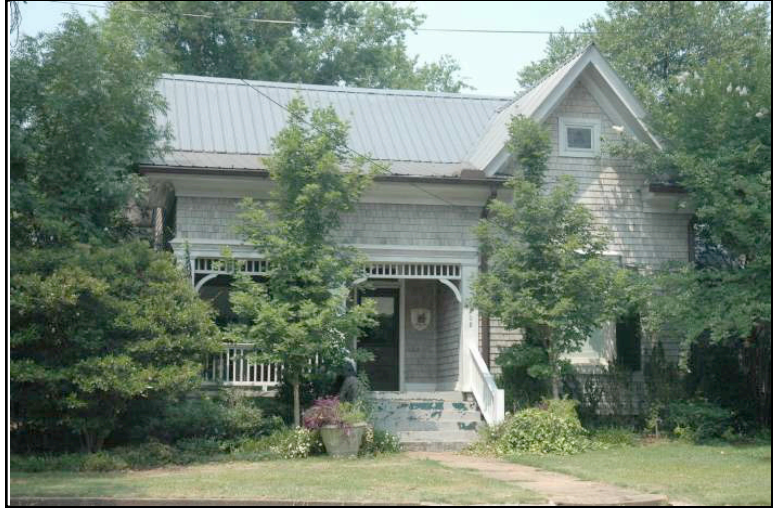
Rectangular 1-story frame dwelling with a cross gable industrial metal roof; faces east, 3x4 bay core with slightly projecting rectangular front-facing bay at north bay of facade.

Condition: good _____ Integrity: good _____ Ownership: private _____ Category: Building _____
 Historic Use: Single Dwelling - Non Farm _____ Current Use: Single Dwelling - Non Farm _____
 Function: Residence _____ Function: Residence _____

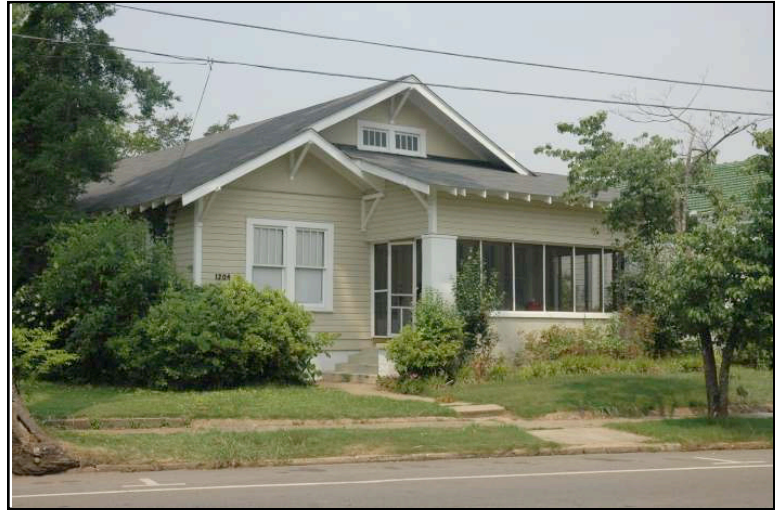
Rectangular 1-story frame dwelling with a front-facing gable composition shingle roof with exposed rafter ends; faces east, 3x4 bay core with slightly projecting front-facing gable bay at south bay of facade.

Condition: good _____ Integrity: good _____ Ownership: private _____ Category: Building _____
Historic Use: Single Dwelling - Non Farm _____ Current Use: Single Dwelling - Non Farm _____
Function: Residence _____ Function: Residence _____

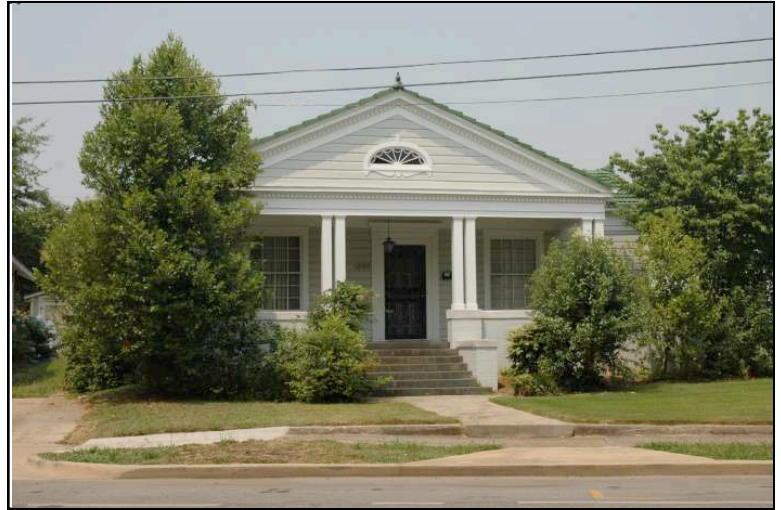
Rectangular 1-story frame dwelling with a front-facing gable clay tile roof; faces east, 3x5 bay core with rear extension.

Condition: good _____ Integrity: good _____ Ownership: private _____ Category: Building _____
 Historic Use: Single Dwelling - Non Farm _____ Current Use: Single Dwelling - Non Farm _____
 Function: Residence _____ Function: Residence _____

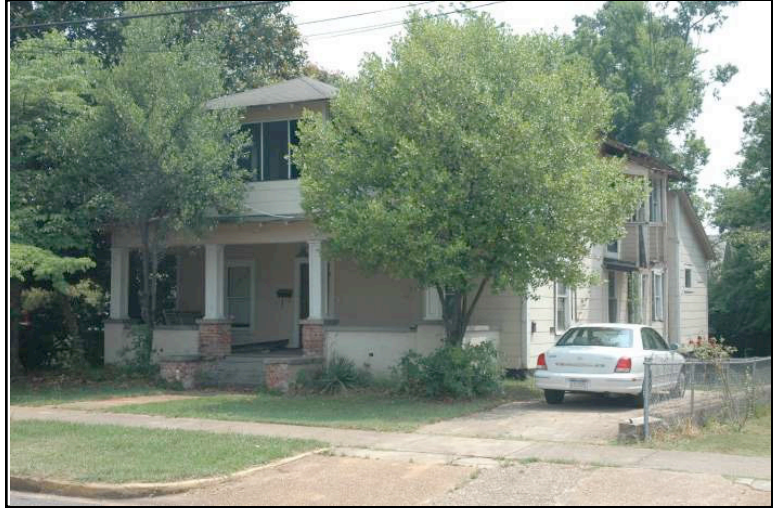
Rectangular 2-story frame dwelling with a hipped gable composition shingle roof with exposed rafter ends; faces west, 3x4 bay core with rear shed addition.

Condition: fair _____ Integrity: good _____ Ownership: private _____ Category: Building _____
 Historic Use: Single Dwelling - Non Farm _____ Current Use: Single Dwelling - Non Farm _____
 Function: Residence _____ Function: Residence _____

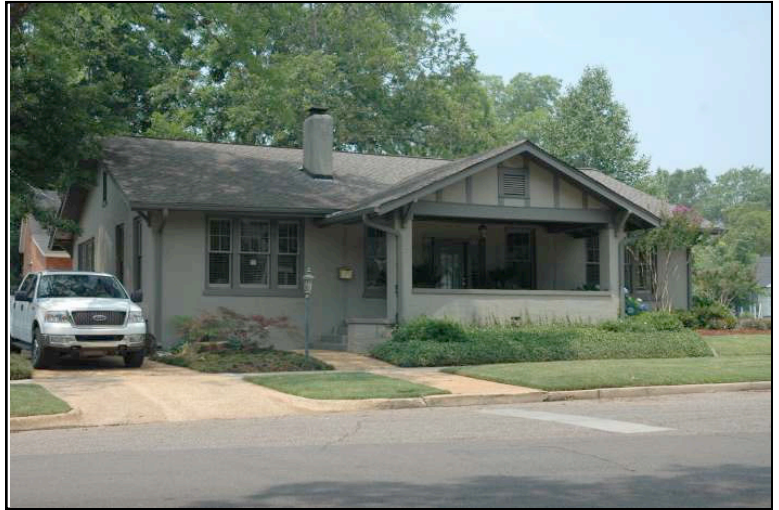
Rectangular 1-story stucco dwelling with a side gable composition shingle roof; faces east, 5x3 bay core.

Condition: good _____ Integrity: good _____ Ownership: private _____ Category: Building _____
 Historic Use: Single Dwelling - Non Farm _____ Current Use: Single Dwelling - Non Farm _____
 Function: Residence _____ Function: Residence _____

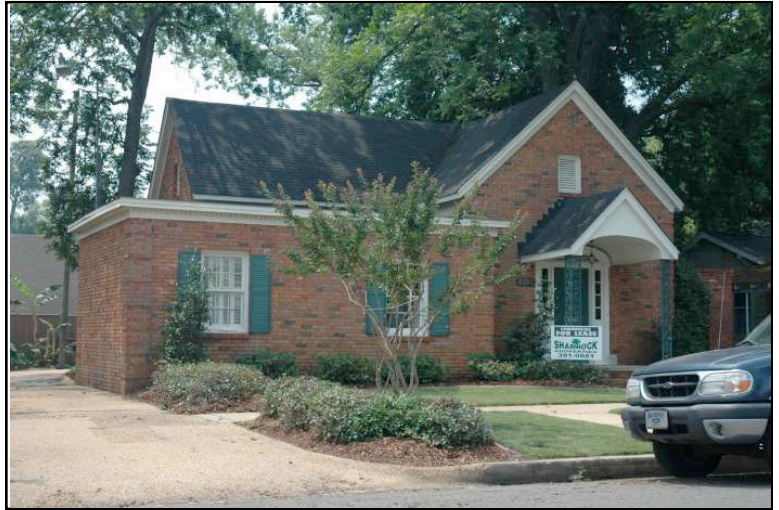
T-shaped 1-story brick veneer dwelling with a cross gable composition shingle roof; faces north, 5x3 bay core with front and rear T wings to west.

Condition: good _____ Integrity: poor _____ Ownership: private _____ Category: Building _____
Historic Use: Single Dwelling - Non Farm _____ Current Use: Single Dwelling - Non Farm _____
Function: Residence _____ Function: Residence _____

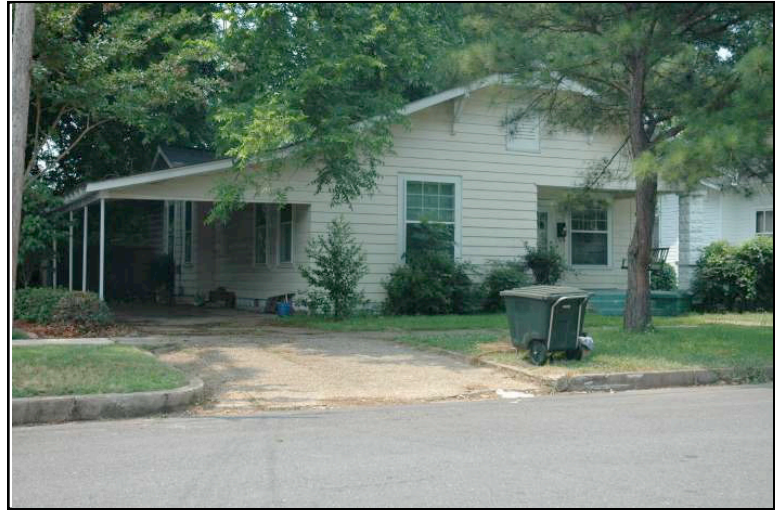
Rectangular 1-story frame dwelling with a front-facing gable composition shingle roof; faces north, 3x3 bay core.

Condition: good _____ Integrity: fair _____ Ownership: private _____ Category: Building _____
 Historic Use: Single Dwelling - Non Farm _____ Current Use: Single Dwelling - Non Farm _____
 Function: Residence _____ Function: Residence _____

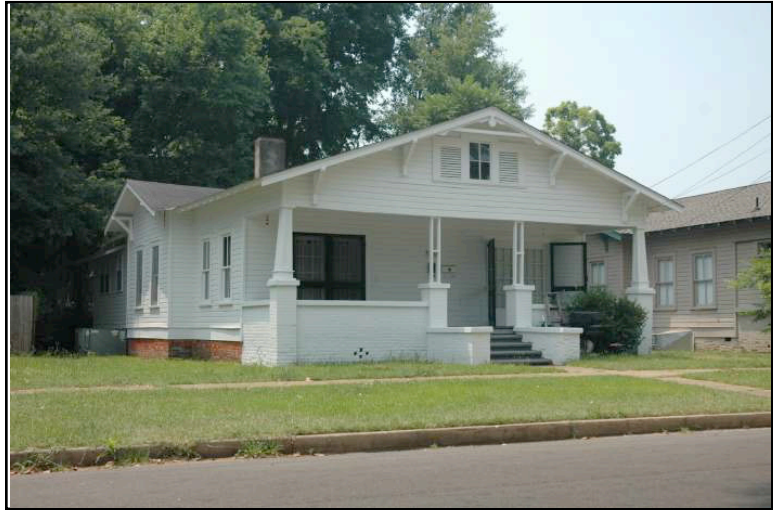
Rectangular 1-story frame dwelling with a front-facing gable composition shingle roof with secondary cross gables; faces north, 3x3 bay core with slightly projecting central bays at side elevations..

Condition: good _____ Integrity: good _____ Ownership: private _____ Category: Building _____
 Historic Use: Single Dwelling - Non Farm _____ Current Use: Single Dwelling - Non Farm _____
 Function: Residence _____ Function: Residence _____

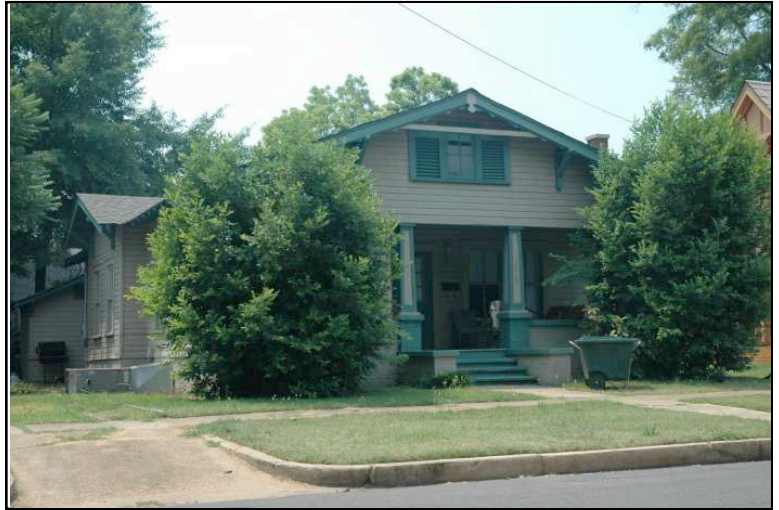
Rectangular 1-story frame dwelling with a front-facing gable composition shingle roof with secondary cross gable; faces north, 3x3 bay core with slightly projecting central bay at east elevation.

Condition: good _____ Integrity: good _____ Ownership: private _____ Category: Building _____
 Historic Use: Single Dwelling - Non Farm _____ Current Use: Single Dwelling - Non Farm _____
 Function: Residence _____ Function: Residence _____

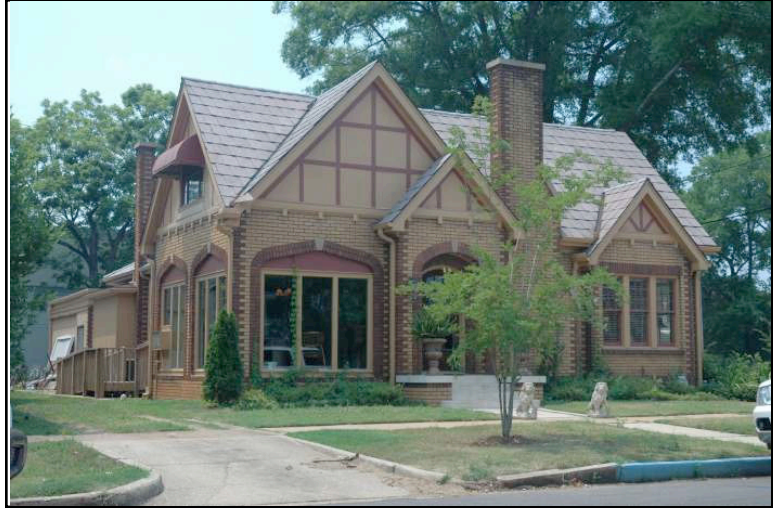
Irregular-shaped 1.5-story stucco and brick dwelling with a cross gable clay tile roof; faces north, 3x5 bay core.

Condition: good _____ Integrity: fair _____ Ownership: private _____ Category: Building _____
 Historic Use: Single Dwelling - Non Farm _____ Current Use: Single Dwelling - Non Farm _____
 Function: Residence _____ Function: Residence _____

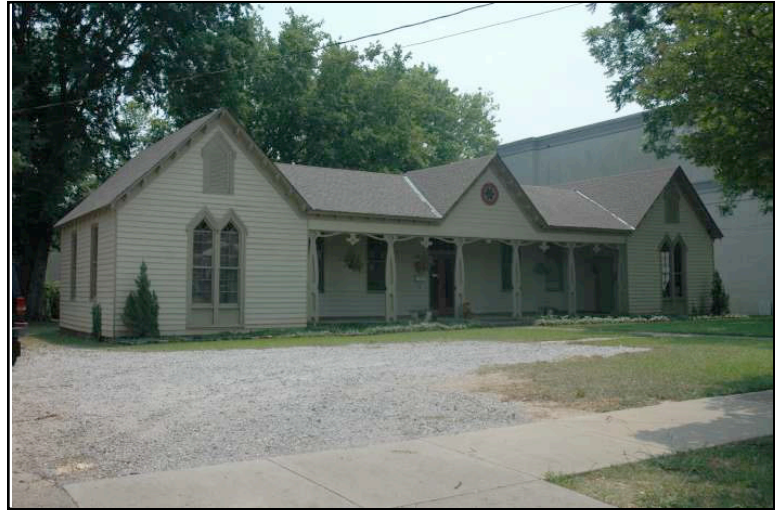
Irregular-shaped 1-story frame dwelling with a cross gable composition shingle roof; faces west, 7x1 bay core with slightly projecting front-facing gable bays at outer bays of facade, rear extensions.

Condition: good _____ Integrity: good _____ Ownership: private _____ Category: Building _____
 Historic Use: Single Dwelling - Non Farm _____ Current Use: Single Dwelling - Non Farm _____
 Function: Residence _____ Function: Residence _____

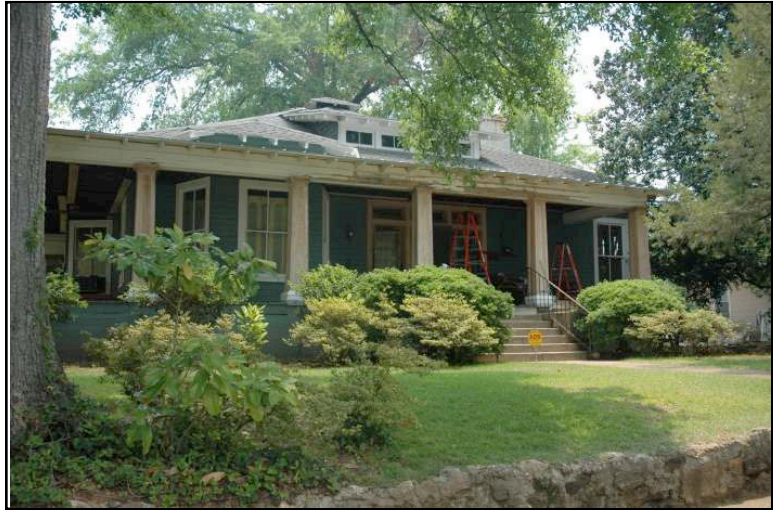
Rectangular 1-story frame dwelling with a hipped composition shingle roof with decorative shed dormers, exposed rafter ends; faces west, 3x4 bay core.

Condition: good _____ Integrity: good _____ Ownership: private _____ Category: Building _____
 Historic Use: Single Dwelling - Non Farm _____ Current Use: Single Dwelling - Non Farm _____
 Function: Residence _____ Function: Residence _____

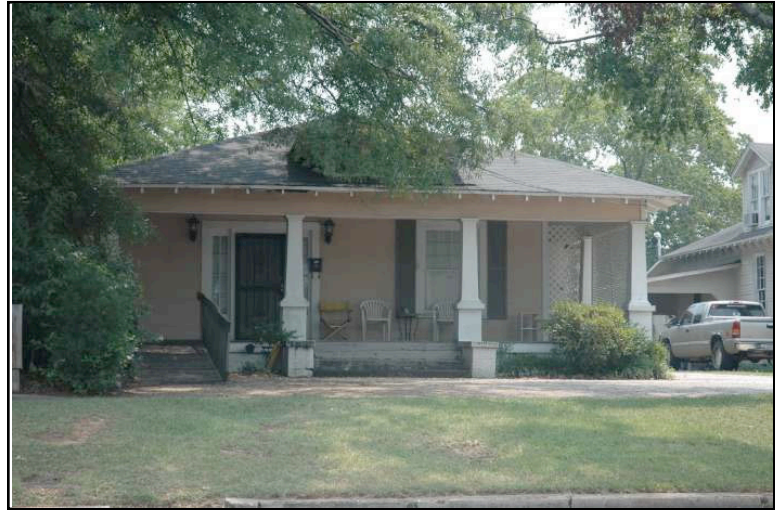
One-story frame dwelling with a hipped roof with exposed rafter ends; faces west, 3x3 bay rectangular core with recessed southern bay; full façade recessed porch with tapered wood supports on masonry pedestals wraps to south elevation; entrance at west bay of façade with sidelights flanked by Bungalow geometric double hung windows, similar windows at side elevations; replacement asbestos shingle siding (ca. 1960).

Condition: good _____ Integrity: fair _____ Ownership: private _____ Category: Building _____
 Historic Use: Single Dwelling - Non Farm _____ Current Use: Single Dwelling - Non Farm _____
 Function: Residence _____ Function: Residence _____

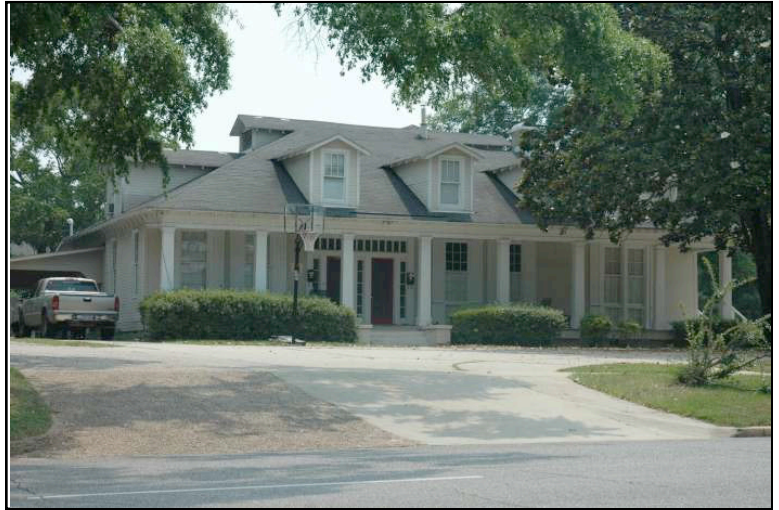
1.5-story frame dwelling with a hipped roof with gable dormers and exposed rafter ends; faces west, 6x3 bay L-shaped core with rear 2-story L to north with side wing to the east; full façade recessed porch with wood pillars; off-center entrance at façade with two doors, transom, & sidelights flanked to either side by single 9/9 double hung windows with a double 4/4/4 triple hung window in the south bay, similar windows at side elevations; weatherboard siding.

Condition: good _____ Integrity: good _____ Ownership: private _____ Category: Building _____
 Historic Use: Single Dwelling - Non Farm _____ Current Use: Single Dwelling - Non Farm _____
 Function: Residence _____ Function: Residence _____

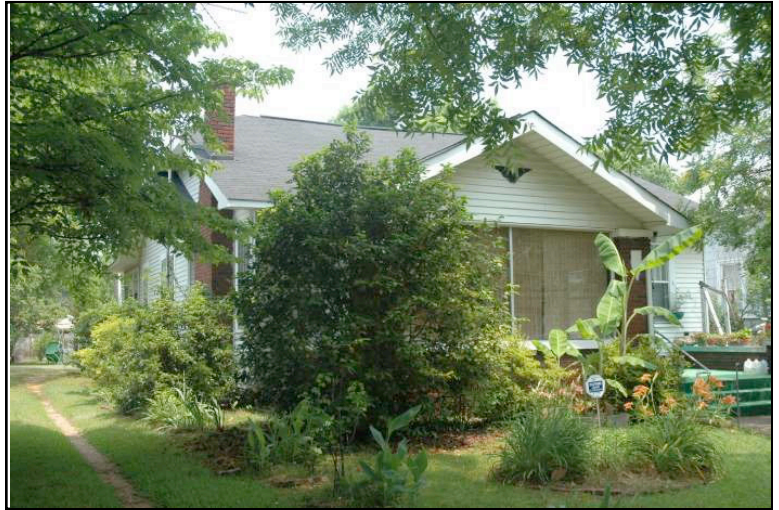
1-story frame dwelling with a side jerking head gable composition shingle roof; faces south, 3x4 bay rectangular core; full façade gable porch with modern porch enclosure and historic brick pillars and apron wall wood pillars; off-center entrance at east bay façade flanked by single Craftsman geometric windows, similar windows at side elevations; replacement aluminum siding (ca. 1975).

Condition: good _____ Integrity: fair _____ Ownership: private _____ Category: Building _____
 Historic Use: Single Dwelling - Non Farm _____ Current Use: Single Dwelling - Non Farm _____
 Function: Residence _____ Function: Residence _____

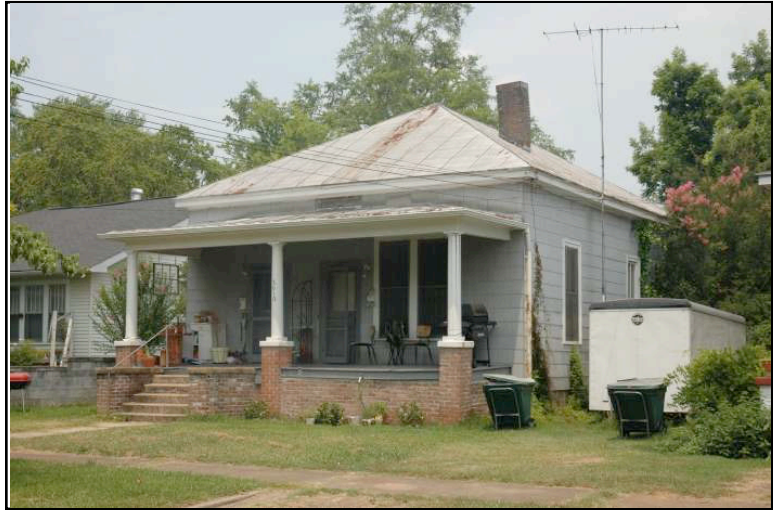
1-story frame pyramidal form dwelling with a hipped raised seam metal roof; faces south, 3x4 bay rectangular core; full façade hipped porch with replacement aluminum columns on brick pedestals; entrances at two western bays of the façade flanked by a double 2/2 double hung window, similar windows at side elevations; replacement asbestos shingle siding (ca. 1960).

Condition: good _____ Integrity: good _____ Ownership: private _____ Category: Building _____
Historic Use: Single Dwelling - Non Farm _____ Current Use: Single Dwelling - Non Farm _____
Function: Residence _____ Function: Residence _____

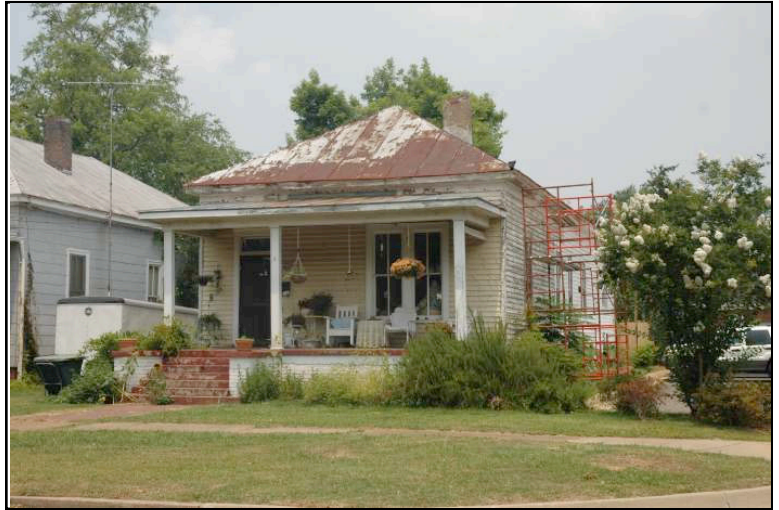
1-story frame pyramidal form dwelling with a hipped raised seam metal roof; faces south, 2x4 bay rectangular core with a rear shed addition; full façade hipped porch with wood posts; entrance at west bay of façade flanked by a double 2/2 double hung window, similar windows at side elevations; plain weatherboard siding.

Condition: good _____ Integrity: good _____ Ownership: private _____ Category: Building _____
Historic Use: Single Dwelling - Non Farm _____ Current Use: Single Dwelling - Non Farm _____
Function: Residence _____ Function: Residence _____

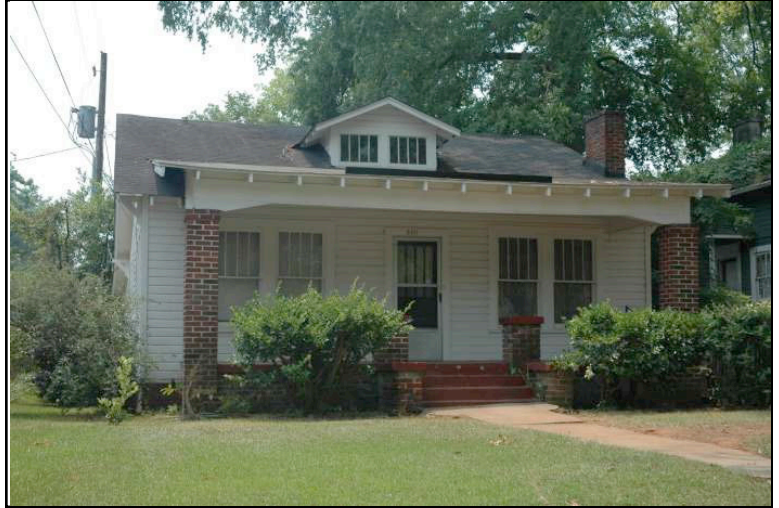
1-story frame Craftsman style dwelling with a side gable composition shingle roof with exposed rafter ends, central decorative gable dormer; faces north, 3x4 bay rectangular core with a rear shed extension; less than full façade shed porch with brick pillars; central entrance at façade flanked by double Craftsman geometric double hung windows, similar single and double windows at side elevations; wood novelty siding; contributing frame garage.

Condition: good _____ Integrity: good _____ Ownership: private _____ Category: Building _____
 Historic Use: Single Dwelling - Non Farm _____ Current Use: Single Dwelling - Non Farm _____
 Function: Residence _____ Function: Residence _____

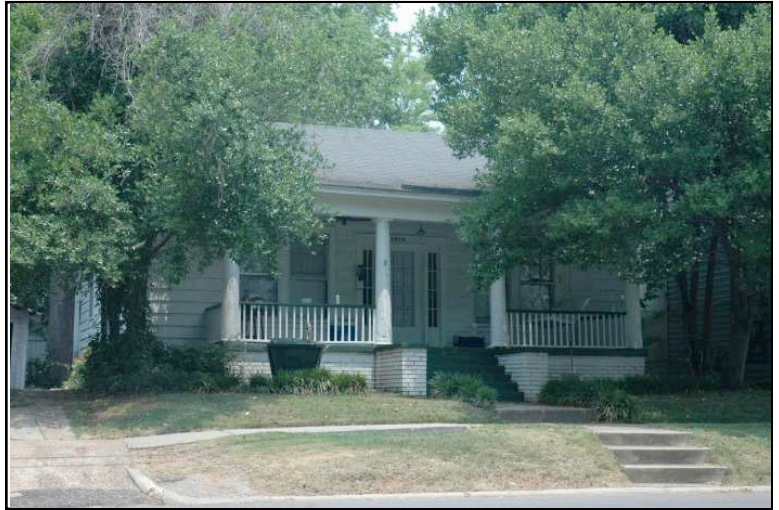
1-story frame dwelling with a cross gable composition shingle roof; faces south, 3x4 bay rectangular core; less than full façade shed porch with wood columns and railing; central entrance at façade with sidelights flanked by double 6/1 double hung windows, similar single and double windows at side elevations; plain weatherboard siding.

Condition: good _____ Integrity: good _____ Ownership: private _____ Category: Building _____
 Historic Use: Single Dwelling - Non Farm _____ Current Use: Single Dwelling - Non Farm _____
 Function: Residence _____ Function: Residence _____

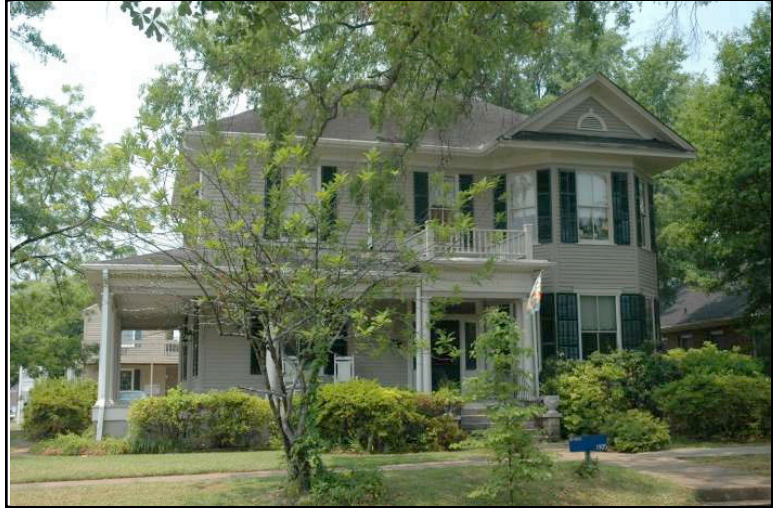
2-story frame Queen Anne style dwelling with a hipped composition shingle roof with cross gables; faces east, 3x4 bay rectangular core with polygonal bays at north bay of façade and at north elevation, projecting rectangular 2-story wing at north bay of west elevation with 1-story extension; less than full façade hipped porch with wood columns wraps to south elevation, 2-story hipped porch with insect screening at west elevation; central entrance at façade with leaded glass transom & sidelights flanked by single 2/2 double hung windows, similar windows at upper level and side elevations; plain weatherboard siding.

Condition: good _____ Integrity: good _____ Ownership: private _____ Category: Building _____
 Historic Use: Single Dwelling - Non Farm _____ Current Use: Single Dwelling - Non Farm _____
 Function: Residence _____ Function: Residence _____
