Tuscaloosa

Greater Downtown Study
Historic Resource Survey - 2006

Survey Number: _____ 1 _____
Historic name(s): House, Not Named
Common name: Southeast Appraisers
Location: University Blvd., 2720

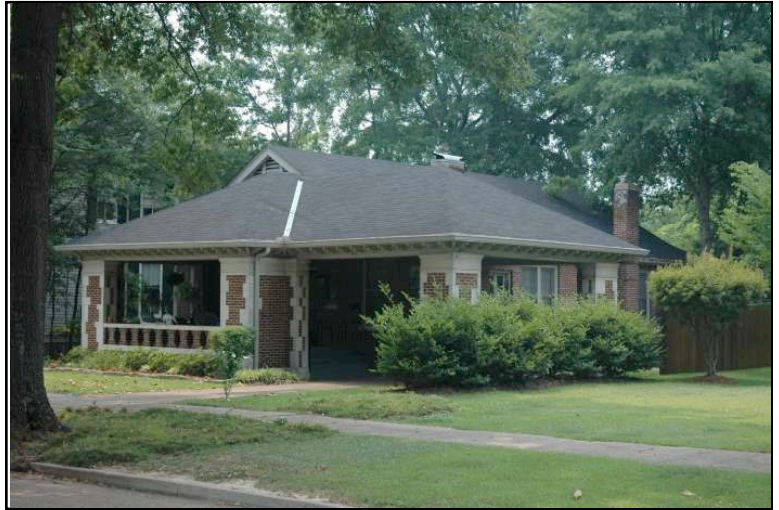
1-story brick veneer dwelling with a gable on hipped composition shingle roof with decorative exposed rafter ends; faces east, 3x3 bay rectangular core; less than full façade hipped porch with wide brick piers and open brick railing flanked to the north by a hipped porte cochere; off-center entrance at façade flanked by single and double Craftsman geometric double hung windows, similar windows at side elevations; exposed brick exterior walls with cast stone quoins and cornice.

Condition: good _____ Integrity: good _____ Ownership: private _____ Category: Building _____
Historic Use: Single Dwelling - Non Farm _____ Current Use: Single Dwelling - Non Farm _____
Function: Residence _____ Function: Residence _____

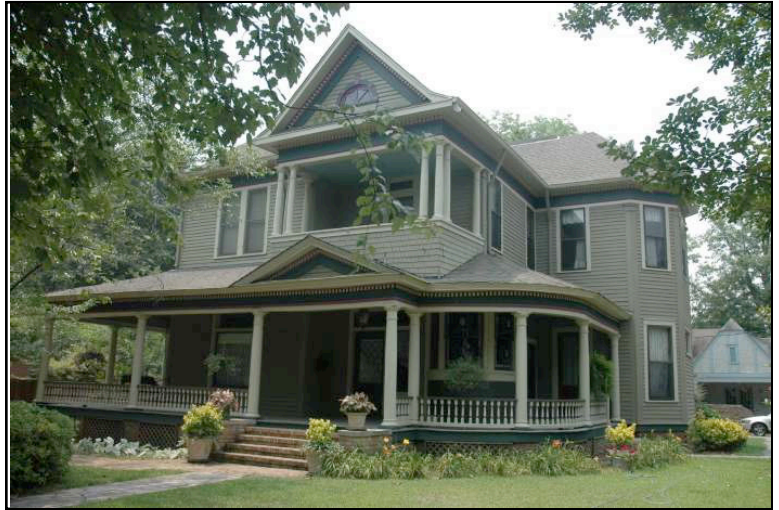
2-story frame Queen Anne style dwelling with a hipped composition shingle roof with cross gables; faces east, 2x3 bay rectangular core with projecting southern bay of at its façade, a polygonal bay at the rear bay of its north elevation, projecting rectangular 2-story wing at rear bay of its south elevation; less than full façade hipped porch with wood columns and turned railing wraps to side elevations; entrance at north bay of façade with stained glass transom flanked to the east by a fixed window with stained glass transom and to the east by a radius double hung window with stained glass, single and double 1/1 double hung windows at upper level and side elevations; plain weatherboard siding.

Condition: good _____ Integrity: good _____ Ownership: private _____ Category: Building _____
Historic Use: Single Dwelling - Non Farm _____ Current Use: Single Dwelling - Non Farm _____
Function: Residence _____ Function: Residence _____

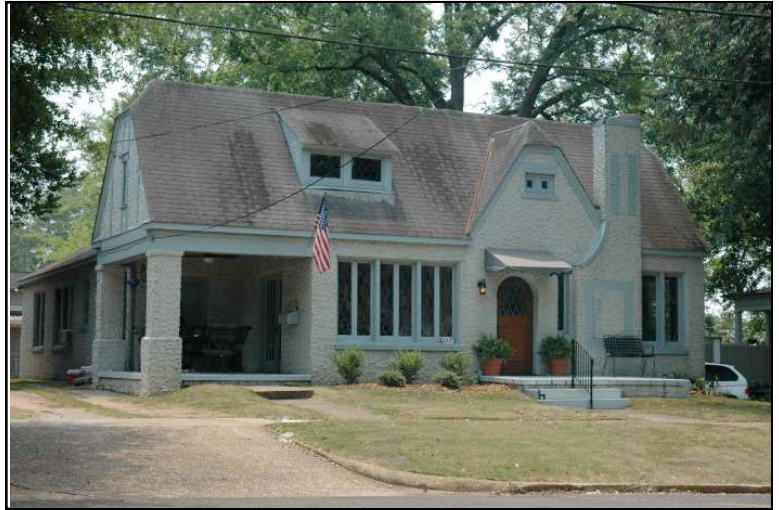
1-story stucco dwelling with a cross jerkin head gable composition shingle roof with a cross gable and a decorative shed dormer, exterior front chimney; faces north, 3x5 bay rectangular; less than full façade recessed porch stucco piers on pedestals; off-center entrance at façade flanked to the east by a triple leaded casement window and to the west by single and double leaded casement windows, similar windows side elevations; rough texture stucco at exterior walls.

Condition: good _____ Integrity: good _____ Ownership: private _____ Category: Building _____
 Historic Use: Single Dwelling - Non Farm _____ Current Use: Single Dwelling - Non Farm _____
 Function: Residence _____ Function: Residence _____

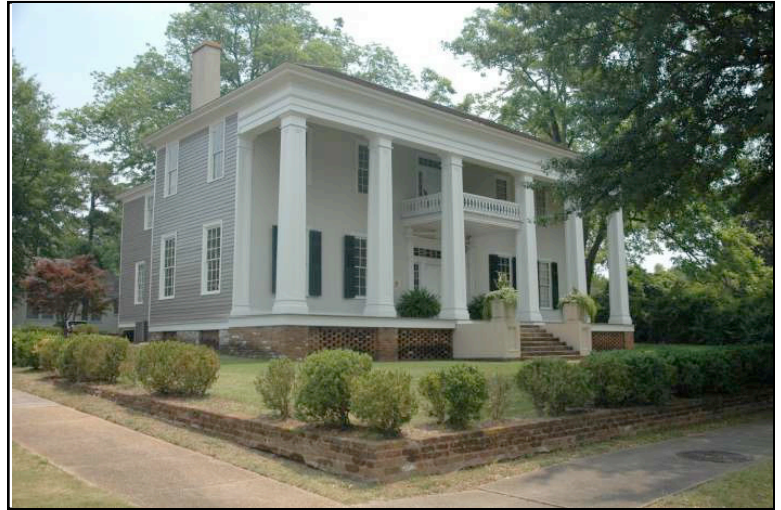
2-story frame Greek Revival style dwelling with a hipped composition shingle roof; faces west, 5x2 bay rectangular core with a rear extension; full façade monumental full-height porch with intermediate deck at entrance bay only and paneled wood columns; central entrance at façade with elaborate surround, transom, & sidelights flanked by single wood 9/9 double hung sash windows, similar entrance and windows at upper level, similar windows at side elevations; plain weatherboard siding.

Condition: good _____ Integrity: good _____ Ownership: private _____ Category: Building _____
Historic Use: Single Dwelling - Non Farm _____ Current Use: Single Dwelling - Non Farm _____
Function: Residence _____ Function: Residence _____

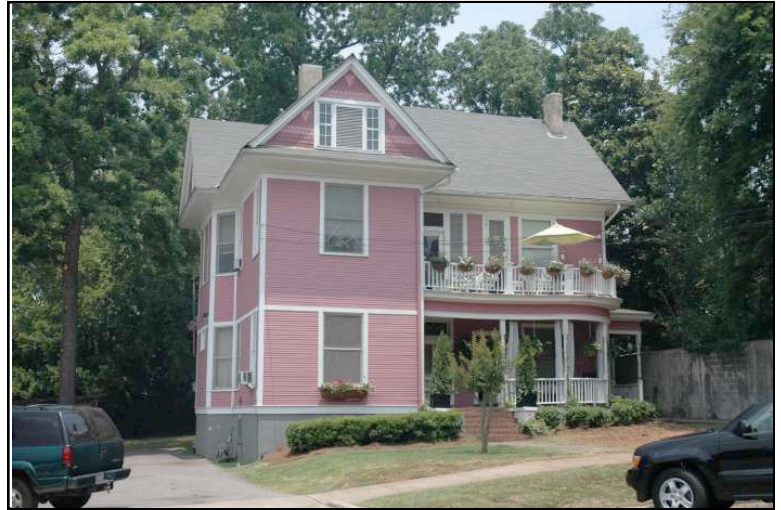
2-story frame Queen Anne style dwelling with a cross gable composition shingle roof; faces south, 4x2 bay rectangular core with a front-facing rectangular bay at the west side of its façade and a side polygonal bay at the west elevation; less than full façade porch with turned posts and upper deck and rounded east end, 1-story hipped porch at east elevation; central entrance at façade with transom flanked by single 1/1 double hung windows, similar windows at upper level and side elevations; plain weatherboard siding. With decorative shingles at gable end.

Condition: good _____ Integrity: good _____ Ownership: private _____ Category: Building _____
 Historic Use: Single Dwelling - Non Farm _____ Current Use: Single Dwelling - Non Farm _____
 Function: Residence _____ Function: Residence _____

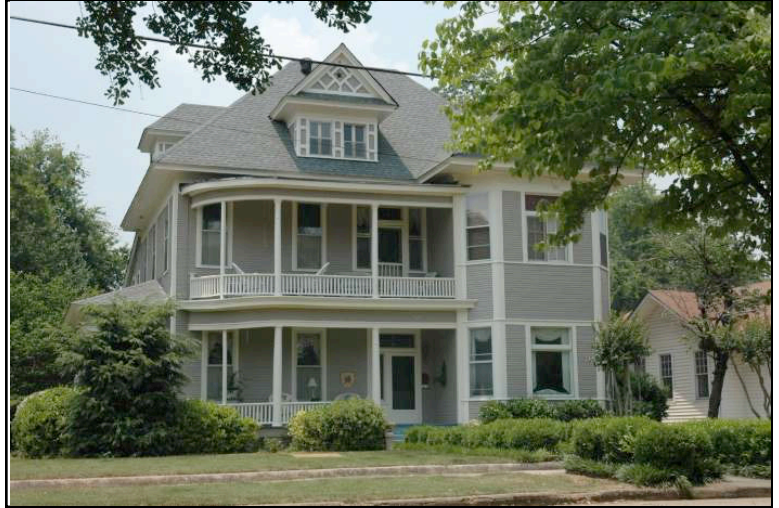
2-story frame Queen Anne style dwelling with a hipped composition shingle roof with pedimented cross gables and decorative pedimented gable dormers; faces east, 4x3 bay rectangular core with a projecting polygonal bay at the north bay of its façade, a rectangular projection to the north, and a rear shed extension; less than full façade 2-tier porch with turned wood columns and railings with rounded south end; central entrance at façade with stained glass transom flanked by single 1/1 double hung windows, similar windows at upper level and side elevations; plain weatherboard siding.

Condition: good _____ Integrity: good _____ Ownership: private _____ Category: Building _____
Historic Use: Single Dwelling - Non Farm _____ Current Use: Single Dwelling - Non Farm _____
Function: Residence _____ Function: Residence _____

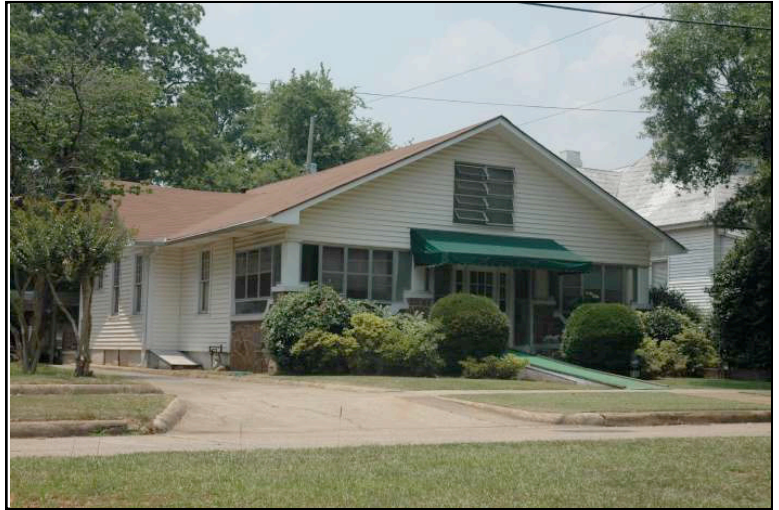
1-story frame gable front form dwelling with a cross gable composition shingle roof; faces east, 3x4 bay rectangular core with projecting bays at its side elevations; full façade recessed porch with wood supports on brick pedestals now enclosed (ca. 1960); fenestration at façade obscured by porch enclosure, single Craftsman 9/1 double hung windows at side elevations; replacement vinyl siding (ca. 1990).

Condition: good _____ Integrity: fair _____ Ownership: private _____ Category: Building _____
Historic Use: Single Dwelling - Non Farm _____ Current Use: Single Dwelling - Non Farm _____
Function: Residence _____ Function: Residence _____

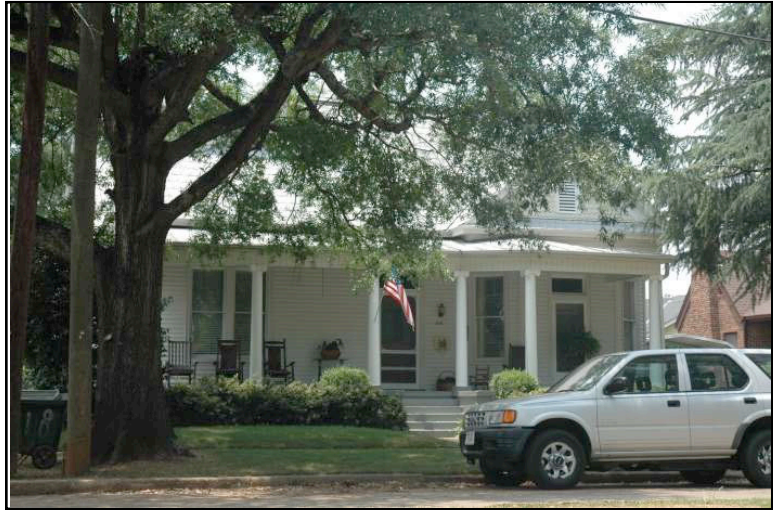
1-story frame pyramidal form Folk Victorian dwelling with a hipped pressed metal roof with a cross gable; faces east, 3x2 bay rectangular core with projecting polygonal bay at the north bay of its façade; full façade hipped porch with wood columns; central entrance at façade with transom flanked to the south by a double 1/1 double hung window and to the north by the polygonal bay with an entrance at its center face; replacement vinyl siding (ca. 1990).

Condition: good _____ Integrity: fair _____ Ownership: private _____ Category: Building _____
 Historic Use: Single Dwelling - Non Farm _____ Current Use: Single Dwelling - Non Farm _____
 Function: Residence _____ Function: Residence _____

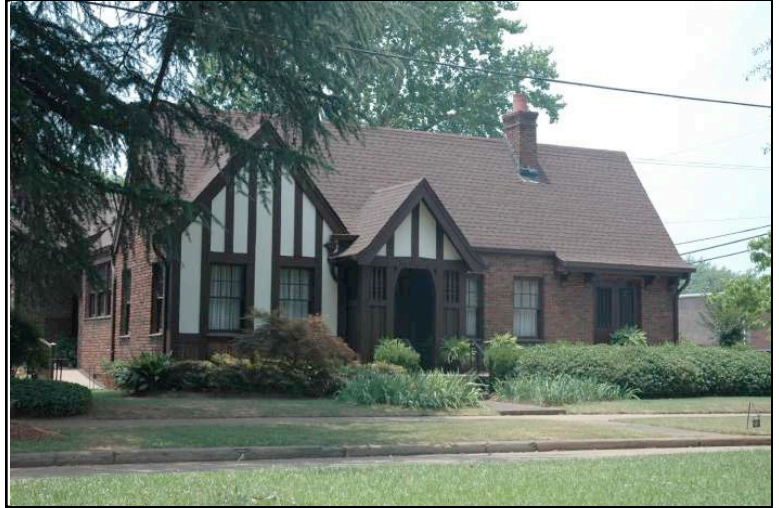
1-story brick veneer Tudor Revival style dwelling with a cross gable composition shingle roof with a cross gables; faces east, 5x3 bay rectangular core with a projecting bays at the front bay of the north elevation and rear bay of the south elevation; entrance bay gable portico; off-center entrance at façade flanked by paired 6/1 double hung window, similar single and triple windows at side elevations; brick exterior walls with half timbering at southern bay of facade and at entrance portico gable.

Condition: good _____ Integrity: good _____ Ownership: private _____ Category: Building _____
Historic Use: Single Dwelling - Non Farm _____ Current Use: Single Dwelling - Non Farm _____
Function: Residence _____ Function: Residence _____

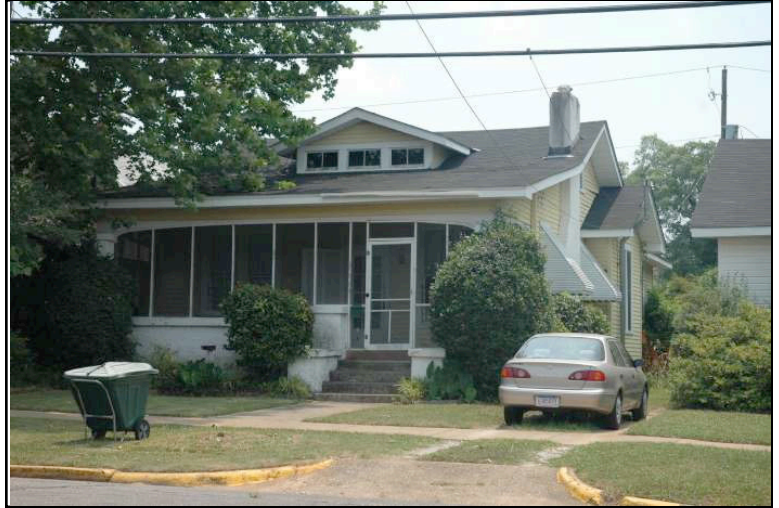
1-story frame Craftsman style dwelling with a side gable composition shingle roof with central decorative gable dormer; faces north, 3x3 bay rectangular core with a rear extension; full façade shed porch with stucco pillars; and apron wall, wide arch, insect screening; central entrance at façade flanked by double 2/2 double hung windows, similar single and double windows at side elevations; replacement vinyl siding (ca. 1980).

Condition: good _____ Integrity: good _____ Ownership: private _____ Category: Building _____
Historic Use: Single Dwelling - Non Farm _____ Current Use: Single Dwelling - Non Farm _____
Function: Residence _____ Function: Residence _____

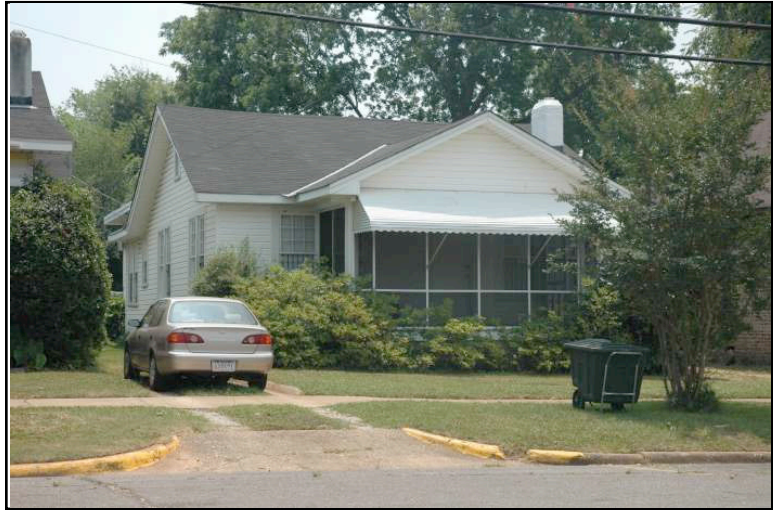
1-story frame dwelling with a cross gable composition shingle roof; faces north, 3x2 bay rectangular core with a rear extension; less than full façade gable porch with wood posts and insect screening, modern aluminum awning; off-center entrance at façade flanked by double 9/ double hung windows, similar single and double windows at side elevations; replacement vinyl siding (ca. 1980).

Condition: good _____ Integrity: fair _____ Ownership: private _____ Category: Building _____
 Historic Use: Single Dwelling - Non Farm _____ Current Use: Single Dwelling - Non Farm _____
 Function: Residence _____ Function: Residence _____

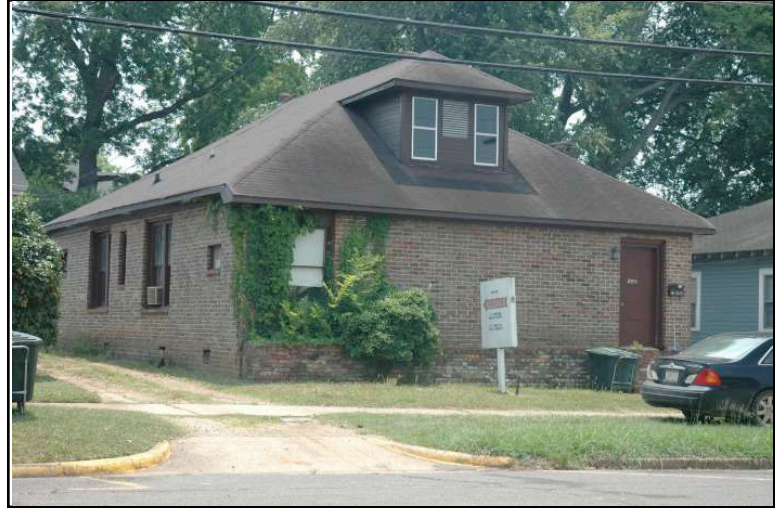
1-story brick veneer dwelling with a hipped composition shingle roof with a central hipped decorative dormer; faces north, 2x3 bay rectangular core; no porch; modern entrance at west bay of façade flanked by a replacement window, single and double windows at side elevations; replacement brick veneer (ca. 1975).

Condition: good _____ Integrity: fair _____ Ownership: private _____ Category: Building _____
Historic Use: Single Dwelling - Non Farm _____ Current Use: Single Dwelling - Non Farm _____
Function: Residence _____ Function: Residence _____

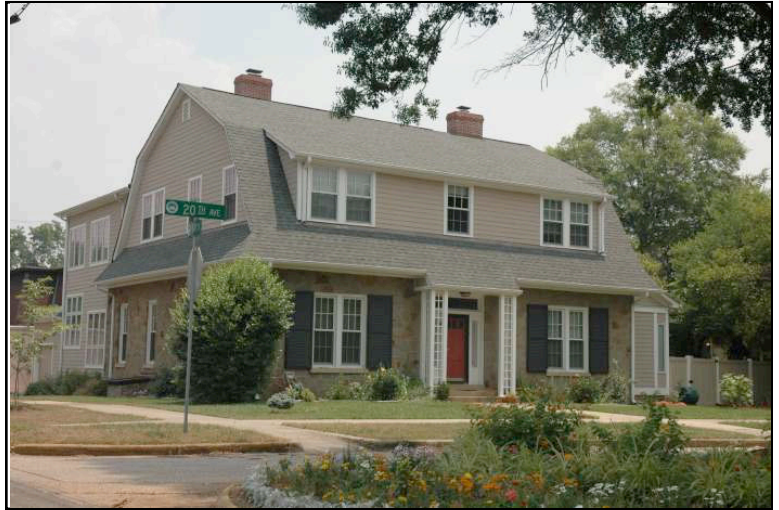
1.5-story frame dwelling with a gambrel composition shingle roof with an extended shed dormer; faces west, 3x3 bay rectangular core with a rear 2-story addition; entrance bay stoop; central entrance at façade with transom & sidelights flanked to either side by double 6/6 double hung sash windows, similar single and double windows at side elevations and upper level; stone veneer at lower level.

Condition: good _____ Integrity: good _____ Ownership: private _____ Category: Building _____
 Historic Use: Single Dwelling - Non Farm _____ Current Use: Single Dwelling - Non Farm _____
 Function: Residence _____ Function: Residence _____

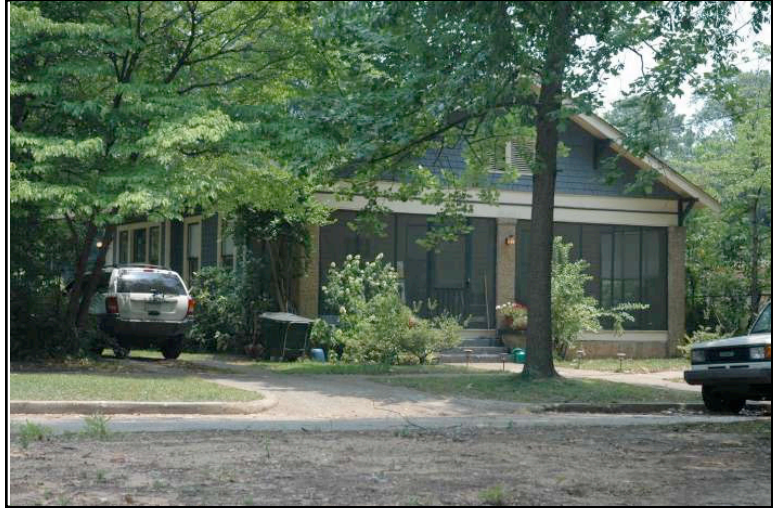
1-story frame gable front form dwelling with a front-facing gable composition shingle roof; faces west, 3x4 bay rectangular core; full façade recessed porch with stucco pillars and insect screening; off-center entrance at facade flanked by 1/1 double hung sash windows, similar single and triple windows at side elevations; wood weatherboard siding with shingles at gable end.

Condition: good _____ Integrity: good _____ Ownership: private _____ Category: Building _____
Historic Use: Single Dwelling - Non Farm _____ Current Use: Single Dwelling - Non Farm _____
Function: Residence _____ Function: Residence _____

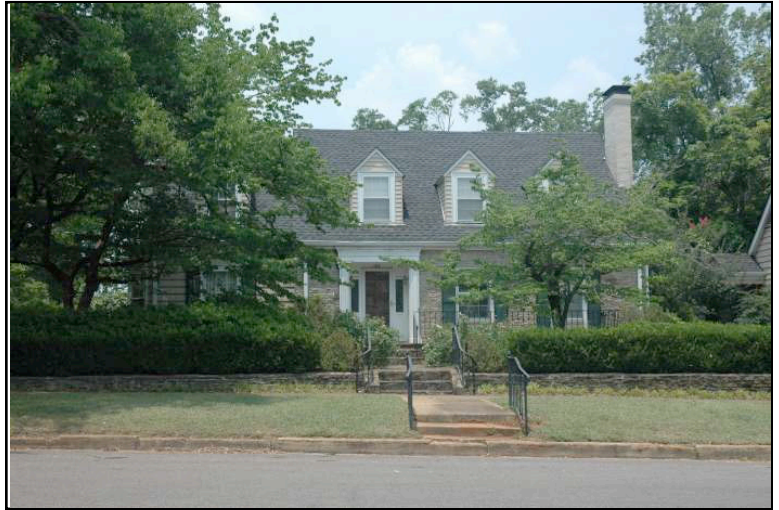
1.5-story stone dwelling with a side gable composition shingle roof with 3 gable dormers; faces south, 3x2 bay rectangular core with 1 bay wide frame extension to west; recessed entrance portico; entrance at west bay of core facade flanked by 6/6 double hung sash windows, similar windows at side elevations and dormers; ancillary dwelling at rear.

Condition: good _____ Integrity: good _____ Ownership: private _____ Category: Building _____
 Historic Use: Single Dwelling - Non Farm _____ Current Use: Single Dwelling - Non Farm _____
 Function: Residence _____ Function: Residence _____

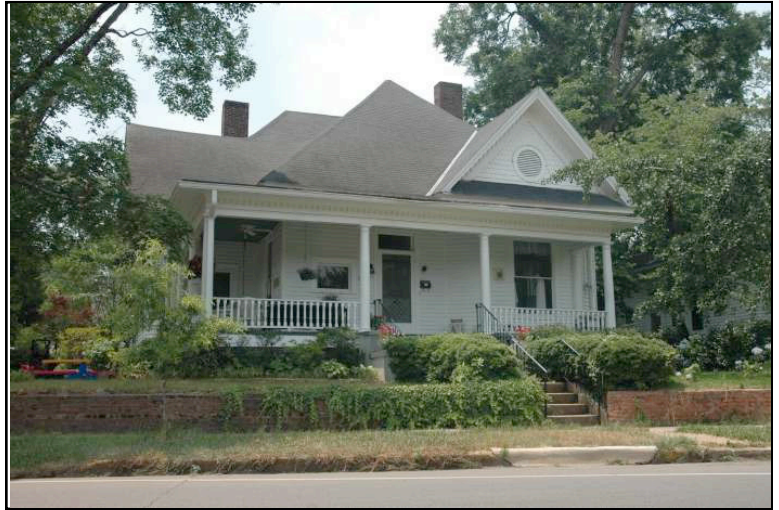
1-story frame pyramidal form Folk Victorian dwelling with a hipped composition shingle roof with cross gables; faces east, 3x3 bay rectangular core with a polygonal bay at the north bay of its façade and a projecting rectangular side bay to the south; full façade porch with wood columns and turned balustrade; off-center entrance at facade flanked by to the south by a fixed window and to north by a 1/1 double hung sash window, similar windows at side elevations; plain weatherboard siding.

Condition: good _____ Integrity: good _____ Ownership: private _____ Category: Building _____
Historic Use: Single Dwelling - Non Farm _____ Current Use: Single Dwelling - Non Farm _____
Function: Residence _____ Function: Residence _____

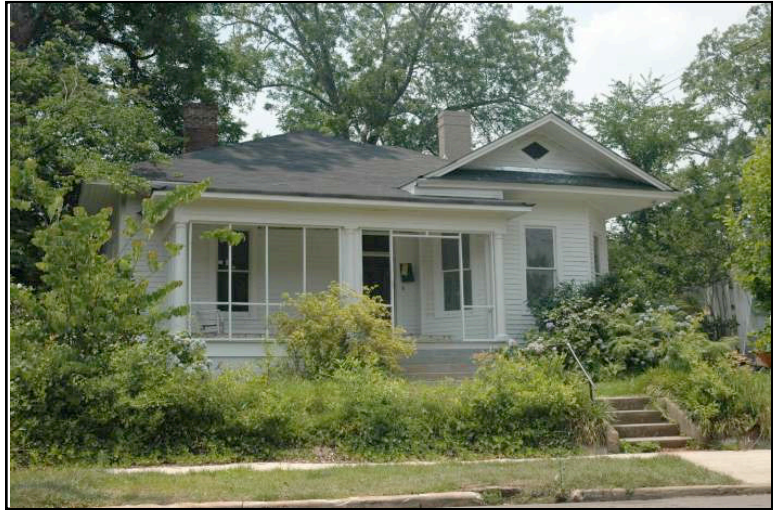
1-story frame pyramidal form Folk Victorian dwelling with a hipped composition shingle roof with cross gables; faces east, 3x3 bay rectangular core with a polygonal bay at the north bay of its façade; less than full façade porch with wood columns and insect screen framing; central entrance at facade flanked by 1/1 double hung sash windows, similar windows at side elevations; plain weatherboard siding.

Condition: good _____ Integrity: good _____ Ownership: private _____ Category: Building _____
 Historic Use: Single Dwelling - Non Farm _____ Current Use: Single Dwelling - Non Farm _____
 Function: Residence _____ Function: Residence _____

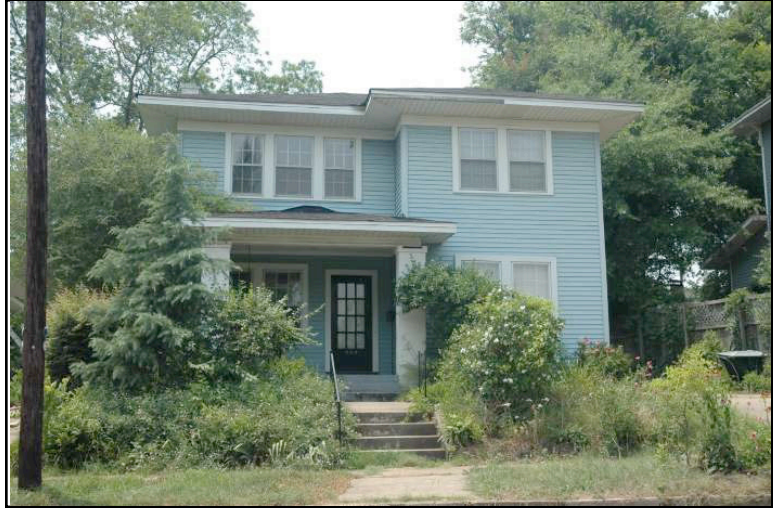
2-story frame pyramidal form dwelling with a hipped composition shingle roof; faces east, 3x3 bay rectangular core with a projecting rectangular bay at the north bay of its façade; less than full façade porch with brick pillars; central entrance at facade flanked by double 6/6 double hung sash windows, similar single, double, and triple windows at side elevations and upper level; replacement vinyl siding (ca. 1985).

Condition: good _____ Integrity: fair _____ Ownership: private _____ Category: Building _____
 Historic Use: Single Dwelling - Non Farm _____ Current Use: Single Dwelling - Non Farm _____
 Function: Residence _____ Function: Residence _____

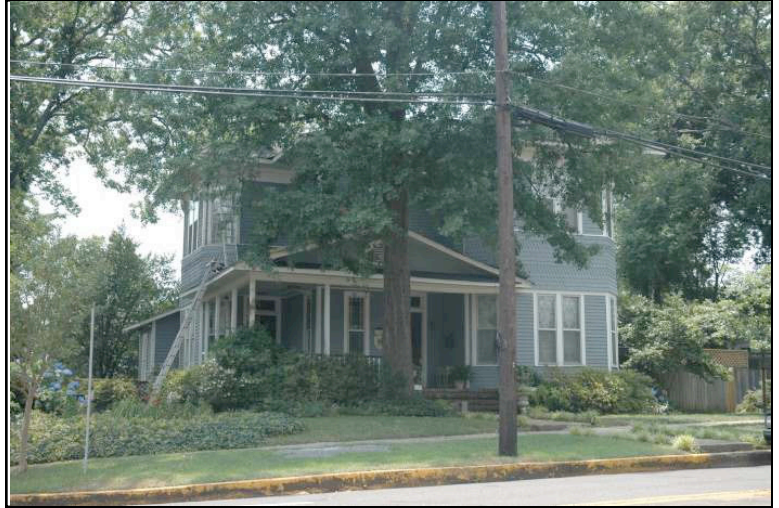
2-story frame Queen Anne style dwelling with a hipped composition shingle roof; faces east, 3x3 bay rectangular core with a projecting polygonal bays at the north bay of its façade and at the south elevation; less than full façade gable porch with wood posts (ca. 1975); off-center entrance at facade with transom flanked by a single 1/1 window with Queen Anne block glass and single and double 1/1 windows at the polygonal bay 6/6 double hung sash windows, similar windows at side elevations and upper level; wood weatherboard and decorative shingle siding.

Condition: good _____ Integrity: good _____ Ownership: private _____ Category: Building _____
 Historic Use: Single Dwelling - Non Farm _____ Current Use: Single Dwelling - Non Farm _____
 Function: Residence _____ Function: Residence _____

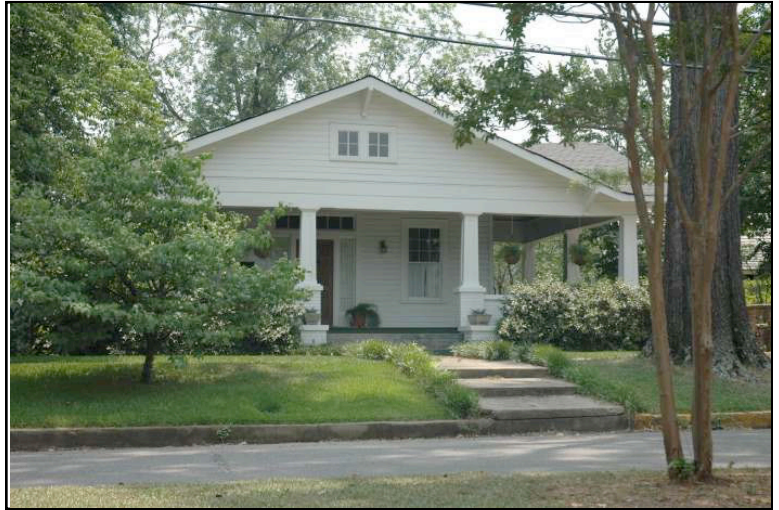
1-story frame gable front form dwelling with a Craftsman style details and a front-facing gable composition shingle roof with angle bracketed eaves; faces north, 3x4 bay rectangular core; full façade gable porch with tapered wood supports on brick pedestals with apron wall wraps to west elevation; central entrance at facade with transom and sidelight flanked by a single 9/1 windows, similar windows at side elevations; wood weatherboard siding.

Condition: good _____ Integrity: good _____ Ownership: private _____ Category: Building _____
Historic Use: Single Dwelling - Non Farm _____ Current Use: Single Dwelling - Non Farm _____
Function: Residence _____ Function: Residence _____

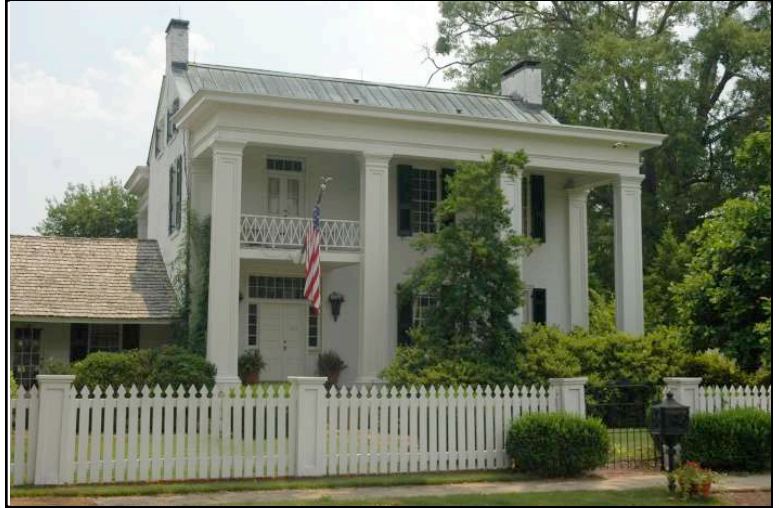
2-story brick Greek Revival style dwelling with a side gable raised seam metal roof; faces north, 3x2 bay rectangular core with 1-story extensions to the east; full façade full height portico with monumental paneled square pillars with intermediate balcony at the entrance bay; entrance at the east bay of the core with multi-light transom & sidelights flanked to the west by single 9/9 double hung sash windows, similar windows at side elevations and upper level; painted brick exterior walls with wood weatherboard siding at 1-story extension.

Condition: good _____ Integrity: good _____ Ownership: private _____ Category: Building _____
Historic Use: Single Dwelling - Non Farm _____ Current Use: Single Dwelling - Non Farm _____
Function: Residence _____ Function: Residence _____

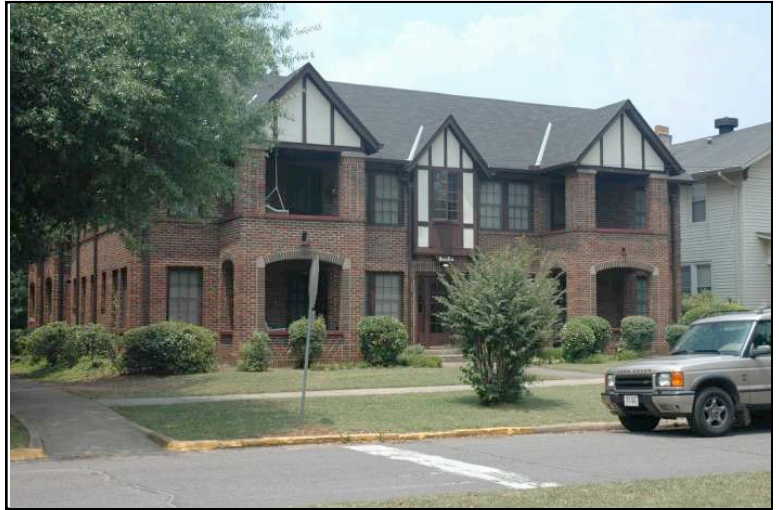
2-story brick veneer Tudor Revival style apartment building with a cross gable composition shingle roof; faces south, 7x3 bay rectangular core with a 6-bay deep rear L wing to the west; two tier 1-bay wide gable porches at the 3rd and 6th bay of the façade; central entrance with sidelights flanked to either side by double 6/6 double hung sash windows, entrances at the porches, and similar single windows at the outer bays, similar windows at side elevations and upper level; brick exterior walls with half timbering at the gable ends and a t a slightly projecting upper level bay window above the main entrance

Condition: good _____ Integrity: good _____ Ownership: private _____ Category: Building _____
Historic Use: Single Dwelling - Farm _____ Current Use: Multiple Dwelling _____
Function: Apartment Building _____ Function: Apartment Building _____

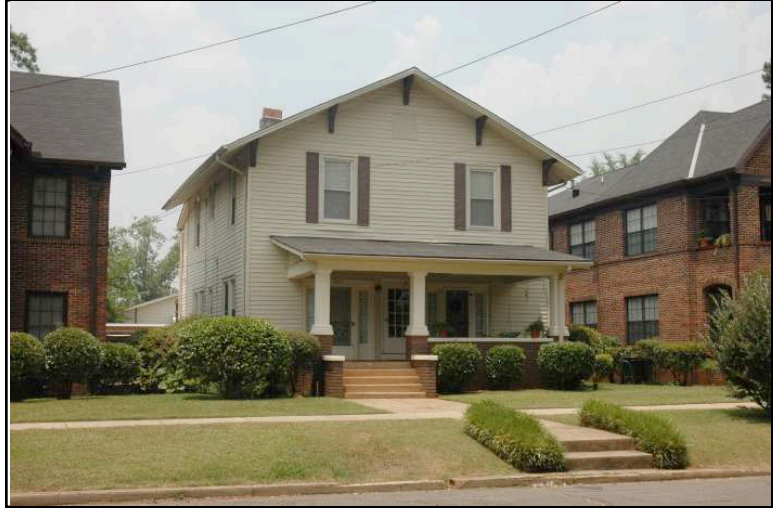
Rectangular 2-story frame dwelling with a front-gable composition shingle roof with angle bracket eaves; faces south; 3x3 bay core with rear shed extension; 1-story shed porch with supports on pedestals; replacement vinyl siding (ca. 1985).

Condition: good _____ Integrity: good _____ Ownership: private _____ Category: Building _____
 Historic Use: Single Dwelling - Non Farm _____ Current Use: Single Dwelling - Non Farm _____
 Function: Residence _____ Function: Residence _____

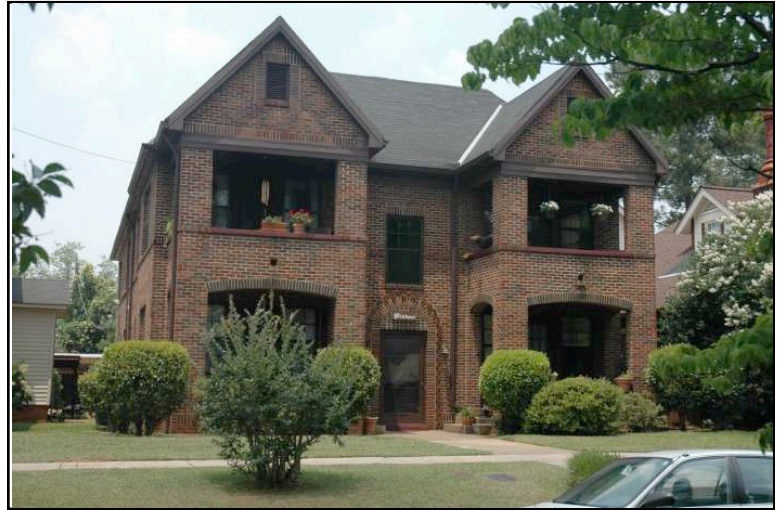
2-story brick veneer Tudor Revival style duplex with a hipped composition shingle roof with cross gables; faces south, 7x6 bay rectangular core; two tier 3-bay wide gable porches at the at either end of the façade; central entrance flanked to either side by groupings of 2 single 6/6 double hung sash windows flanking secondary entrances within the porches, similar windows at side elevations and upper level; brick exterior walls .

Condition: good _____ Integrity: good _____ Ownership: private _____ Category: Building _____
Historic Use: Multiple Dwelling _____ Current Use: Multiple Dwelling _____
Function: Duplex _____ Function: Duplex _____

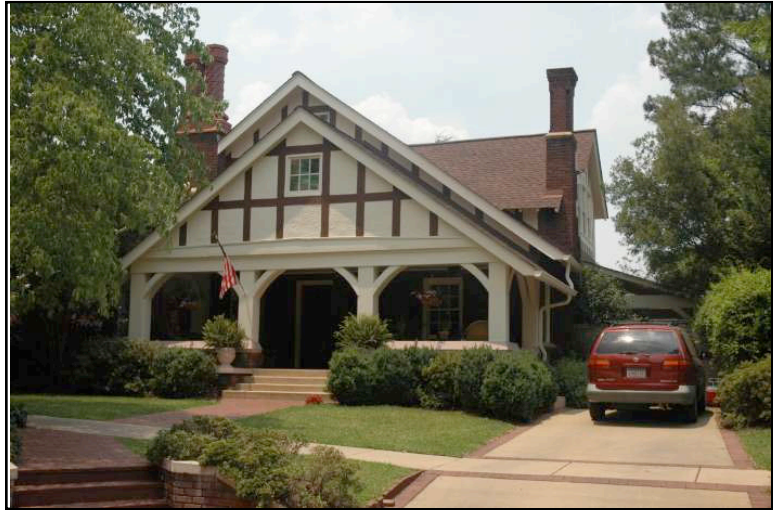
1.5-story brick veneer Tudor Revival style dwelling with a cross gable composition shingle roof, chimne with paired decorative terra cotta chimney pots; faces south, 4x3 bay rectangular core with rear extension and addition to NW; 1-stort less than full façade gable porch with heavy timber; off-center entrance flanked by single 6/6 double hung sash windows, similar single and grouped windows at side elevations and upper level; brick exterior walls with half timbering at gable ends.

Condition: good _____ Integrity: good _____ Ownership: private _____ Category: Building _____
Historic Use: Single Dwelling - Non Farm _____ Current Use: Single Dwelling - Non Farm _____
Function: Residence _____ Function: Residence _____

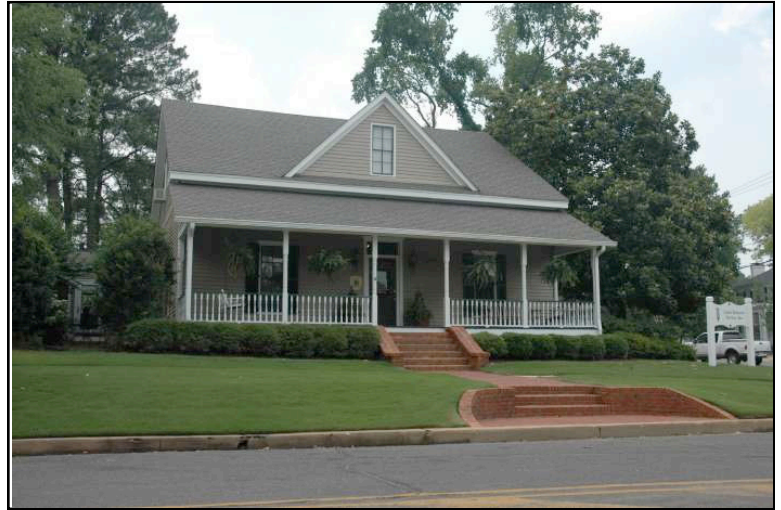
Rectangular 1-story frame dwelling with a side-gable composition shingle roof with central decorative gable dormer; faces south; 3x2 bay core with rear shed extension; full façade 1-story shed porch with turned posts and railing; central entrance with transom flanked by 4/4 windows; plain weatherboard siding.

Condition: good _____ Integrity: good _____ Ownership: private _____ Category: Building _____
Historic Use: Single Dwelling - Non Farm _____ Current Use: Single Dwelling - Non Farm _____
Function: Residence _____ Function: Residence _____

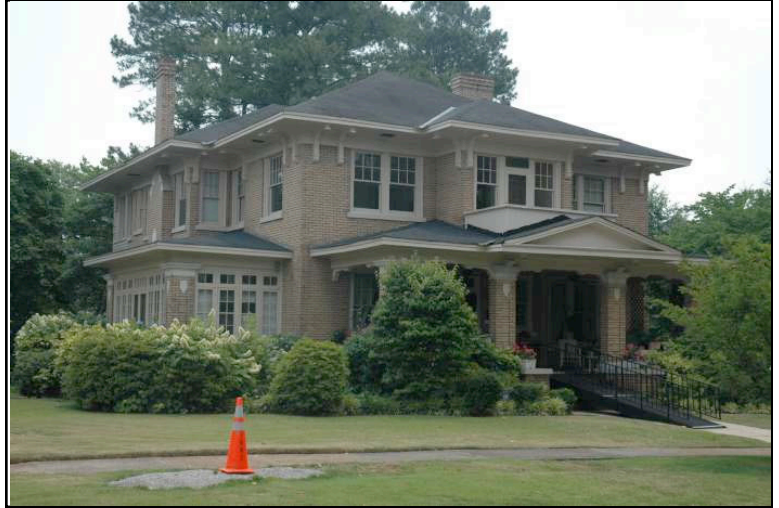
Two-story brick Craftsman style dwelling with a hipped composition shingle roof, faces north.

Condition: good _____ Integrity: good _____ Ownership: private _____ Category: Building _____
 Historic Use: Single Dwelling - Non Farm _____ Current Use: Single Dwelling - Non Farm _____
 Function: Residence _____ Function: Residence _____

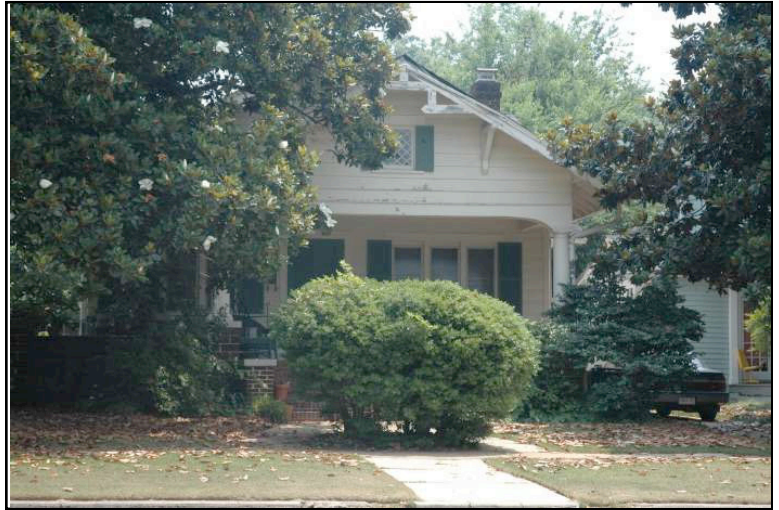
1-story frame gable front form dwelling with a Craftsman style details and a front-facing gable composition shingle roof with angle bracketed eaves; faces north, 3x3 bay rectangular core; full façade gable porch with wood columns; off-center entrance at facade flanked by a double and triple replacement jalousie windows (ca. 1955), similar windows at side elevations; wood weatherboard siding.

Condition: good _____ Integrity: good _____ Ownership: private _____ Category: Building _____
 Historic Use: Single Dwelling - Non Farm _____ Current Use: Single Dwelling - Non Farm _____
 Function: Residence _____ Function: Residence _____

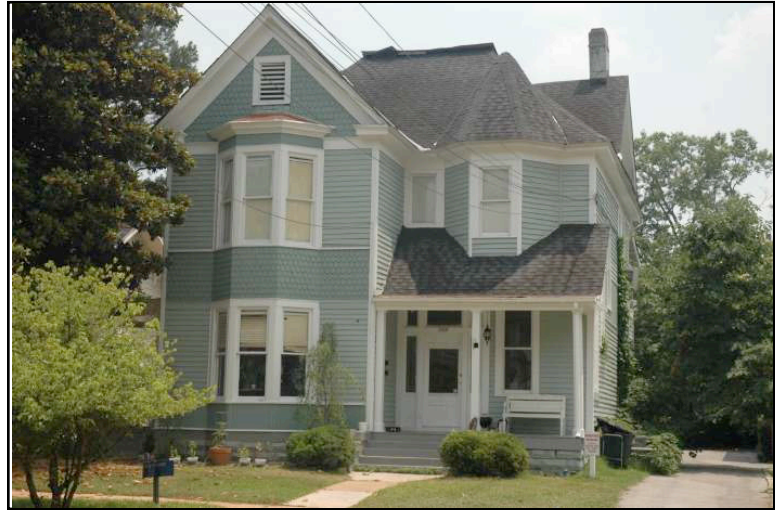
2-story frame Queen Anne style dwelling with a hipped composition shingle roof with cross gables; faces north, 3x3 bay rectangular core with a projecting wing with polygonal bay at the east bay of its façade and a polygonal bay centered at the upper level of the 2 western bays; less than full façade shed porch with wood posts; off-center entrance at facade with transom & sidelights flanked by single 1/1 double hung sash windows, similar windows at side elevations and upper level; wood weatherboard and decorative shingle siding.

Condition: good _____ Integrity: good _____ Ownership: private _____ Category: Building _____
Historic Use: Single Dwelling - Non Farm _____ Current Use: Single Dwelling - Non Farm _____
Function: Residence _____ Function: Residence _____

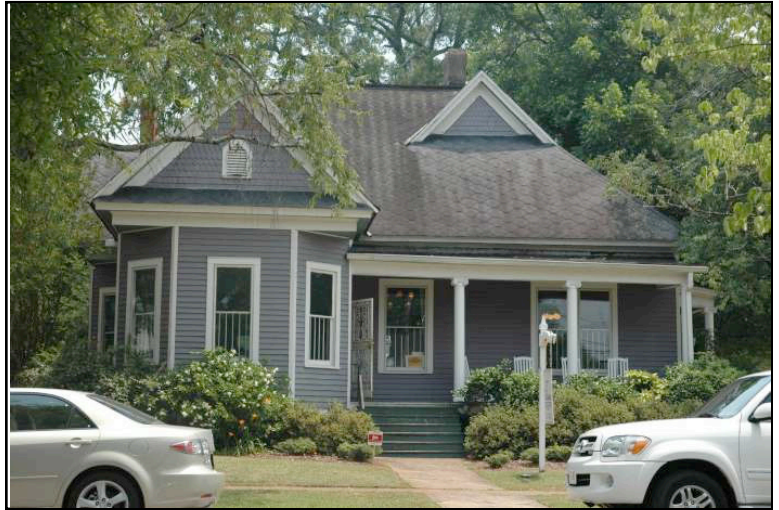
1-story frame Queen Anne style dwelling with a hipped composition shingle roof with pedimented cross gables; faces north, 3x3 bay rectangular core with a projecting polygonal bay at the east bay of its façade and a small rear wing; less than full façade shed porch with wood columns; entrance at west elevation of bay flanked at facade by single and double 1/1 double hung sash windows, similar windows at side elevations; wood weatherboard siding.

Condition: good _____ Integrity: good _____ Ownership: private _____ Category: Building _____
Historic Use: Single Dwelling - Non Farm _____ Current Use: Single Dwelling - Non Farm _____
Function: Residence _____ Function: Residence _____

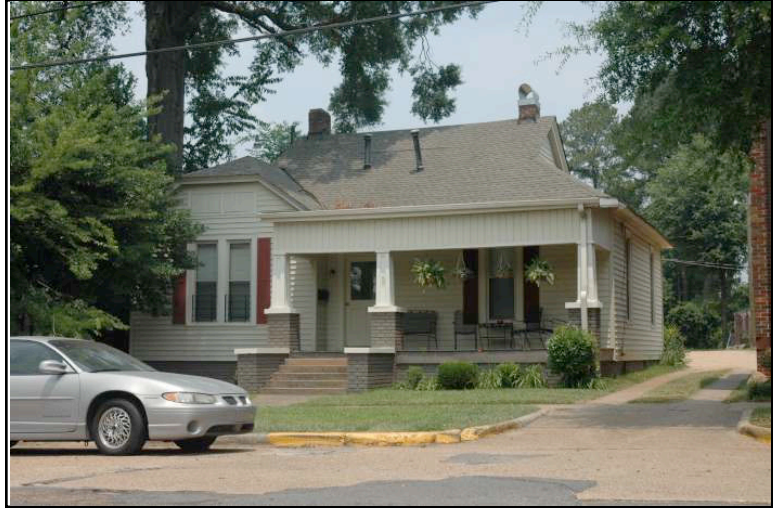
1-story frame dwelling with a side gable composition shingle roof with a jerking had cross gable; faces north, 3x2 bay rectangular core with a projecting wing at the east bay of its façade and a rear extension; less than full façade shed porch with tapered wood supports on brick pedestals; off-central entrance at façade flanked by single and double 6/6 double hung sash windows, similar windows at side elevations; replacement vinyl siding (1985 ca.).

Condition: good _____ Integrity: good _____ Ownership: private _____ Category: Building _____
 Historic Use: Single Dwelling - Non Farm _____ Current Use: Single Dwelling - Non Farm _____
 Function: Residence _____ Function: Residence _____

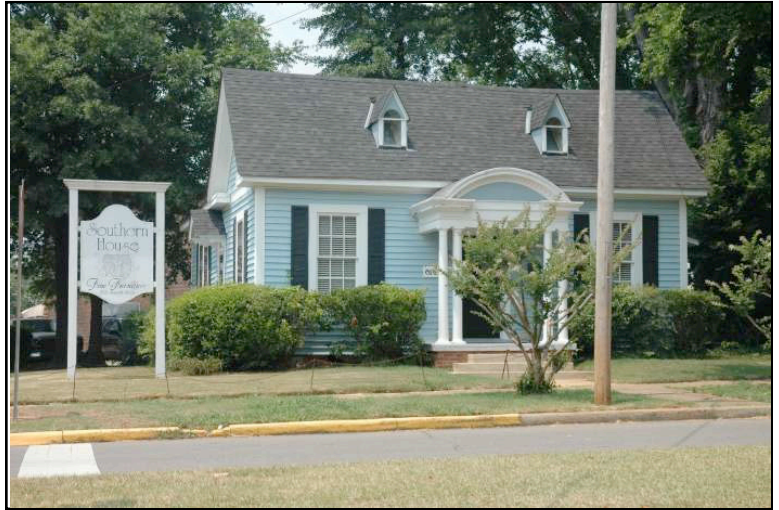
1-story frame dwelling with a cross gable composition shingle roof with a 2 small gable decorative dormers; faces south, 3x2 bay rectangular core; entrance bay round roofed portico with double columns; central entrance at façade flanked by single 6/6 double hung sash windows, similar windows at side elevations; replacement vinyl siding (1985 ca.).

Condition: good _____ Integrity: good _____ Ownership: private _____ Category: Building _____
Historic Use: Single Dwelling - Non Farm _____ Current Use: Single Dwelling - Non Farm _____
Function: Residence _____ Function: Residence _____

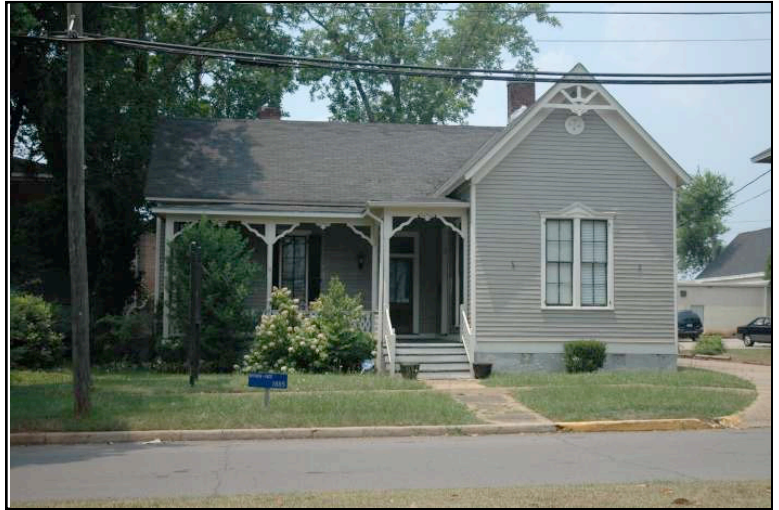
1-story frame gable front & wing form Folk Victorian dwelling with a cross gable composition shingle roof; faces south, 4x2 bay rectangular core with front-gable wing at east bay of facade; less than full façade hipped porch with chamfered posts and sawn brackets; off-center entrance at façade with transom flanked by single and double 4/4 double hung sash windows, similar windows at side elevations; plain weatherboard siding.

Condition: good _____ Integrity: good _____ Ownership: private _____ Category: Building _____
 Historic Use: Single Dwelling - Non Farm _____ Current Use: Single Dwelling - Non Farm _____
 Function: Residence _____ Function: Residence _____

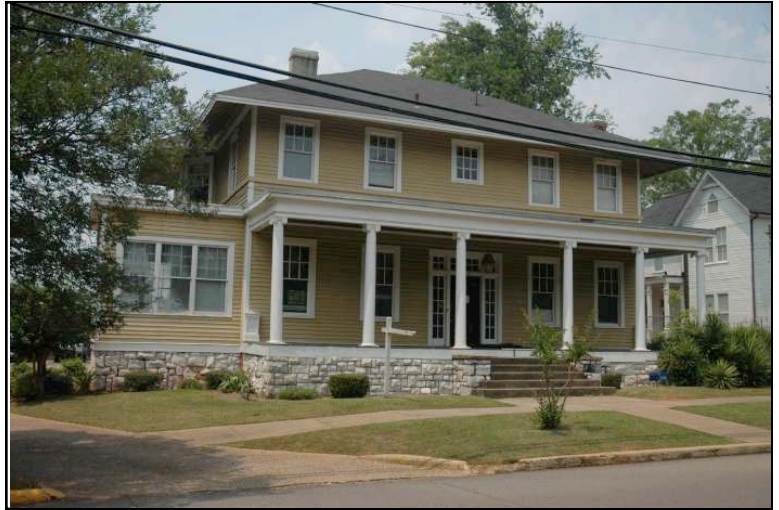
2-story frame dwelling with a hipped composition shingle roof; faces south, 5x2 bay rectangular core with polygonal projections at the rear bays of the side elevations, 1-story addition to the west; full façade hipped porch with columns; central entrance at façade with transom and sidelights flanked by single 6/1 double hung sash windows, similar windows at side elevations and upper level; plain weatherboard siding.

Condition: good _____ Integrity: good _____ Ownership: _____ Category: _____
Historic Use: Single Dwelling - Non Farm Current Use: Single Dwelling - Non Farm
Function: Residence Function: Residence

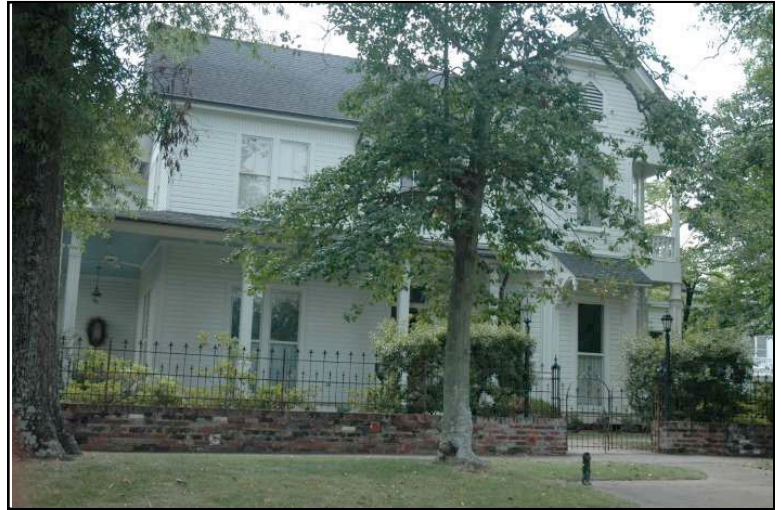
2-story frame Queen Anne style dwelling with a cross gable composition shingle roof; faces east, 3x2 bay rectangular core with a projecting polygonal wing with balconies at the north bay of its façade, polygonal projection at the rear bay of the south elevation, and rectangular projection to the rear; less than full façade shed porch with paired paneled wood posts; central entrance at facade with transom & flanked by single and double 1/1 double hung sash windows, similar windows at side elevations and upper level; replacement vinyl siding (ca. 1990).

Condition: good _____ Integrity: good _____ Ownership: _____ Category: _____
Historic Use: Single Dwelling - Non Farm Current Use: Single Dwelling - Non Farm
Function: Residence Function: Residence

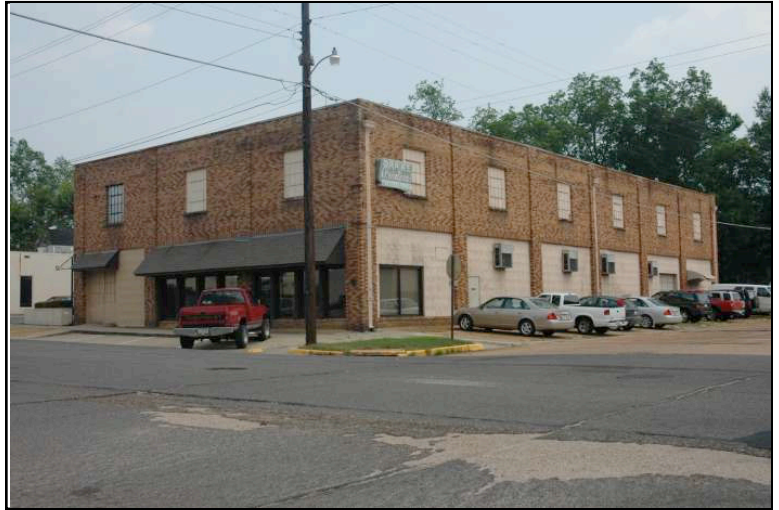
Rectangular 2-story brick veneer commercial building with a flat roof; faces north, 3x6 bay core; storefronts at 2 western bays of façade with modern storefront systems and shed canopy, garage doors at eastern bay, storefronts at west elevation have been infilled; industrial metal windows at upper level; exposed brick veneer exterior walls with low-relief pilasters at corners and between bays.

Condition: good _____ Integrity: good _____ Ownership: private _____ Category: Building _____
Historic Use: Commerce/Trade _____ Current Use: Commerce/Trade _____
Function: Specialty Store _____ Function: Specialty Store _____

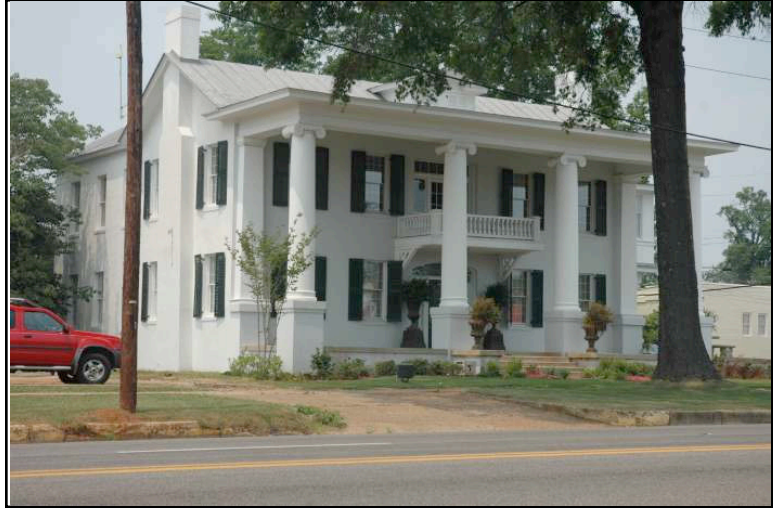
2-story stucco Greek Revival style dwelling with a side gable raised seam metal roof; faces south, 5x2 bay rectangular core with a rear L wing to the west with additions to the east; full façade full-height porch with intermediate deck at entrance bay only and masonry monumental Ionic columns on pedestals, enclosed sleeping porch over side porch at east; central entrance at façade with fanlight & sidelights flanked by single replacement 9/9 windows (ca. 1990), entrance with transom & sidelights with similar windows at upper level, similar windows at side elevations; stucco exterior walls siding.

Condition: good _____ Integrity: good _____ Ownership: private _____ Category: Building _____
 Historic Use: Single Dwelling - Non Farm _____ Current Use: Single Dwelling - Non Farm _____
 Function: Residence _____ Function: Residence _____

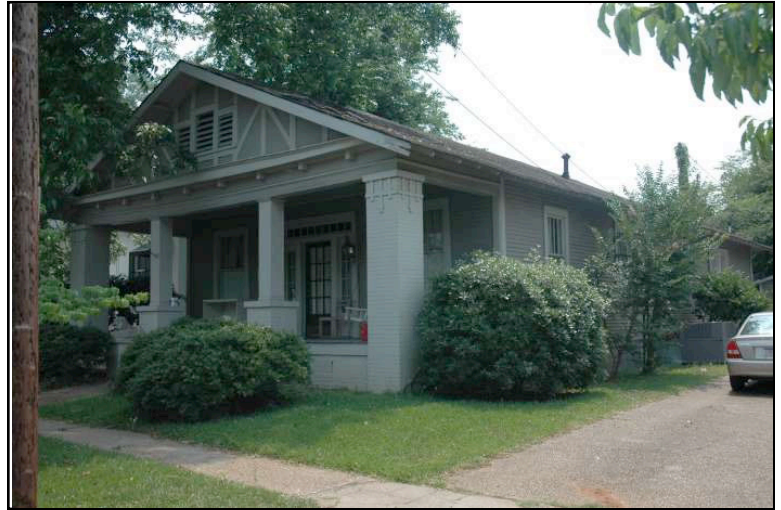
1-story frame gable front form dwelling with a Craftsman style details and a front-facing gable composition shingle roof with exposed rafter ends; faces east, 3x7 bay rectangular core with slightly projecting bay at south elevation; full façade recessed porch with inner wood supports on brick pedestals and outer brick pillars; center entrance at facade with transom & sidelights flanked by single Craftsman geometric double hung sash windows, similar windows at side elevations; wood weatherboard siding.

Condition: good _____ Integrity: good _____ Ownership: private _____ Category: Building _____
 Historic Use: Single Dwelling - Non Farm _____ Current Use: Single Dwelling - Non Farm _____
 Function: Residence _____ Function: Residence _____
