Tuscaloosa

Greater Downtown Study
Historic Resource Survey - 2006

Survey Number: _____ 1 _____
Historic name(s): House, Not Named
Common name: Southeast Appraisers
Location: University Blvd., 2720

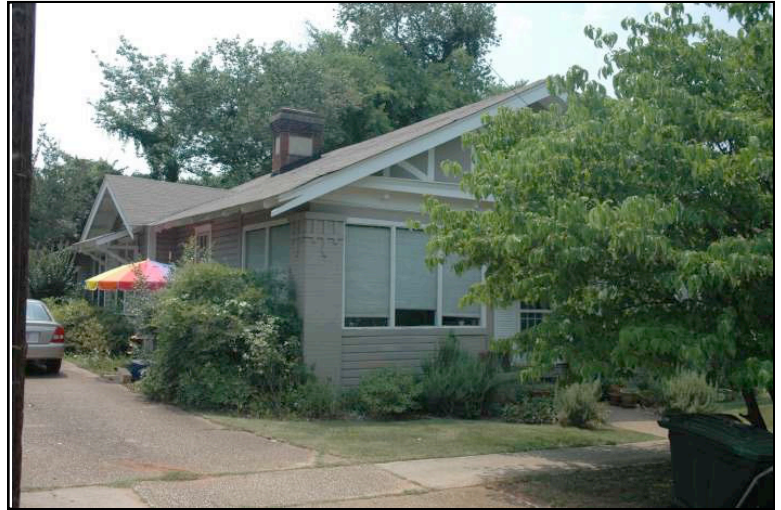
1-story frame gable front form dwelling with a Craftsman style details and a front-facing gable composition shingle roof with exposed rafter ends; faces east, 3x7 bay rectangular core with slightly projecting bay at south elevation; full façade recessed porch with brick pillars and a modern enclosure (ca. 1975); fenestration at façade obscured by porch enclosure, Craftsman geometric double hung sash windows at side elevations; wood novelty siding.

Condition: good _____ Integrity: fair _____ Ownership: private _____ Category: Building _____
Historic Use: Single Dwelling - Non Farm _____ Current Use: Single Dwelling - Non Farm _____
Function: Residence _____ Function: Residence _____

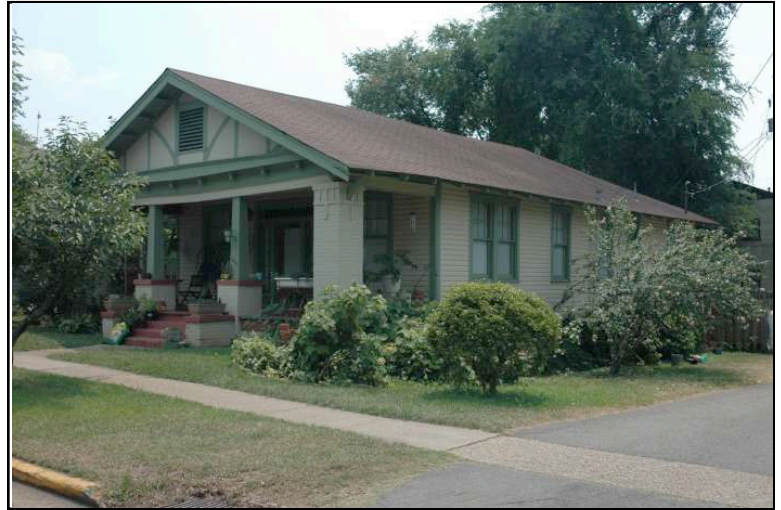
1-story frame gable front form dwelling with a Craftsman style details and a front-facing gable composition shingle roof with exposed rafter ends; faces east, 3x6 bay rectangular core with slightly projecting bay at south elevation; full façade recessed porch with inner tapered wood supports on brick pedestals and outer brick pillars; center entrance at facade with transom & sidelights flanked by single 6/1 double hung sash windows, similar windows at side elevations; replacement vinyl siding (ca. 1990).

Condition: good _____ Integrity: good _____ Ownership: private _____ Category: Building _____
Historic Use: Single Dwelling - Non Farm _____ Current Use: Single Dwelling - Non Farm _____
Function: Residence _____ Function: Residence _____

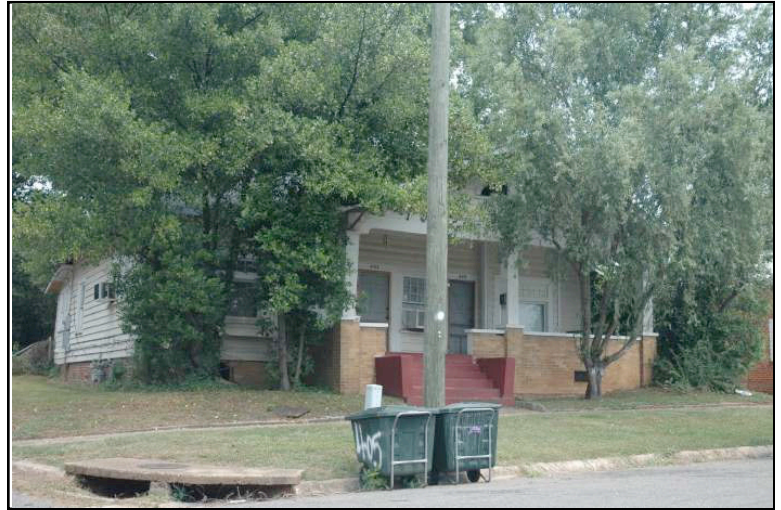
1-story frame gable front form dwelling with a Craftsman style details and a front-facing gable composition shingle roof with exposed rafter ends and angle bracketed eaves; faces west, 5x3 bay rectangular core with slightly projecting bay at south elevation; less than full façade gable porch with wood supports on brick pedestals and apron wall; entrances at the 2nd & 4th bay of the facade flanked by a single fixed window with multi-light transom & single 9/1 double hung sash windows, similar windows at side elevations; plain weatherboard siding.

Condition: good _____ Integrity: good _____ Ownership: private _____ Category: Building _____
 Historic Use: Single Dwelling - Non Farm _____ Current Use: Single Dwelling - Non Farm _____
 Function: Residence _____ Function: Residence _____

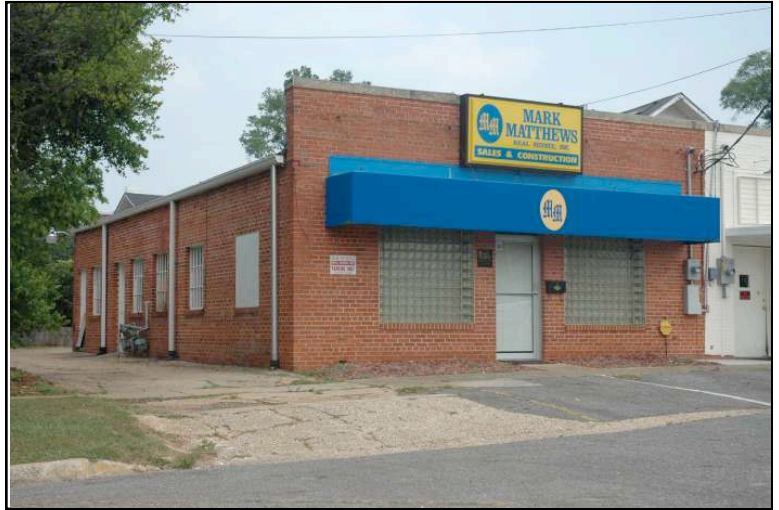
Rectangular 1-story brick commercial building with a monopitch roof concealed at its façade by a flat parapet with cast cap; faces west, 3x7 bay core; central entrance at façade flanked by glass block windows, modern canvas awning; single windows at entrances at side elevations; exposed brick se in common bond.

Condition: good _____ Integrity: good _____ Ownership: private _____ Category: Building _____
Historic Use: Single Dwelling - Non Farm _____ Current Use: Single Dwelling - Non Farm _____
Function: Residence _____ Function: Residence _____

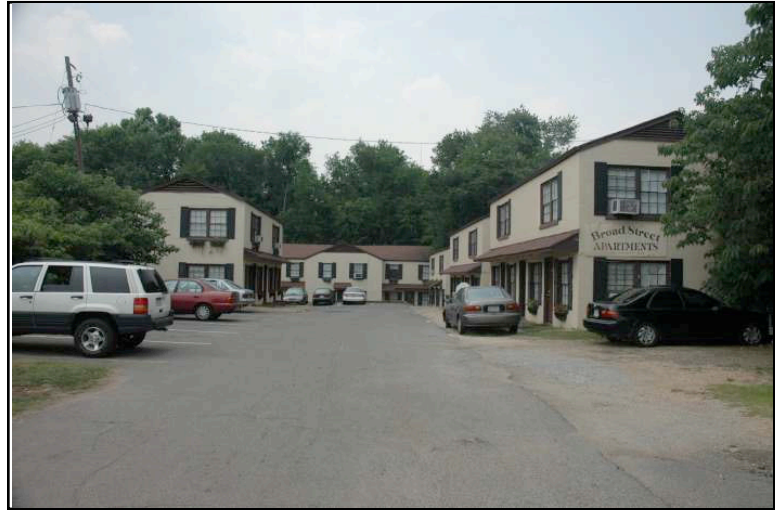
Grouping of 7 rectangular 2-story concrete block apartmnt buildings with side gable roofs and double 6/6 windows.

Condition: good _____ Integrity: good _____ Ownership: private _____ Category: Building _____
Historic Use: Single Dwelling - Non Farm _____ Current Use: Single Dwelling - Non Farm _____
Function: Residence _____ Function: Residence _____

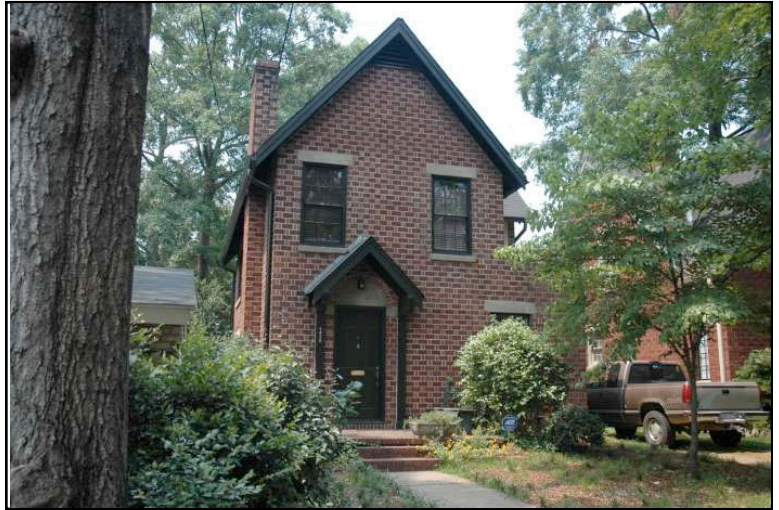
2-story brick veneer dwelling with a cross gable composition shingle roof; faces south, 1x3 bay rectangular core with a side gable extension at the rear bays of the east elevation and a 1-story extension within the L; no porch; entrance at west bay of façade flanked by a single 6/6 double hung sash window,, similar windows at upper level and side elevations; exposed brick veneer exterior walls.

Condition: good _____ Integrity: good _____ Ownership: private _____ Category: Building _____
Historic Use: Single Dwelling - Non Farm _____ Current Use: Single Dwelling - Non Farm _____
Function: Residence _____ Function: Residence _____

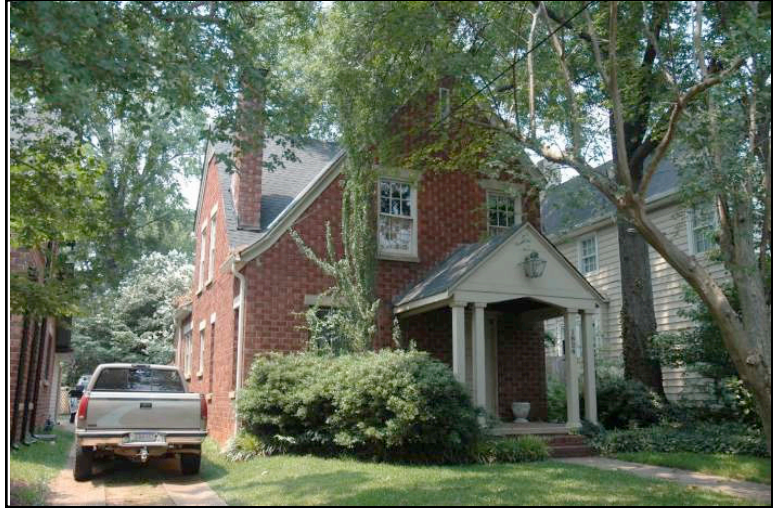
2-story brick veneer dwelling with a cross gable composition shingle roof; faces south, 2x3 bay rectangular core; 1-story gable porch at entrance bay with paired wood posts; entrance at east bay of façade flanked by a single 6/6 double hung sash window, similar windows at upper level and side elevations; exposed brick veneer exterior walls.

Condition: good _____ Integrity: good _____ Ownership: private _____ Category: Building _____
Historic Use: Single Dwelling - Non Farm _____ Current Use: Single Dwelling - Non Farm _____
Function: Residence _____ Function: Residence _____

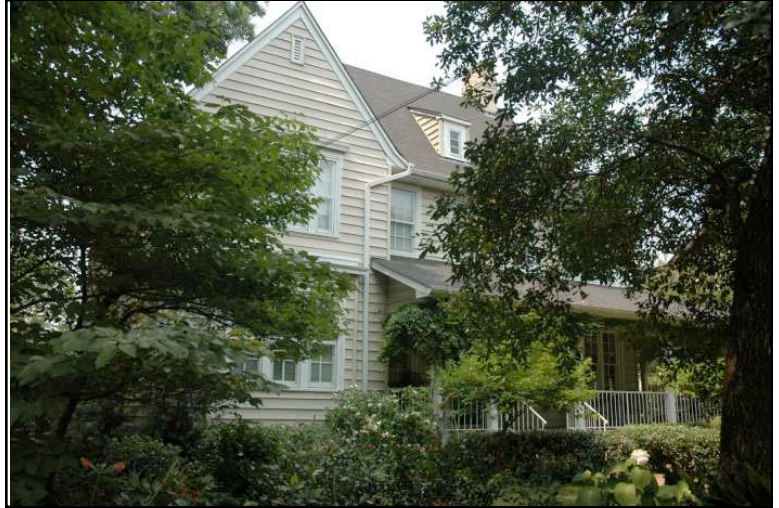
2-story frame dwelling with a cross gable composition shingle roof with small decorative shed dormer; faces south, 4x2 bay T-shaped core with front and rear T wings to the west; less than full façade shed porch with turned posts; off-center entrance at façade flanked by a single and triple 4/4 double hung sash windows, similar tripartite & 6/6 windows at upper level and side elevations; replacement vinyl siding (ca. 1985).

Condition: good _____ Integrity: good _____ Ownership: private _____ Category: Building _____
Historic Use: Single Dwelling - Non Farm _____ Current Use: Single Dwelling - Non Farm _____
Function: Residence _____ Function: Residence _____

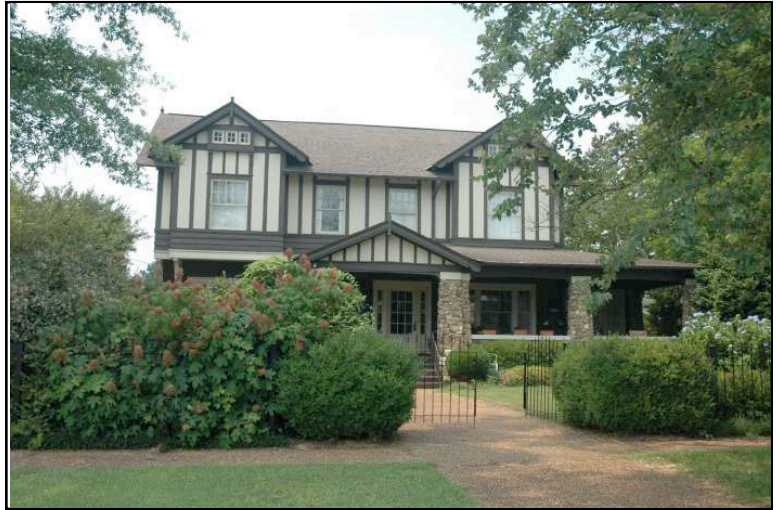
2-story half-timbered Tudor Revival style dwelling with a cross gable composition shingle roof; faces south, 4x3 bay core with rear T wing to the west, projecting front-gable bays at either side of facade; less than full façade gable on hipped porch with stone pillars; off-center entrance at façade with sidelights flanked by tripartite 4/1-10/1-4/1 double hung sash windows, similar 10/1 and 8/1 windows at upper level and side elevations; half-timbered exterior walls.

Condition: good _____ Integrity: good _____ Ownership: private _____ Category: Building _____
Historic Use: Single Dwelling - Non Farm _____ Current Use: Single Dwelling - Non Farm _____
Function: Residence _____ Function: Residence _____

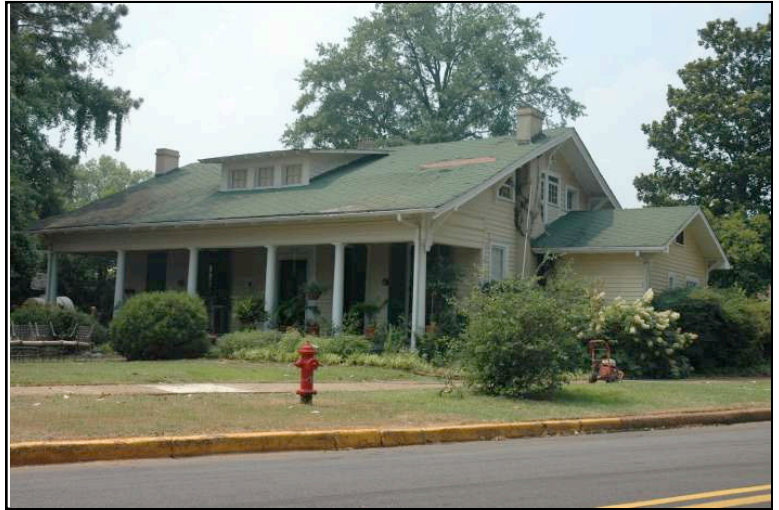
1.5-story frame Craftsman style dwelling with a side gable composition shingle roof with angle bracketed eaves and exposed rafter ends; faces south, 5x3 bay rectangular core with secondary side gable wing to east; full façade recessed porch with wood columns; central entrance at façade flanked by single 9/9 double hung sash windows, similar windows at side elevations; plain weatherboard siding.

Condition: good _____ Integrity: good _____ Ownership: private _____ Category: Building _____
 Historic Use: Single Dwelling - Non Farm _____ Current Use: Single Dwelling - Non Farm _____
 Function: Residence _____ Function: Residence _____

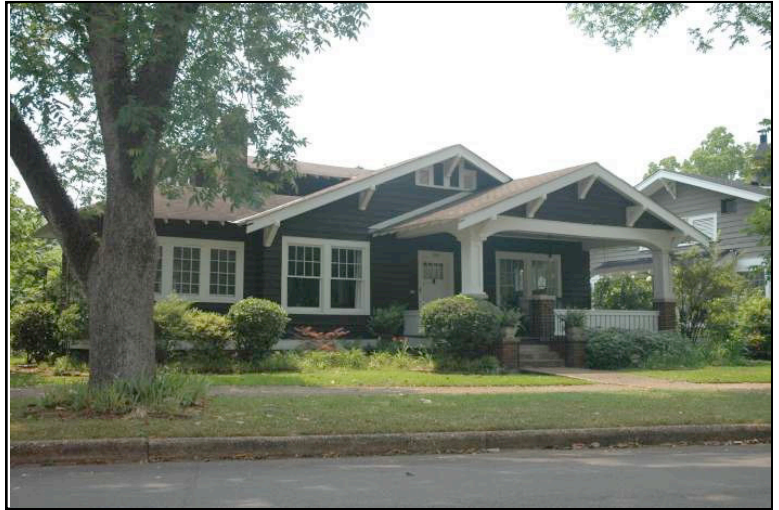
1 -story frame Craftsman style dwelling with a cross gable composition shingle roof with angle bracketed eaves and exposed rafter ends; faces east, 3x3 bay rectangular core with a hipped addition to the south; less than full façade gable porch with wood supports on brick pedestals; off-center entrance at façade flanked by double 8/1 double hung sash windows, similar single, double, and triple windows at side elevations; plain weatherboard siding.

Condition: good _____ Integrity: good _____ Ownership: private _____ Category: Building _____
Historic Use: Single Dwelling - Non Farm _____ Current Use: Single Dwelling - Non Farm _____
Function: Residence _____ Function: Residence _____

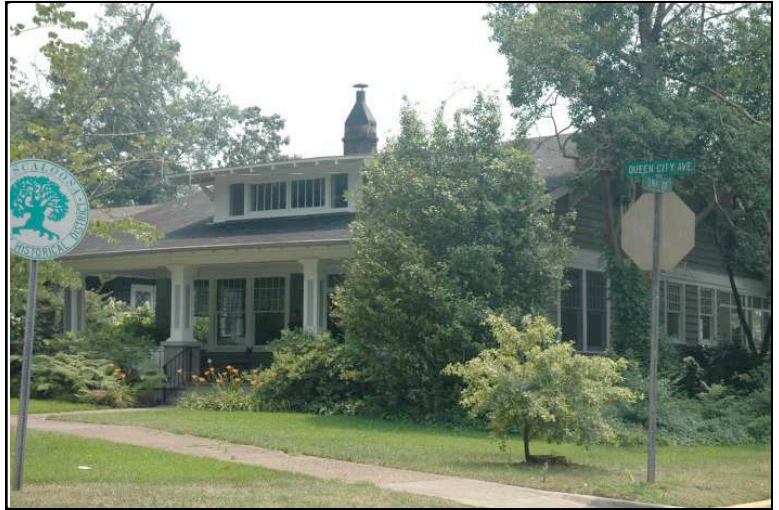
1 -story frame Craftsman style dwelling with a side gable composition shingle roof with angle bracketed eaves and exposed rafter ends; faces east, 3x4 bay rectangular core; full façade recessed porch with wood supports on brick pedestals; center entrance at façade flanked by triple 15/1 double hung sash windows, similar single and double windows at side elevations; plain weatherboard siding.

Condition: good _____ Integrity: good _____ Ownership: private _____ Category: Building _____
Historic Use: Single Dwelling - Non Farm _____ Current Use: Single Dwelling - Non Farm _____
Function: Residence _____ Function: Residence _____

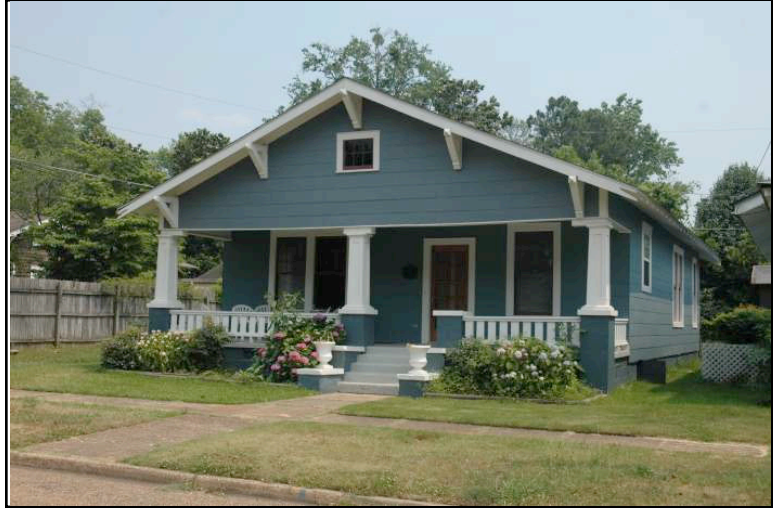
1 -story frame Craftsman style dwelling with a front-facing gable composition shingle roof with angle bracketed eaves and exposed rafter ends; faces north, 3x3 bay rectangular core; full façade recessed porch with wood supports on brick pedestals; off-center entrance at façade flanked by single and double 9/1 double hung sash windows, similar single and double windows at side elevations; replacement asbestos shingle siding (ca, 1955).

Condition: good _____ Integrity: good _____ Ownership: private _____ Category: Building _____
Historic Use: Single Dwelling - Non Farm _____ Current Use: Single Dwelling - Non Farm _____
Function: Residence _____ Function: Residence _____

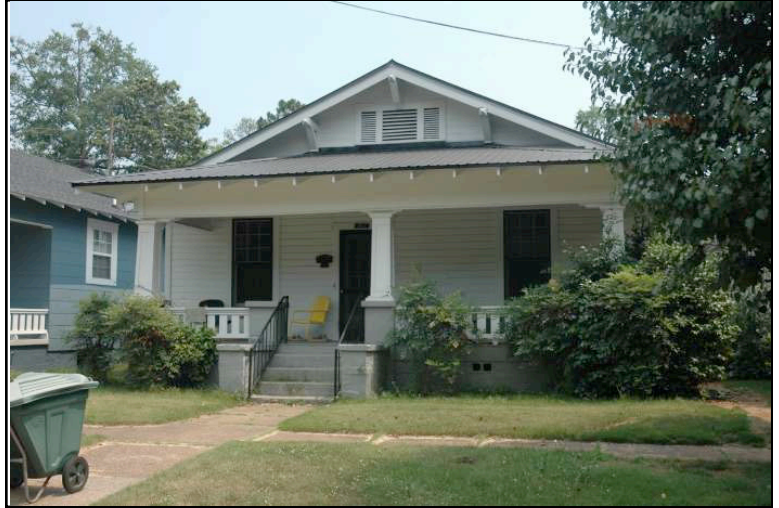
1 -story frame Craftsman style dwelling with a front-facing gable composition shingle roof with angle bracketed eaves and exposed rafter ends; faces north, 3x3 bay rectangular core; full façade hipped porch with wood supports on brick pedestals; off-center entrance at façade flanked by single and double 9/1 double hung sash windows, similar single and double windows at side elevations; wood novelty siding.

Condition: good _____ Integrity: good _____ Ownership: private _____ Category: Building _____
Historic Use: Single Dwelling - Non Farm _____ Current Use: Single Dwelling - Non Farm _____
Function: Residence _____ Function: Residence _____

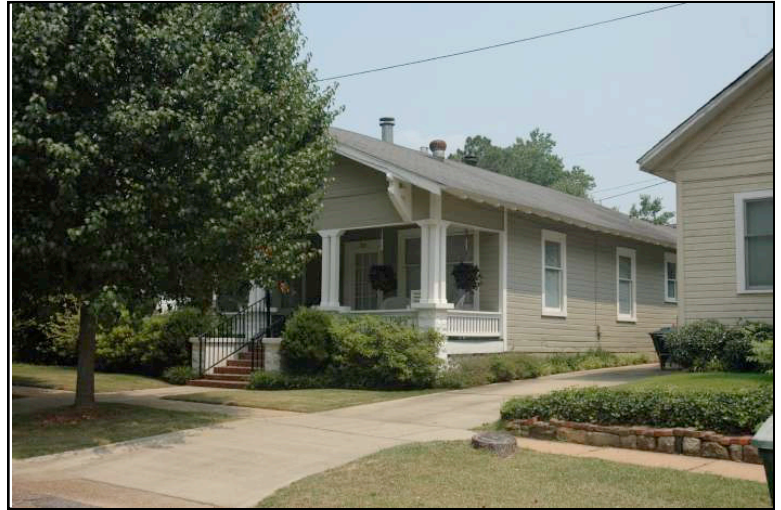
1 -story frame Craftsman style dwelling with a front-facing gable composition shingle roof with angle bracketed eaves and exposed rafter ends; faces north, 3x3 bay rectangular core; full façade recessed porch with paired wood supports on brick pedestals; off-center entrance at façade flanked by single and double 1/1 double hung sash windows, similar single and double windows at side elevations; wood novelty siding.

Condition: good _____ Integrity: good _____ Ownership: private _____ Category: Building _____
 Historic Use: Single Dwelling - Non Farm _____ Current Use: Single Dwelling - Non Farm _____
 Function: Residence _____ Function: Residence _____

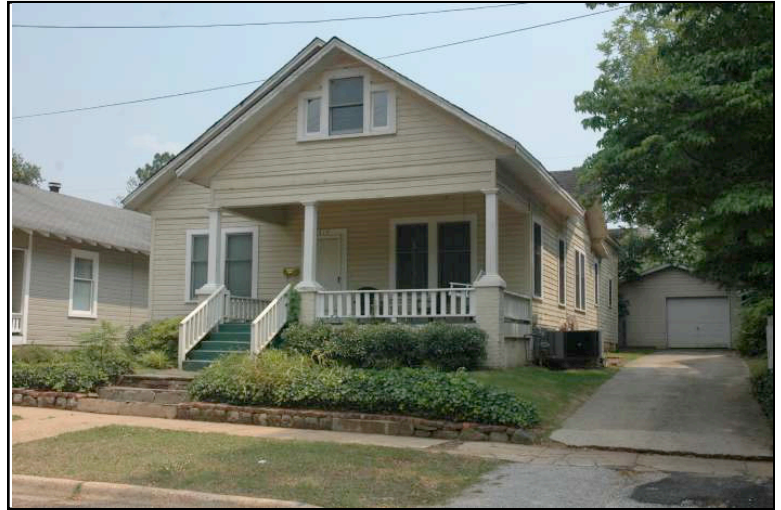
1 -story frame dwelling with a front-facing gable composition shingle roof; faces north, 3x5 bay rectangular core; less than full façade gable porch with wood supports on brick pedestals; central entrance at façade flanked by single and double 1/1 double hung sash windows, similar single windows at side elevations; wood novelty siding.

Condition: good _____ Integrity: good _____ Ownership: private _____ Category: Building _____
Historic Use: Single Dwelling - Non Farm _____ Current Use: Single Dwelling - Non Farm _____
Function: Residence _____ Function: Residence _____

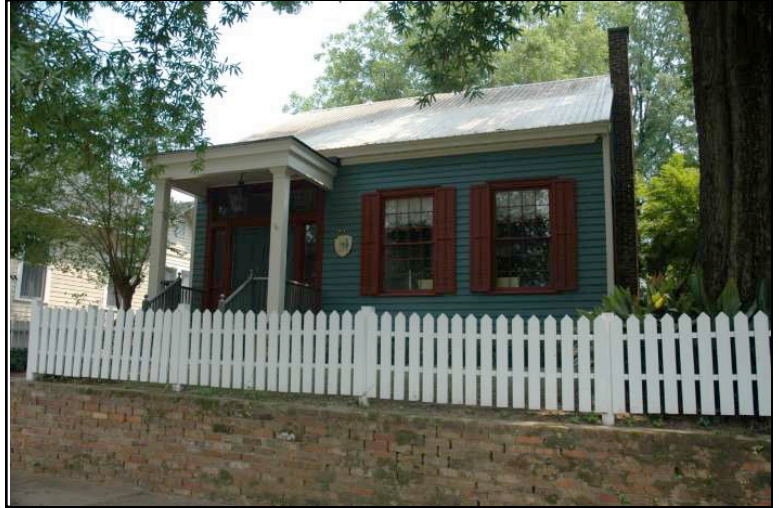
1 -story frame dwelling with a side gable industrial metal roof; faces north, 3x2 bay rectangular core with rear extension; entrance bay portico with wood posts; entrance at west bay of façade flanked by single 12/12 double hung sash windows, similar windows at side elevations; plain weatherboard siding.

Condition: good _____ Integrity: good _____ Ownership: private _____ Category: Building _____
Historic Use: Single Dwelling - Non Farm _____ Current Use: Single Dwelling - Non Farm _____
Function: Residence _____ Function: Residence _____

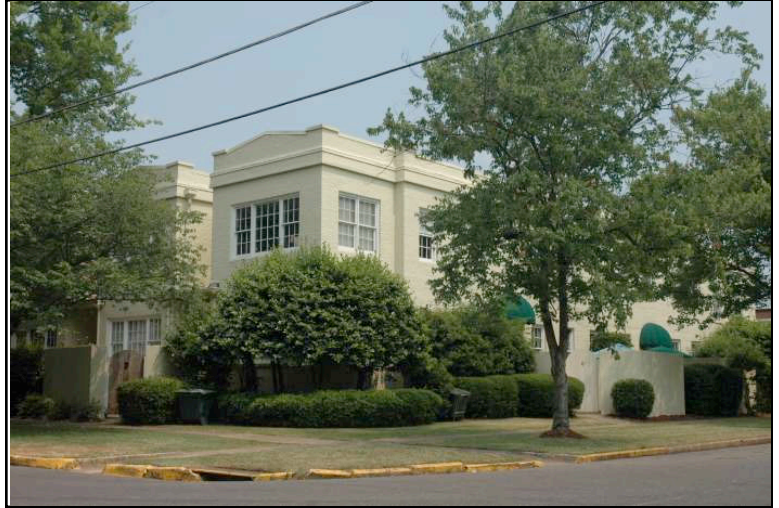
2-story brick apartment complex.

Condition: good _____ Integrity: good _____ Ownership: private _____ Category: Building _____
 Historic Use: Multiple Dwelling _____ Current Use: Multiple Dwelling _____
 Function: Apartment Building _____ Function: Apartment Building _____

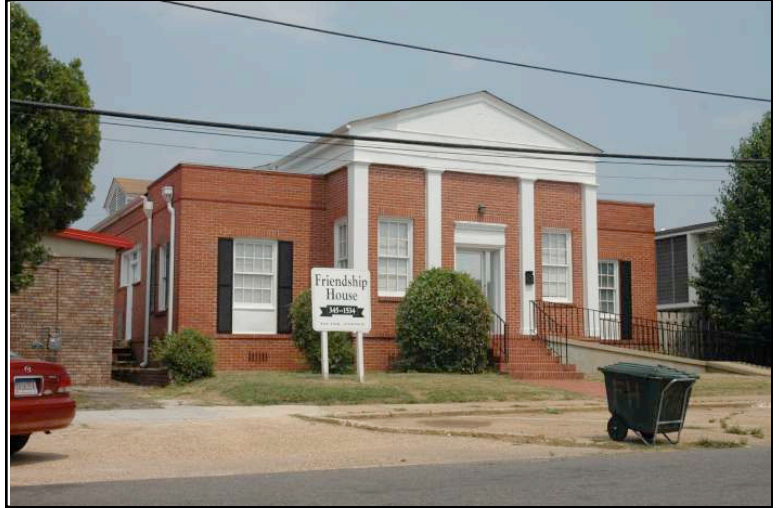
1-story brick veneer building with a central front-gable roof flanked by flat roofs; faces west, rectangular 5x4 bay core with projecting 3-bay central gable pavilion with pedimented gable supported by stucco pilasters; central entrance at façade flanked by 6/6 double hung sash windows, similar windows at side elevations; exposed brick veneer walls.

Condition: good _____ Integrity: good _____ Ownership: private _____ Category: Building _____
Historic Use: Commerce/Trade Current Use: Religion
Function: Business/Professional Office Function: Religious Facility

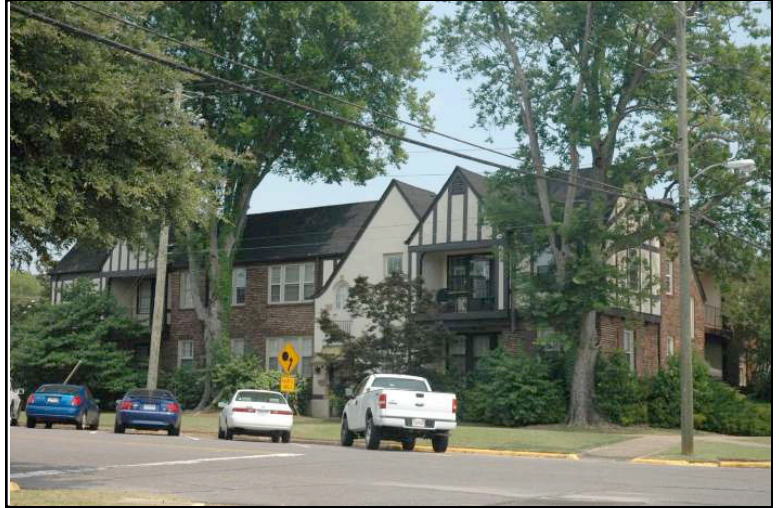
2-story brick and half timbered apartment complex.

Condition: good _____ Integrity: good _____ Ownership: private _____ Category: Building _____
 Historic Use: Single Dwelling - Non Farm _____ Current Use: Single Dwelling - Non Farm _____
 Function: Residence _____ Function: Residence _____

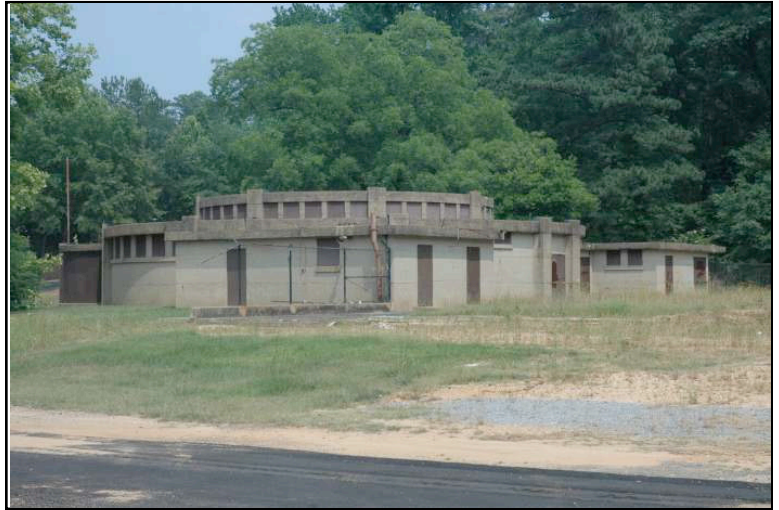
See NR nomination for the Queen City Pool House

Condition: good _____ Integrity: good _____ Ownership: private _____ Category: Building _____
 Historic Use: Recreation/Culture _____ Current Use: Vacant/Not in Use _____
 Function: Pool House _____ Function: _____

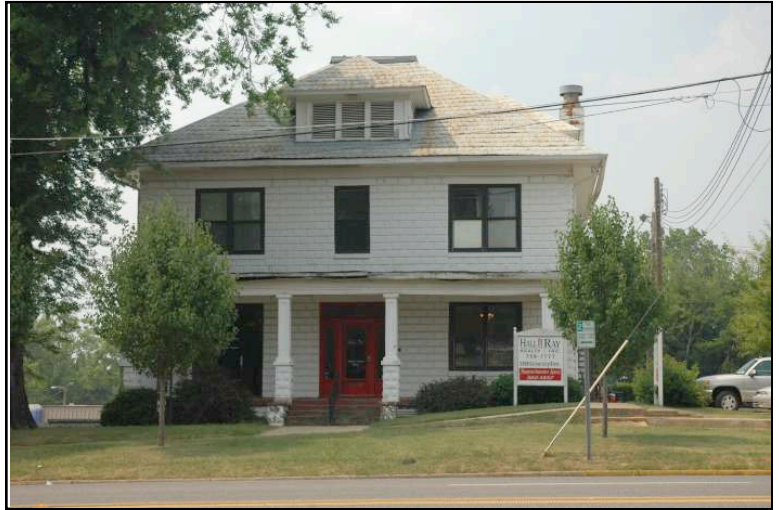
2-story patterned concrete block dwelling with a hipped patterned metal roof with front and side hipped decorative dormers; faces south, 3x3 bay rectangular core; full façade hipped porch with masonry posts on patterned concrete block pedestals; central entrance at façade with transom & sidelights flanked by double 1/1 double hung sash windows, similar single and double windows at upper level and side elevations; painted patterned concrete block exterior walls.

Condition: good _____ Integrity: good _____ Ownership: private _____ Category: Building _____
Historic Use: Single Dwelling - Non Farm _____ Current Use: Commerce/Trade _____
Function: Residence _____ Function: Business/Professional Office _____

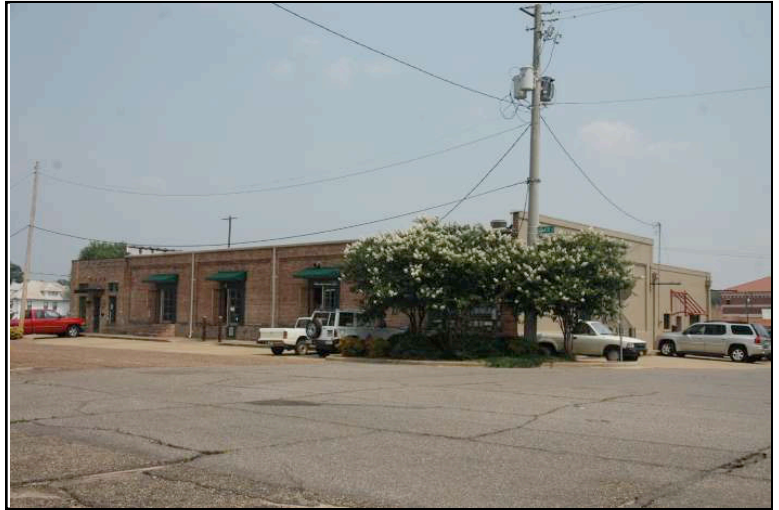
Rectangular 1-story brick commercial building.

Condition: good _____ Integrity: good _____ Ownership: private _____ Category: Building _____
 Historic Use: Commerce/Trade _____ Current Use: Commerce/Trade _____
 Function: Warehouse. _____ Function: Specialty Store _____

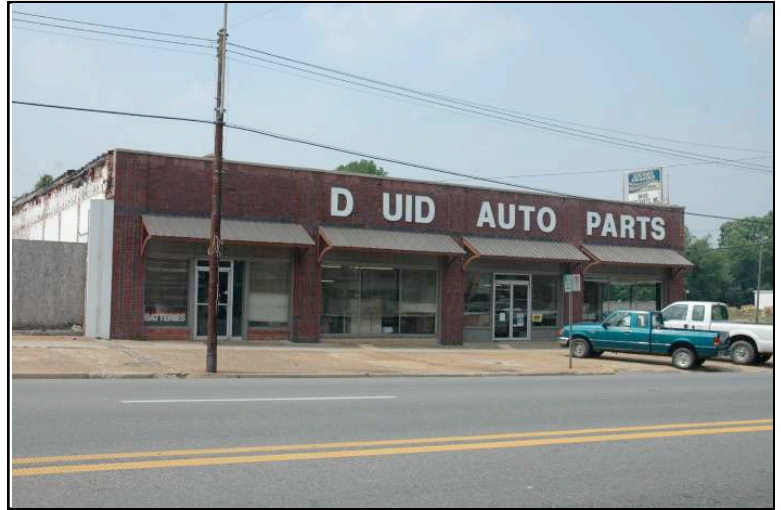
Rectangular 1-story brick commercial building.

Condition: good _____ Integrity: good _____ Ownership: private _____ Category: Building _____
 Historic Use: Commerce/Trade _____ Current Use: Commerce/Trade _____
 Function: Specialty Store _____ Function: Specialty Store _____

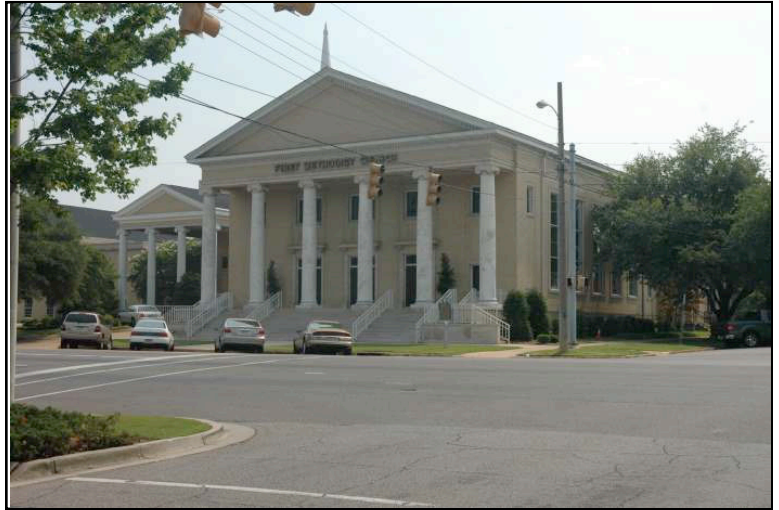
Large Classical Revival Church with a front-facing gable roof and extensive additions.

Condition: good _____ Integrity: good _____ Ownership: private _____ Category: Building _____
 Historic Use: Religion _____ Current Use: Religion _____
 Function: Religious Facility _____ Function: Religious Facility _____

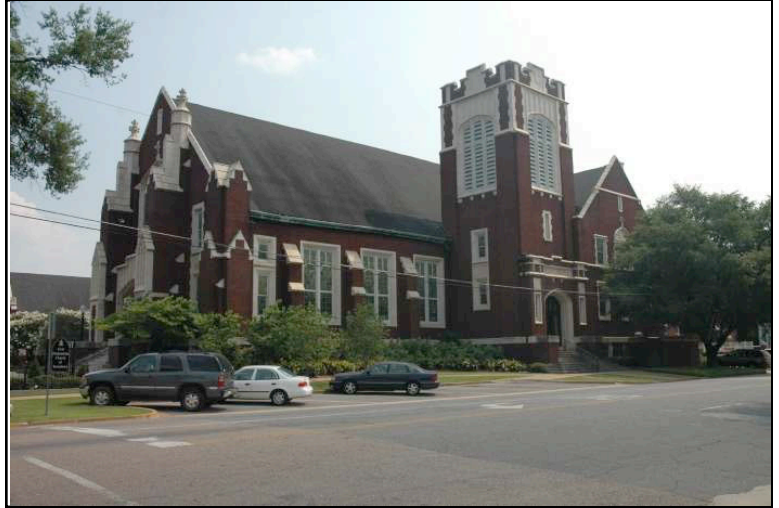
Large Tudor Revival Church with a front-facing gable roof and extensive additions.

Condition: good _____ Integrity: good _____ Ownership: private _____ Category: Building _____
Historic Use: Religion _____ Current Use: Religion _____
Function: Religious Facility _____ Function: Religious Facility _____

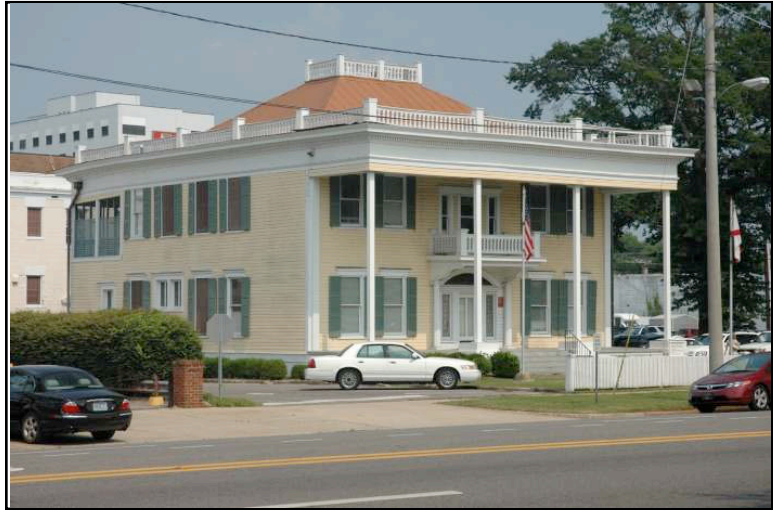
2-story frame dwelling with a hipped raised seam metal roof with deck surrounded by a turned balustrade; faces east, 3x5 bay rectangular core; full façade full-height flat-roofed portico with replacement wood posts, intermediate balcony at entrance bay; central entrance at façade with fanlight & sidelights flanked by paired 1/1 double hung sash windows, similar single and double windows at upper level and side elevations; plain weatherboard siding.

Condition: good _____ Integrity: good _____ Ownership: private _____ Category: Building _____
Historic Use: Single Dwelling - Non Farm _____ Current Use: Commerce/Trade _____
Function: Residence _____ Function: Business/Professional Office _____

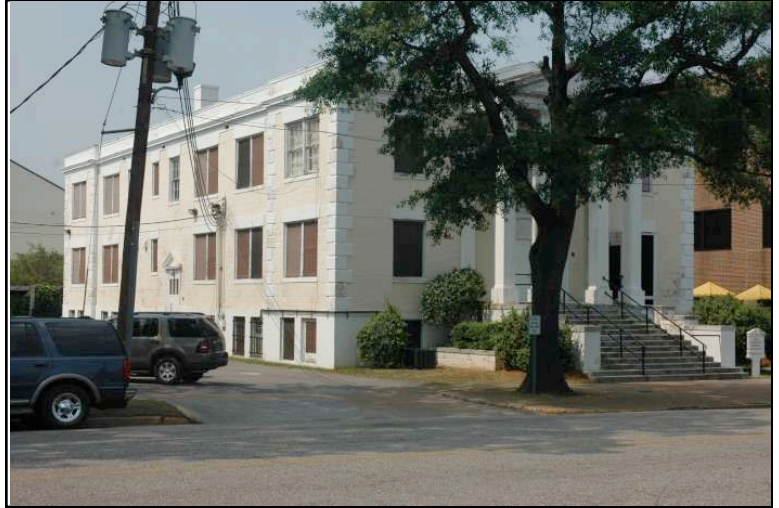
Rectangular 2-story stucco building with a flat roof concealed by flat parapets; faces south, 3x8 bay core; full-height less than full façade pedimented portico with wood pillars; central entrance at façade flanked by single aluminum 6/6 windows, similar single and double windows at side elevations and upper floor.

Condition: good _____ Integrity: good _____ Ownership: private _____ Category: Building _____
Historic Use: Government _____ Current Use: Religion _____
Function: Business/Professional Office _____ Function: Religious Facility _____

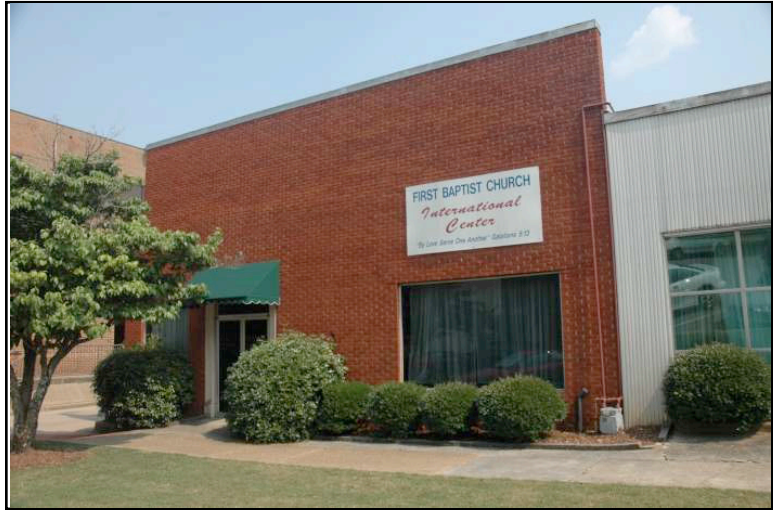
Rectangular 1-story brick veneer commercial building.ca./

Condition: good _____ Integrity: good _____ Ownership: private _____ Category: Building _____
 Historic Use: Commerce/Trade _____ Current Use: Religion _____
 Function: Specialty Store _____ Function: Religious Facility _____

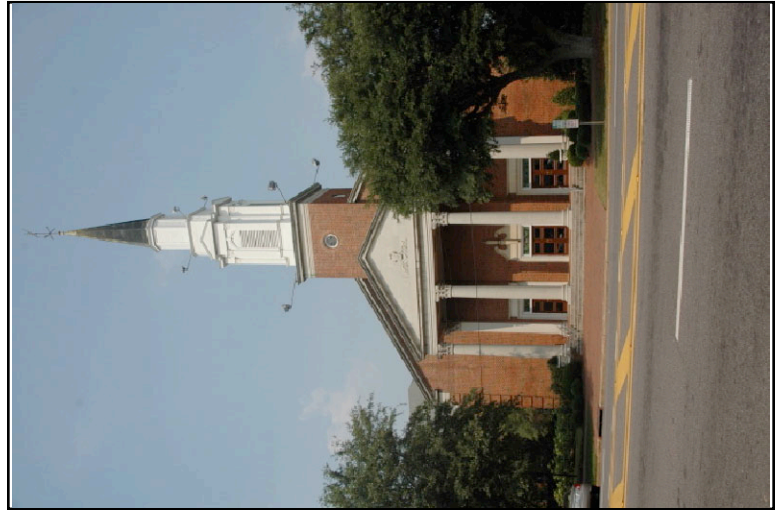
Large Colonial Revival Church with a front-facing gable roof and extensive additions.

Condition: good _____ Integrity: good _____ Ownership: private _____ Category: Building _____
 Historic Use: Single Dwelling - Non Farm _____ Current Use: Single Dwelling - Non Farm _____
 Function: Residence _____ Function: Residence _____

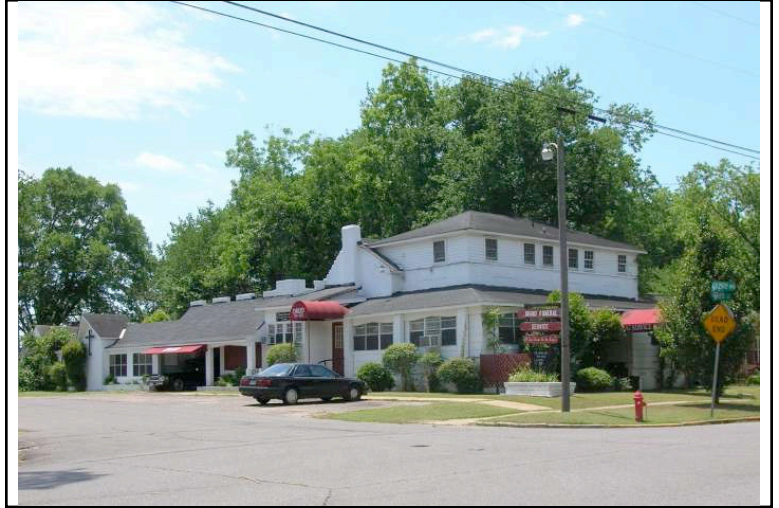
Rectangular 2-story frame building with a hipped composition shingle roof; rectangular core with rear additions and wraparound enclosed porches.

Condition: good _____ Integrity: fair _____ Ownership: private _____ Category: Building _____
 Historic Use: Commerce/Trade _____ Current Use: Commerce/Trade _____
 Function: Funeral Home _____ Function: Funeral Home _____
