# Suttle, Alabama

Written Historical and Descriptive Data, Photographs, Drawings  
8 April 2010

SUTTLE, ALABAMA  
Perry County, Alabama

## Historic Resource Survey

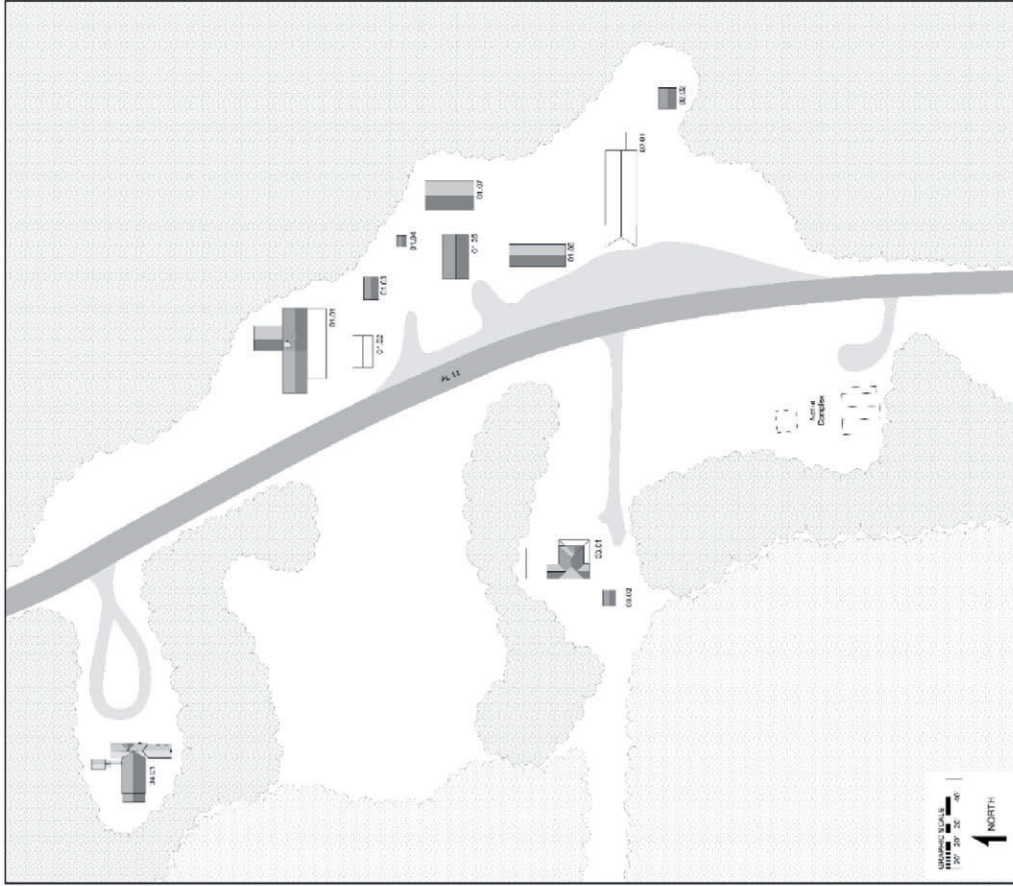
Sheet 1          Siteplan, 8 April, 24x36".

Suttle, Alabama  
Remnants of J. Freeman Suttle Mercantile  
and Residential Complex

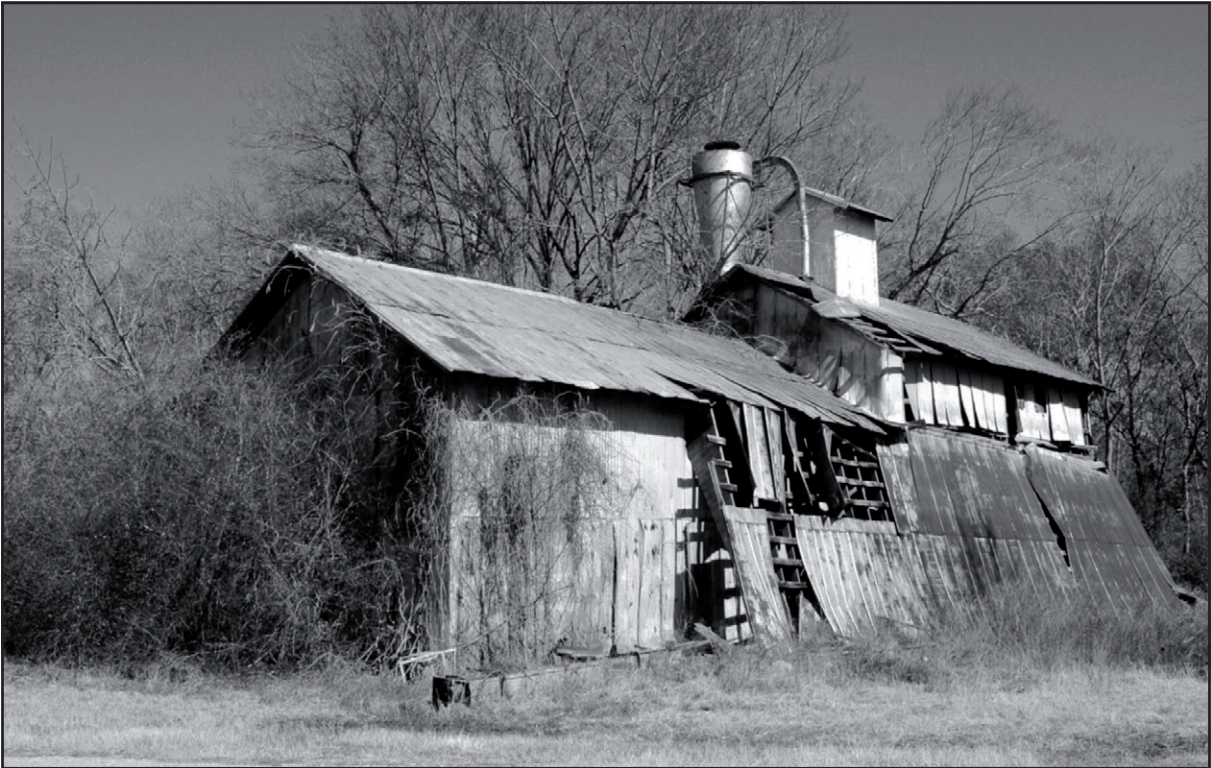
AL\_PerryCo\_Suttle\_0003. Resource #1, camera facing northeast

Highway 16, E side, 750 yds. N of CR 6. The building is a two-story frame cotton gin building with a cross gable corrugated metal roof. Oriented with its long axis extending from west to east perpendicular to the highway, the building has a split-level core with a side gable extension to the north. The taller roof at the rear (east) portion of the building has a small rectangular tower and a grain bin at its western end. A less than full elevation shed canopy along the south elevation has partially collapsed. Only one set of cargo doors could be observed under the canopy and no other openings were visible. The building is clad with corrugated metal siding and is in deteriorated, almost ruinous, condition. Six smaller frame outbuildings of undetermined historic are grouped to the south of the gin. Other than resource 1.06, all are rectangular one-story metal clad buildings of varying sizes with gable roofs. Resource 1.06 is similar but is an open shed and resource #1.02 has collapsed and is being dismantled.

Construction and design details indicate that this building was constructed circa 1915; originally built as a cotton mill ca. 1915, the building was converted into a mill to make cattle feed circa 1935; it ceased operation as cattle and dairy farming were phased out circa 1950-1960, was then used for storage, and has been vacant for the past 20 years or so; demolition of the gin building and its associated outbuildings is anticipated in 2010.

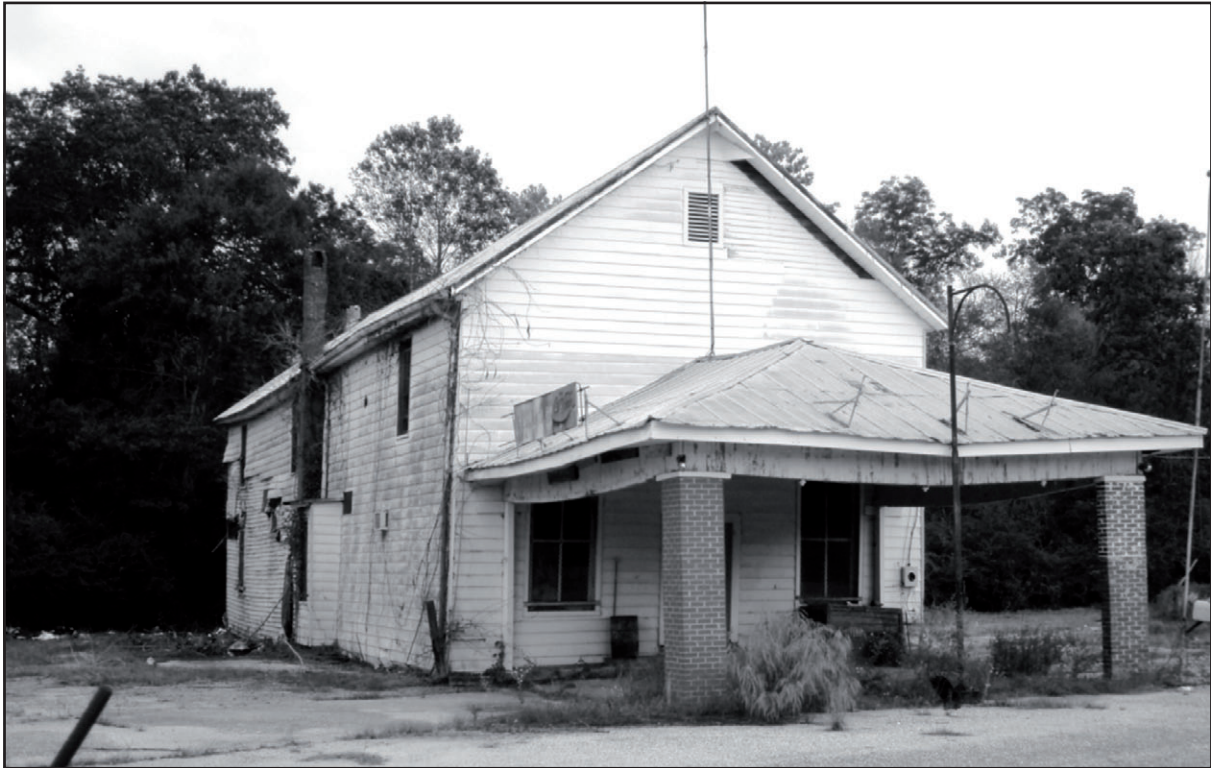
AL\_PerryCo\_Suttle\_0011. Resource #2, prior to demolition, camera facing southeast, photo by MRS Consultants, LLC

Highway 16, E side, 600 yds. N of CR 6. The Suttle store was a two-story frame commercial building with a front-facing gable V-crimped metal roof. The building faced west and had a three-by-three-bay core with a rear two-bay deep one-story extension. Two brick pillars supported a full-façade drive through canopy with a hipped V-crimped metal roof. The principal façade had a central entrance with double leaf doors flanked to either side by single four-light fixed storefront windows. There

were no openings at the upper level of the façade. An off-center six-over-six light double hung sash wood window at the upper level of the south elevation of the core was flanked to either side by similar windows that were widely spaced toward the east and west corners of the building. A similar window was set at the eastern bay of the core corresponding to the upper window with a closely spaced pedestrian entrance to its west. A similar entrance was located at the center bay corresponding to the upper level window. Two high-placed low-height windows flanked the entrance and were centered between bays. The rear extension had a pedestrian entrance at its west bay flanked to the east by a similar window. The north elevation of the core was similar, except that the first floor pedestrian was located further west and an exterior brick flue rose to its west. The north elevation of the rear extension was recessed from the core and has a narrow full-elevation shed porch supported by wood posts. The building was clad with wood weatherboard siding with later synthetic siding having been applied at the facade. The building was demolished in February 2010 except for a formerly interior brick vault that was later removed from the site. The vault had an arched ceiling and retained its original iron vault door. A small frame shed with a front-facing gable V-crimped metal roof and vertical board siding is located to the southeast of the site of the store.

There is conflicting anecdotal information about the construction date of the store, with one source suggesting that it was antebellum and others suggesting it was built between 1880 and 1915. The general merchandise store was operated by J. Freeman Suttle and Suttle is documented to have been operating a store under the name Suttle and Jones Trading Company by at least February 1909. Construction and design details indicated that this building was constructed circa 1900 and remodeled circa 1930. A photograph by noted Hale County photographer William Christianberry taken in 1973 shows the building as the J.F. Suttle Co., Inc." The building was torn down in February 2010.

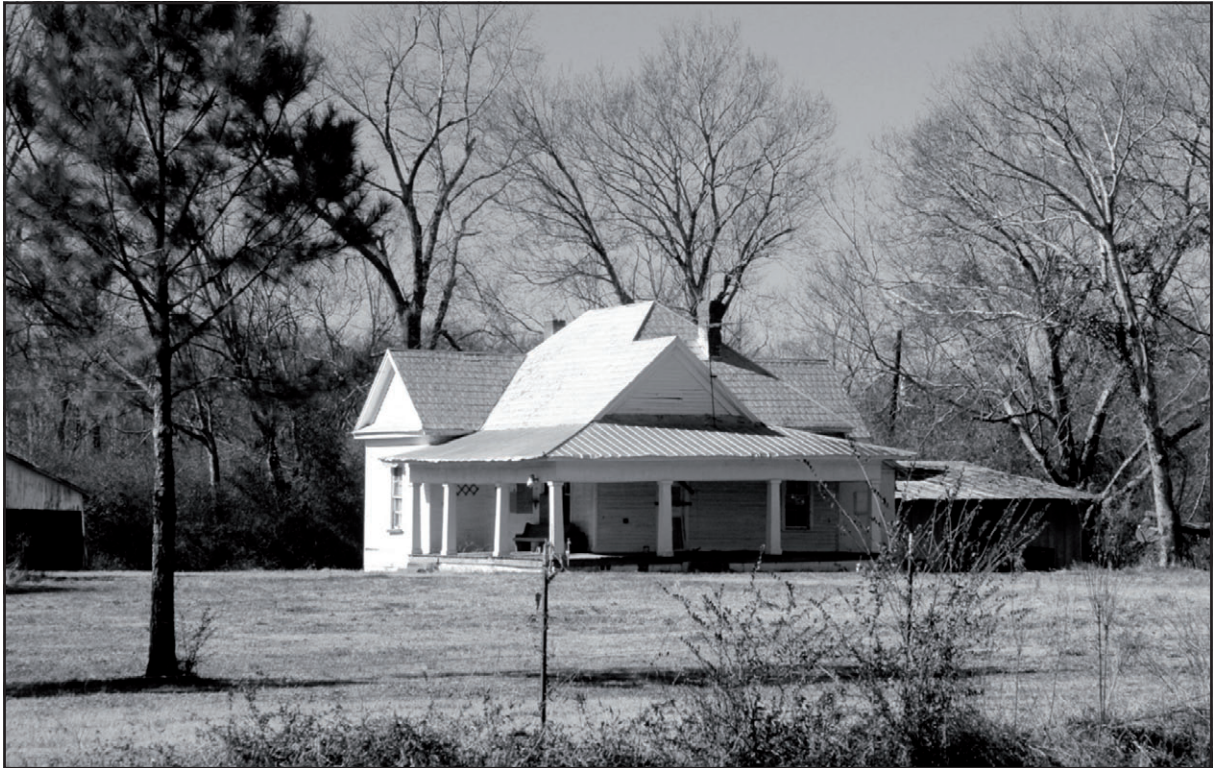
AL\_PerryCo\_Suttle\_0015. Resource #3, camera facing northwest

AL 14, W side, 620 yds. N of CR 6. Note: The following site was inaccessible and the following description was completed from the street and via satellite views. The subject is a one-story frame pyramidal form dwelling with a tall hipped patterned metal roof with pedimented cross gables and two interior brick chimneys. The house faces south and has a three by two bay rectangular core with a front gable projection at the west bay of its facade and a corresponding rear gable wing. A later shed addition was added to the rear circa 1945. The less than full shed porch with tapered wood supports wraps to the east and north elevations. An off-center entrance at the facade is flanked to either side by single wood four-over-four light double hung windows. Similar windows are found at the side elevations. Exterior walls are clad with wood weatherboard siding. A noncontributing frame garage is located to the south of the house.

Construction and design details indicate that this house was constructed circa 1890. Dr. Mason is listed in the 1920 census as a doctor in a general practice living in a rented house next door to Freeman Suttle; he was born circa 1882 and was then living with his wife Amelia, a daughter, 3 sons, and two boarders

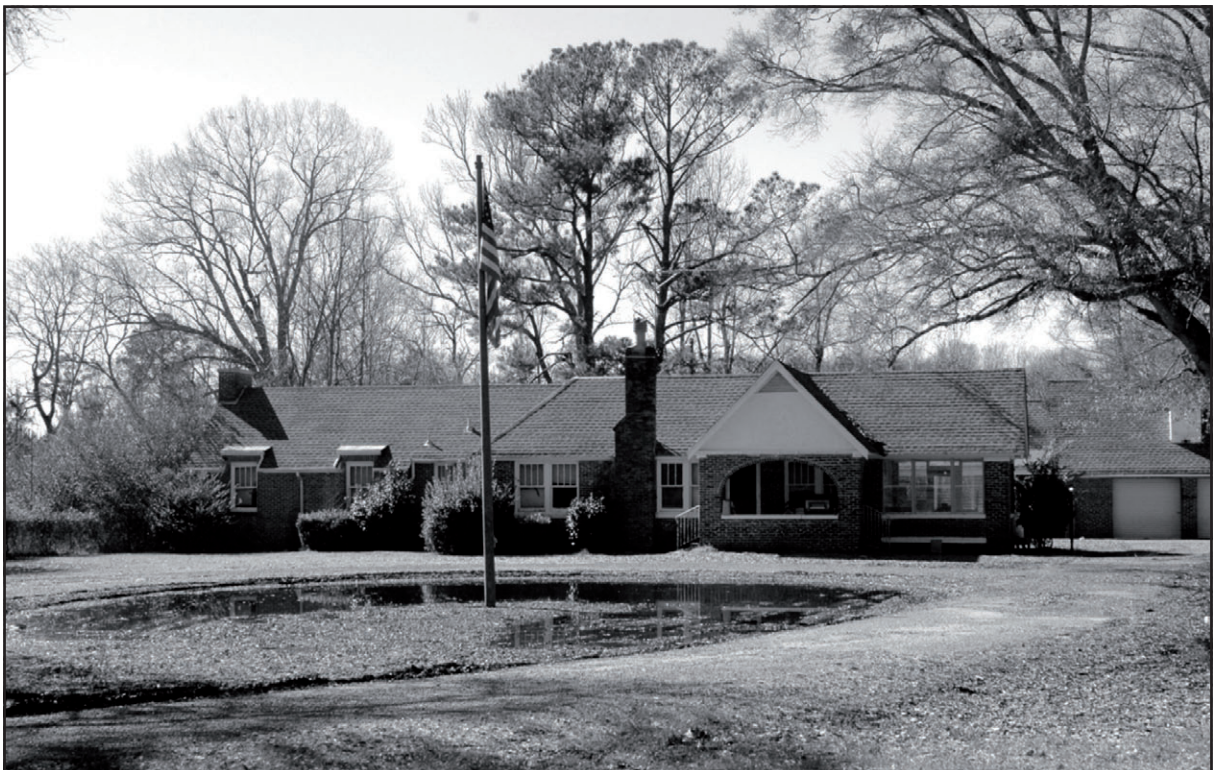
AL\_PerryCo\_Suttle\_0016. Resource #4, camera facing west

Note: The following site was inaccessible and the following description was completed from the street and via satellite views. The subject is a one-story brick veneer dwelling with a cross gable and hipped composition shingle roof with one front brick chimney and exterior end brick chimney. The house faces east and has a four by two bay rectangular core with a side gable extension to the south and a rear gable with with a gable extension to the west. A less than full gable porch with a round arched opening and apron wall extends across the two northern bays of the core and a side gable porch at the front bays of the north elevation is glassed in. An off-center entrance within the porch at the facade is flanked to the north by a double Craftsman geometric wood double hung window. Two similar windows flank the

entrance to the south at the core and the extension has one similar and two single windows. The single windows extend into shed half dormers. Similar single and double Craftsman geometric windows are found at the side elevations. Exterior walls are brick veneer.

Construction and design details indicate that this house was constructed circa 1925. The house was constructed for James Freeman Suttle (1903-1981) and has been used in recent years as a hunting lodge.

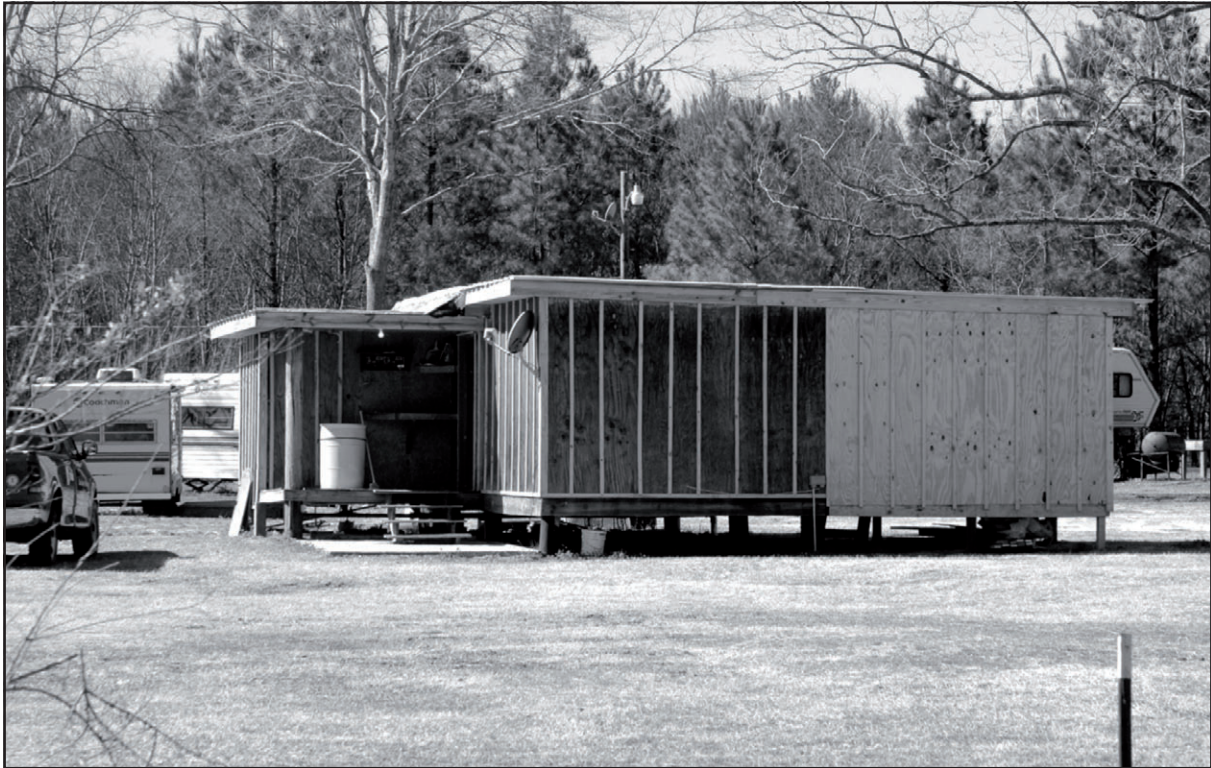
AL\_PerryCo\_Suttle\_0017. Resource #5, camera facing west

AL 14, W side, 560 yds. N of CR 6. Modern one-story frame dwelling with a low-pitched gable metal roof.

Construction and design details indicate that this house was constructed circa 2000.

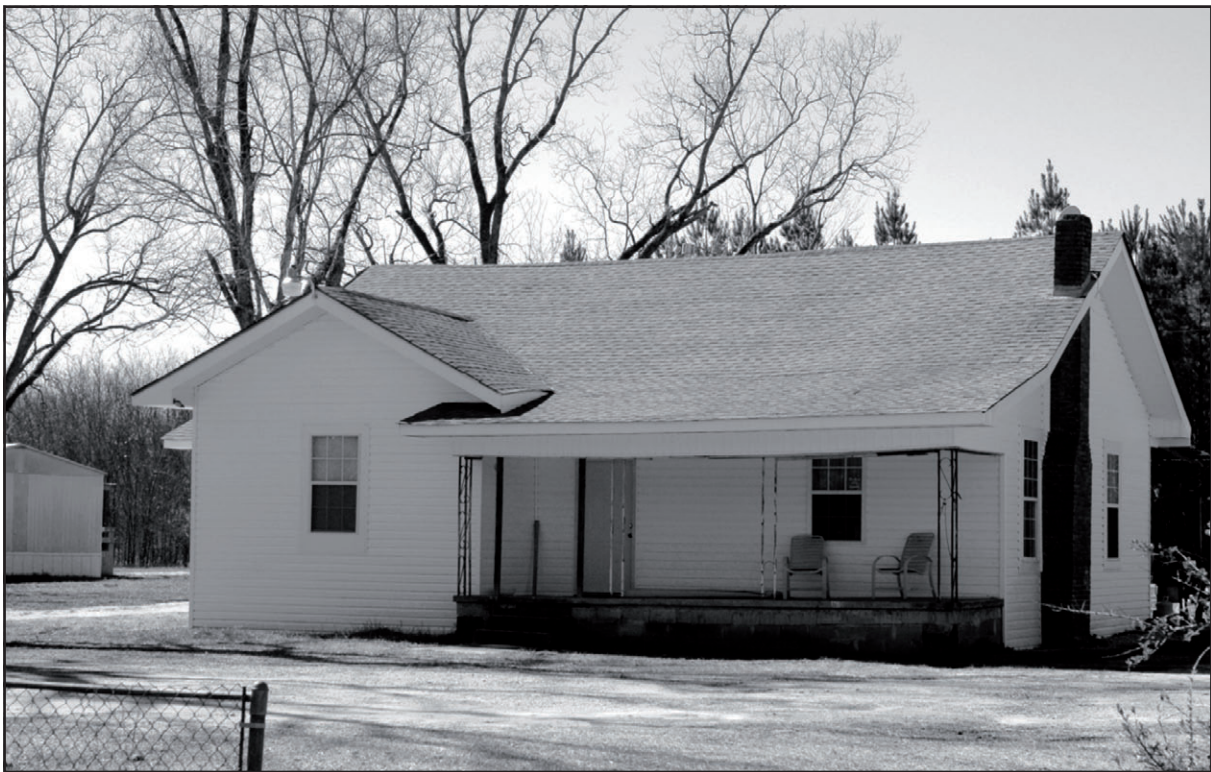
AL\_PerryCo\_Suttle\_0018. Resource #6, camera facing southwest

AL 14, W side, 540 yds. N of CR 6. The subject is a one-story frame dwelling with a cross gable composition shingle roof with one exterior end brick chimney. The L-shaped house faces east and has a three by two bay rectangular core with a front-facing gable projection at the southern bay of its facade and a rear shed extension to the north. A less than full facade engaged porch is supported by replacement decorative metal supports (circa 1965). An off-center entrance at the facade is flanked to either side by single replacement windows (circa 1995). Similar windows are found at the side elevations. The house is clad with replacement vinyl siding (circa 1995).

Construction and design details indicate that this house was constructed circa 1915 and that it was remodeled circa 1965 and circa 1995.

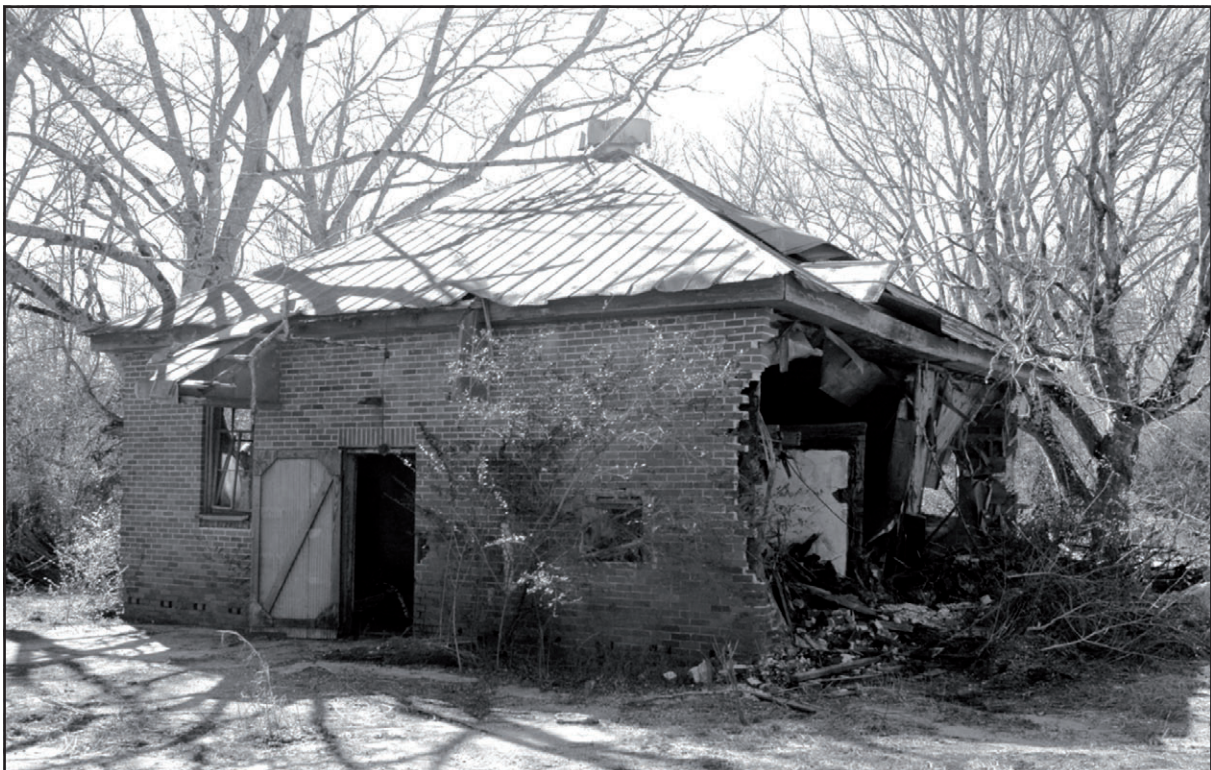
AL\_PerryCo\_Suttle\_0022. Resource #7, camera facing southwest

AL 14, 180 yds W on lane, 410 yds. N of CR 6. The subject is a one-story brick agricultural building with a pyramidal hipped V-crimped metal roof with a central ventilator. The building faces east and is three bays wide and two bays deep. An off-center entrance at the facade is flanked to either side by single wood four-over-four light double hung sash windows. Similar windows are found at the side elevations. The exterior walls are constructed of brick and the north wall has no collapsed. The concrete foundation of a former hog barn is located to the west of the building.

Construction and design details indicate that this building was constructed circa 1925. The building was a cold storage and processing building for a dairy operated by J. Freeman Suttle.

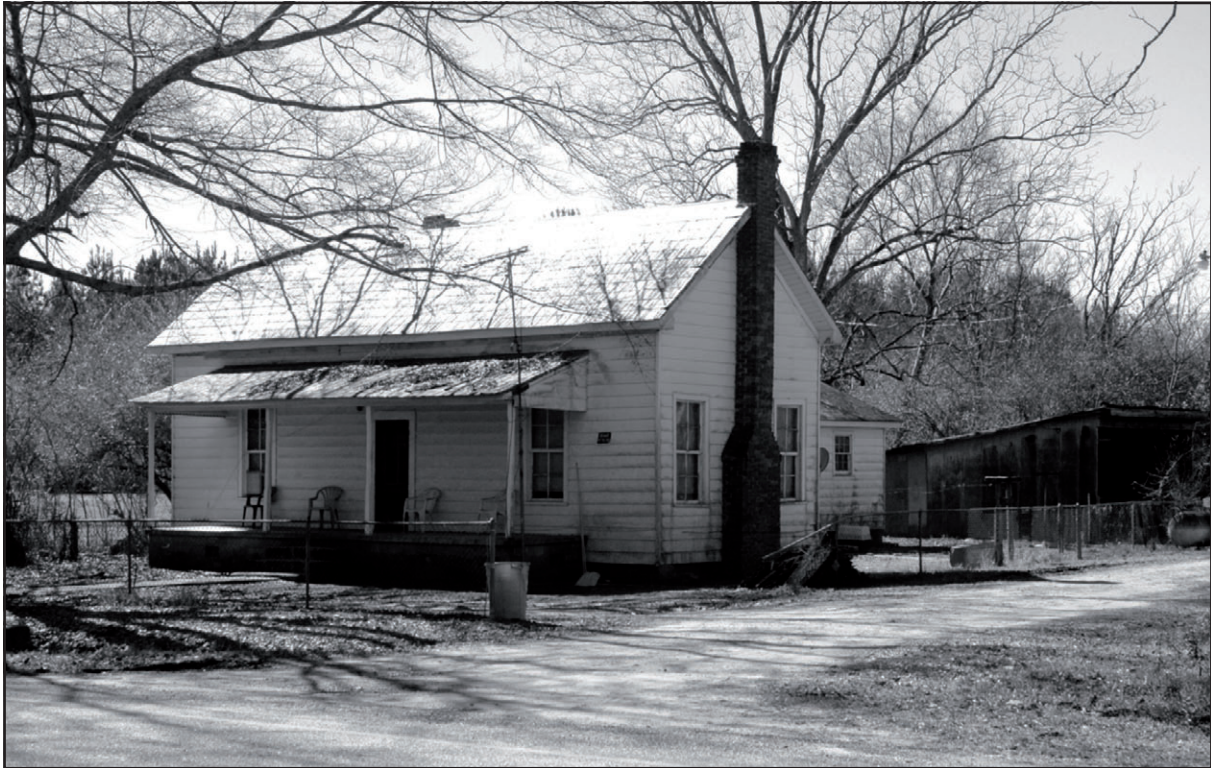
AL\_PerryCo\_Suttle\_0023. Resource #8, camera facing southwest

224 AL 14. The subject is a one-story frame dwelling with a cross gable patterned pressed metal roof with one exterior end brick chimney and one brick flue. The L-shaped house faces east and has a three by one bay rectangular core with a rear two-bay deep L wing to the south. A small shed extension to the east of the rear wing wraps along the north side of the wing and extends one bay to the rear of the house as a secondary gable wing. A less than full facade shed porch is supported by chamfered wood posts. A central entrance at the facade is flanked to either side by single wood four-over-four light double hung sash windows. Similar windows are found at the side elevations. The house is clad with replacement aluminum siding (circa 1975). Two noncontributing frame sheds are located to the rear of the house.

Construction and design details indicate that this house was constructed circa 1915 and that it was remodeled circa 1975.

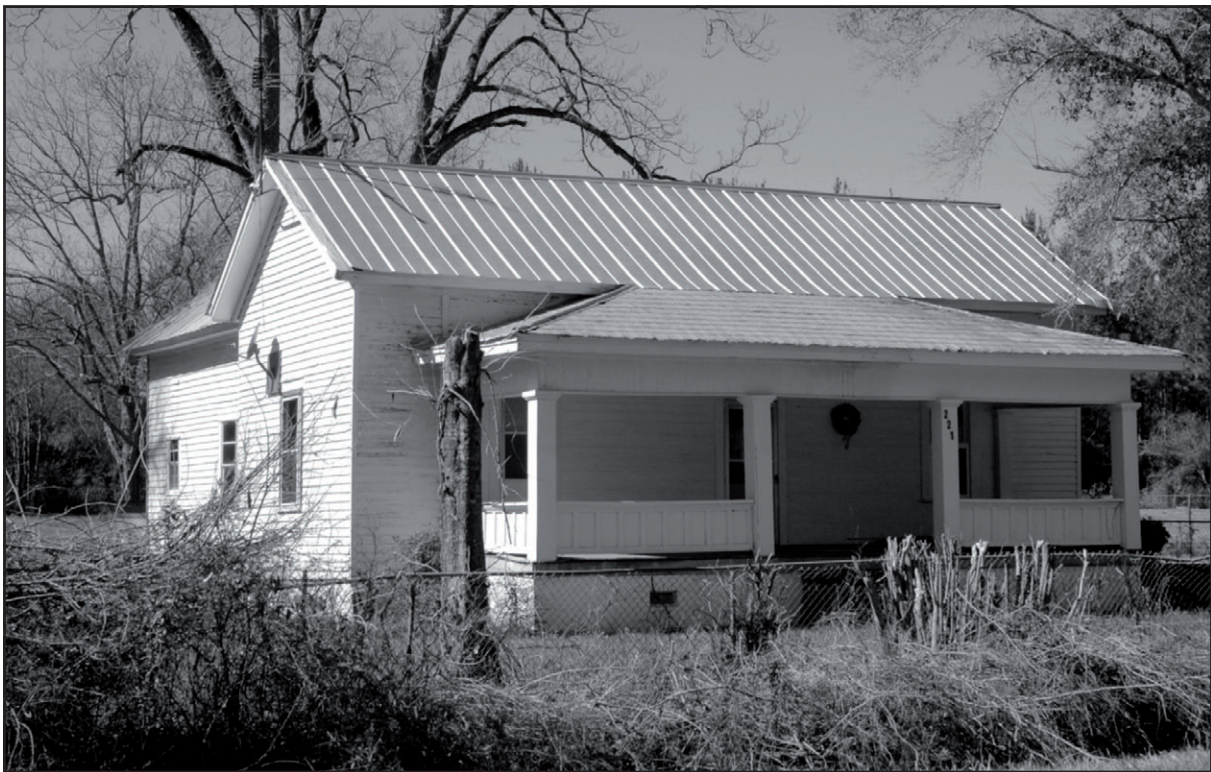
AL\_PerryCo\_Suttle\_0024. Resource #9, camera facing northwest

AL 14, W side, 235 yds. N of CR 6. The subject is a one-story frame dwelling with a cross gable V-crimped metal roof. The

L-shaped house faces east and has a three by one bay rectangular core with a rear two-bay deep L wing to the south and a rear shed extension to the north. A less than full facade hipped porch is supported by wood pillars and has a paneled wood railing. A central entrance at the facade is flanked to the north by a single wood four-over-four light double hung sash window and to the south by a modern replacement window (circa 1975). Similar replacement windows are found at the side elevations. The house is clad with wood weatherboard siding.

Construction and design details indicate that this house was constructed circa 1915 and that it was remodeled circa 1975.

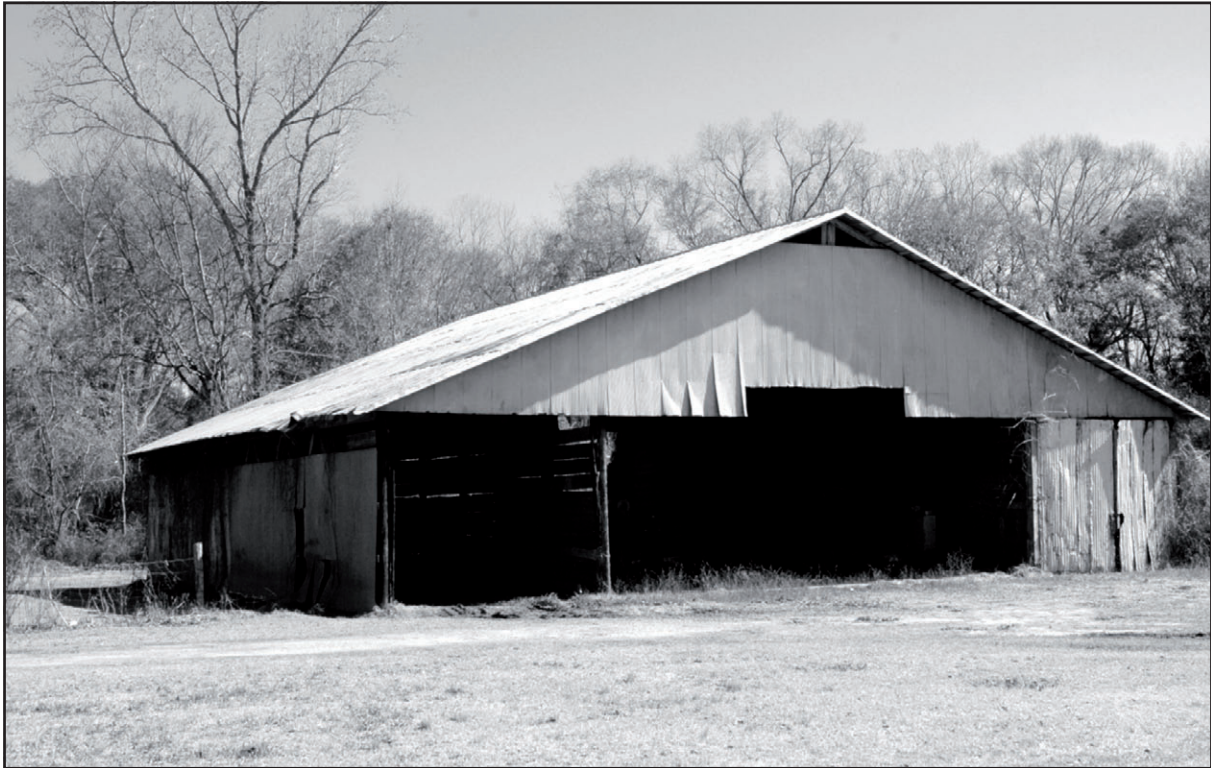
AL\_PerryCo\_Suttle\_0025. Resource #10, camera facing southeast

AL 14, E side, 300 yds. N of CR 6. The subject building is a large rectangular shed with a front-facing gable V-crimped metal roof with exposed rafter ends. The building faces west and has a former single cargo entrance at its facade that has been enlarged to either side. A similar opening is located at the east elevation. The building is clad with corrugated metal siding.

Construction and design details indicate that this building was constructed circa 1935.

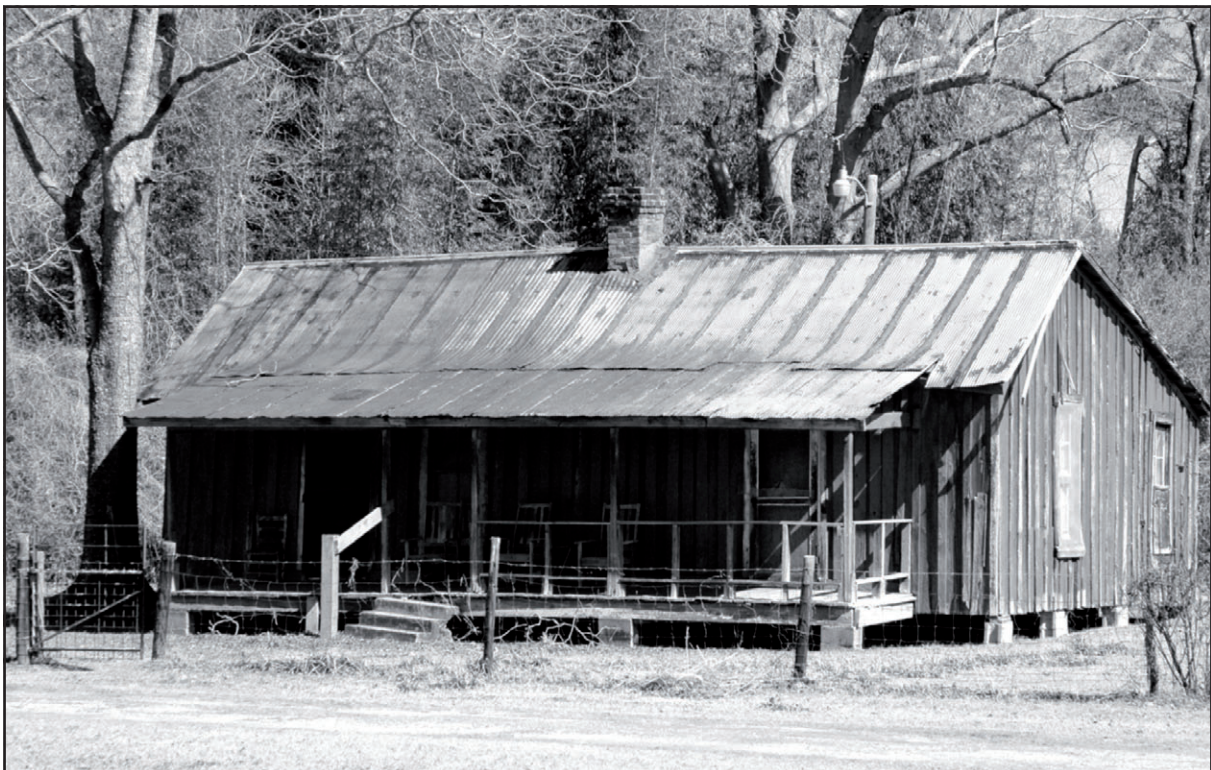
AL\_PerryCo\_Suttle\_0026. Resource #11, camera facing northeast

223 AL 14. The subject is a one-story frame dwelling with a side saltbox gable V-crimped metal roof with one central brick chimney. The house faces west and has a two by two bay rectangular core. A less than full facade shed porch is supported by wood posts and has a simple board railing. Entrances are located in each bay of the facade and side elevations have single wood four-over-four light double hung sash windows in each bay. Exterior walls are clad with board and batten siding and the house has a concrete block pier foundation.

Construction and design details indicate that this house was constructed circa 1915.

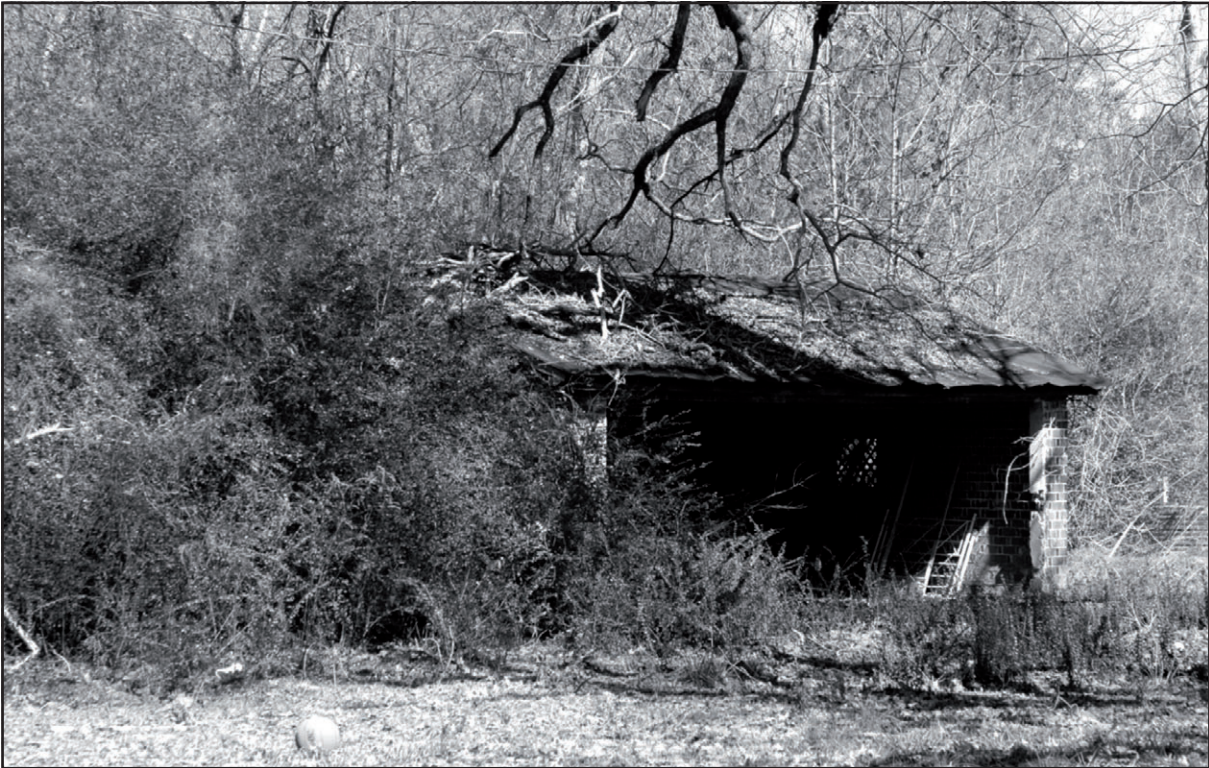
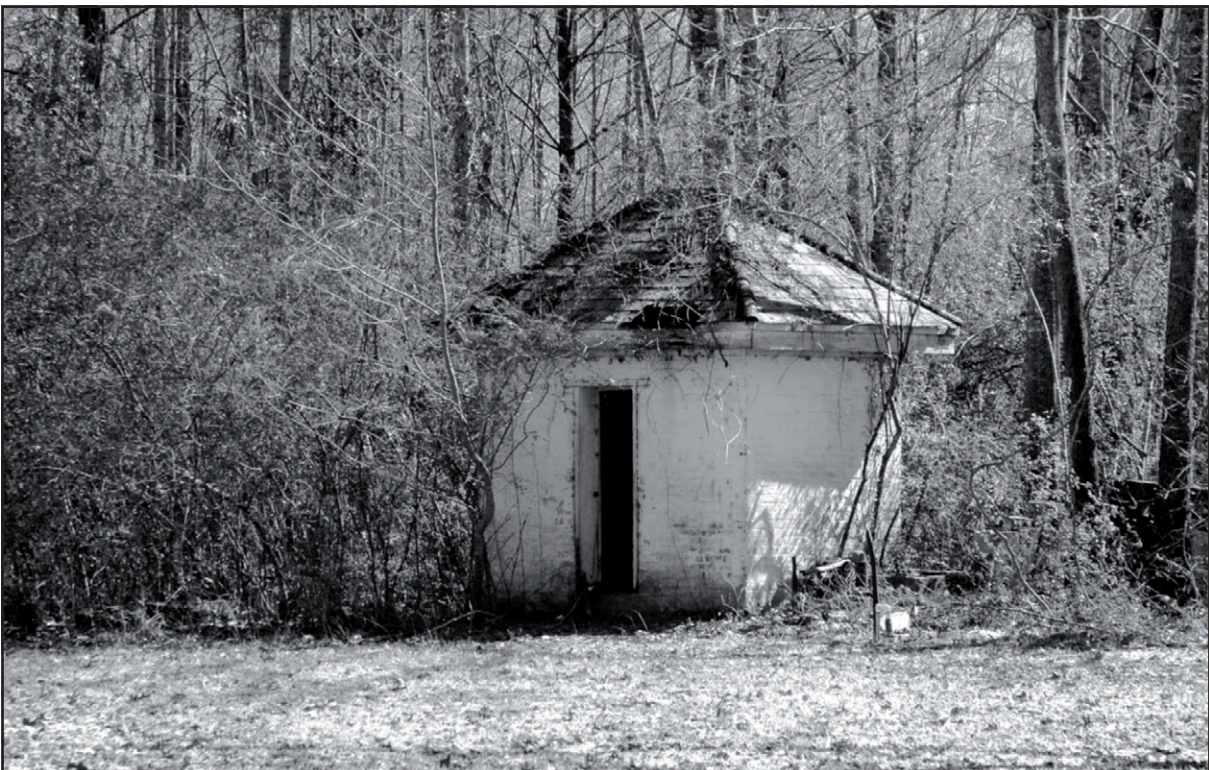
AL 14, E side, 485 yds. N of CR 6. The site contains remnants of a former residential complex including a historic garage (circa 1925), a modern manufactured home, and a historic outbuilding that appears to be a well house (circa 1925). The garage is a rectangular brick building with a side gable composition shingle roof. The building faces south and has a single large garage opening. Exterior walls are constructed of brick and the garage is in deteriorated condition. The well house is a small rectangular brick building with a pyramidal composition shingle roof. It has a door at its north elevation and no other openings. The well house is constructed of brick that has been painted.

Construction and design details indicate that the two historic resources on this site were constructed circa 1925.

AL\_PerryCo\_Suttle\_0027. Resource #12, garage, camera facing northeast

AL\_PerryCo\_Suttle\_0028. Resource #12, well house, camera facing southeast

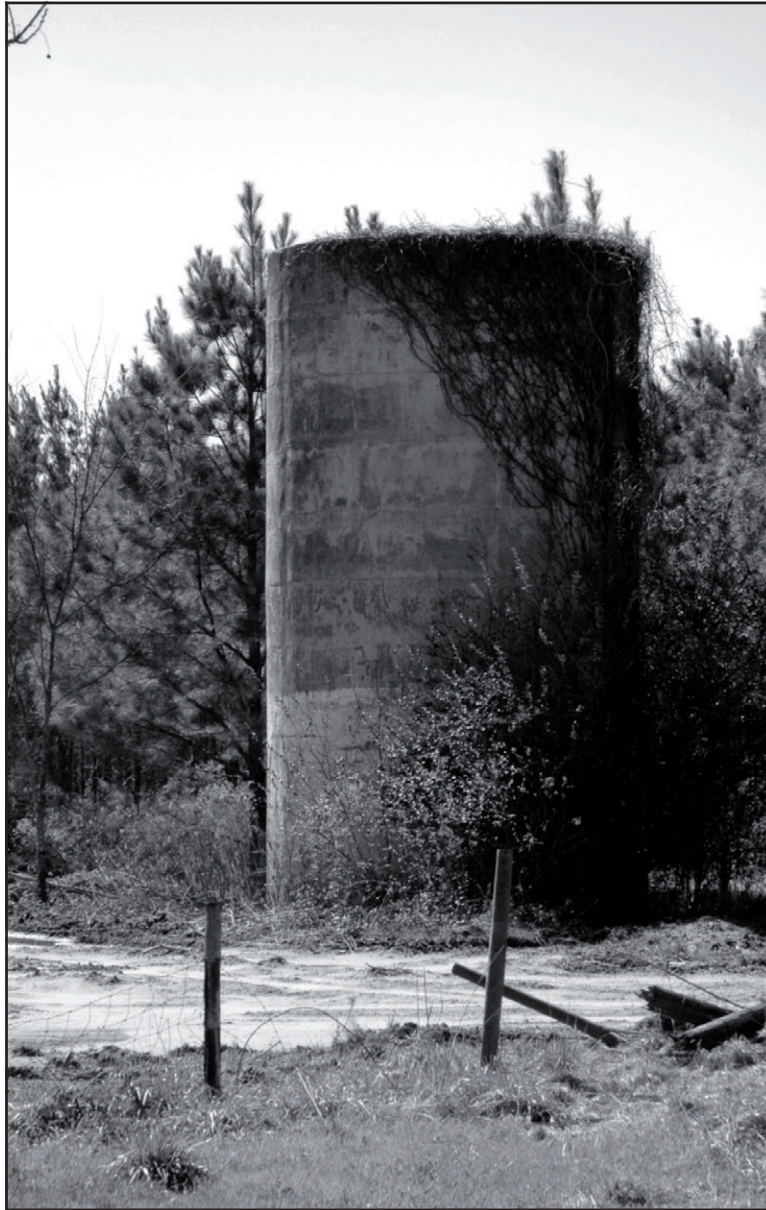
AL\_PerryCo\_Suttle\_0029. Resource #13,  
camera facing southwest

CR 6, S side, 50 yds. W of AL 16. Round poured concrete silo.

Construction and design details indicate that this silo was constructed circa 1930.

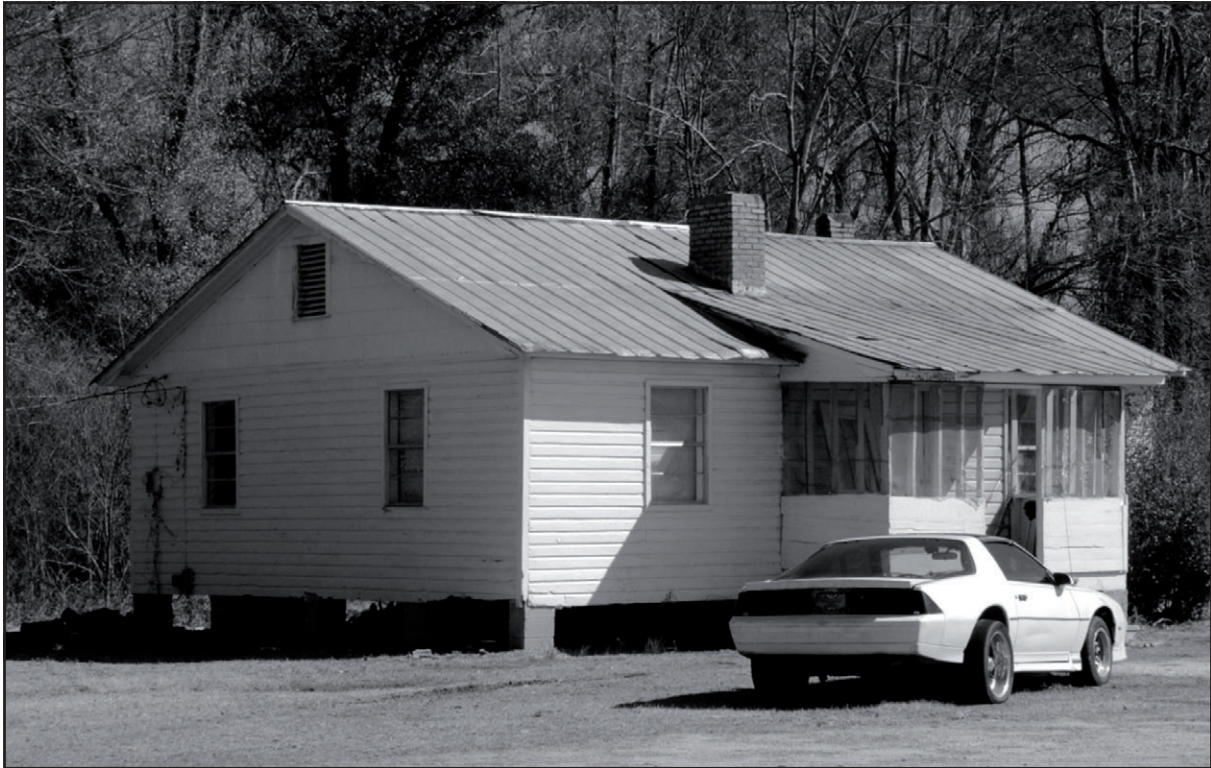
AL\_PerryCo\_Suttle\_0030. Resource #14, camera facing southeast

AL 14, E side, 90 yds. S of CR 6. The subject is a one-story frame dwelling with a side gable V-crimped metal roof with one interior brick chimney and one brick flue. The house faces west and has a three by two bay rectangular core. An entrance bay shed porch has been infilled with insect screening and a plywood apron wall (circa 1975) The central entrance is flanked to either side by single horizontal two-over-two replacement windows (circa 1965). Similar windows are found at the side elevations. Exterior walls are clad with plain weatherboard siding and the house has a concrete block pier foundation.

Construction and design details indicate that this house was constructed circa 1925 and that it was remodeled circa 1965 and circa 1975.

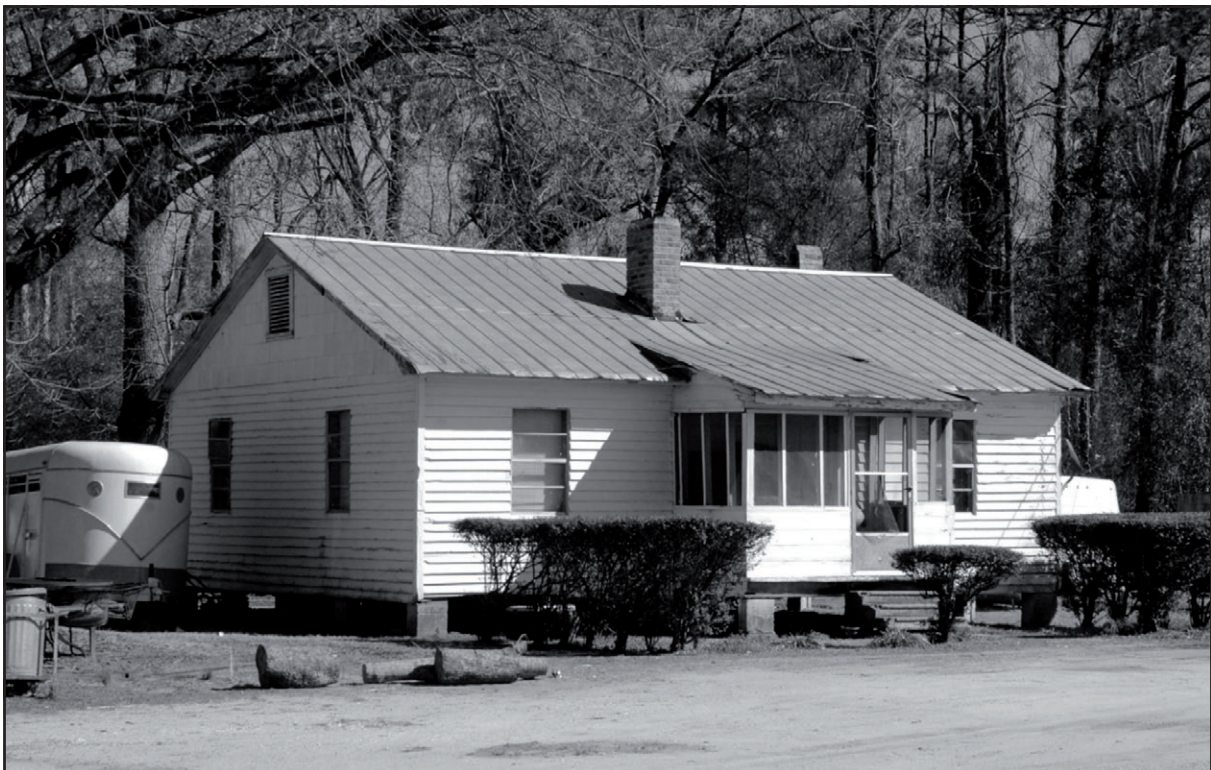
AL\_PerryCo\_Suttle\_0031. Resource #15, camera facing southeast

AL 14, E side, 165 yds. S of CR 6. The subject is a one-story frame dwelling with a side gable V-crimped metal roof with one interior brick chimney and one brick flue. The house faces west and has a three by two bay rectangular core. An entrance bay shed porch has been infilled with insect screening and a plywood apron wall (circa 1975) The central entrance is flanked to either side by single horizontal two-over-two replacement windows (circa 1965). Similar windows are found at the side elevations. Exterior walls are clad with plain weatherboard siding siding and the house has a concrete block pier foundation.

Construction and design details indicate that this house was constructed circa 1925 and that it was remodeled circa 1965 and circa 1975.

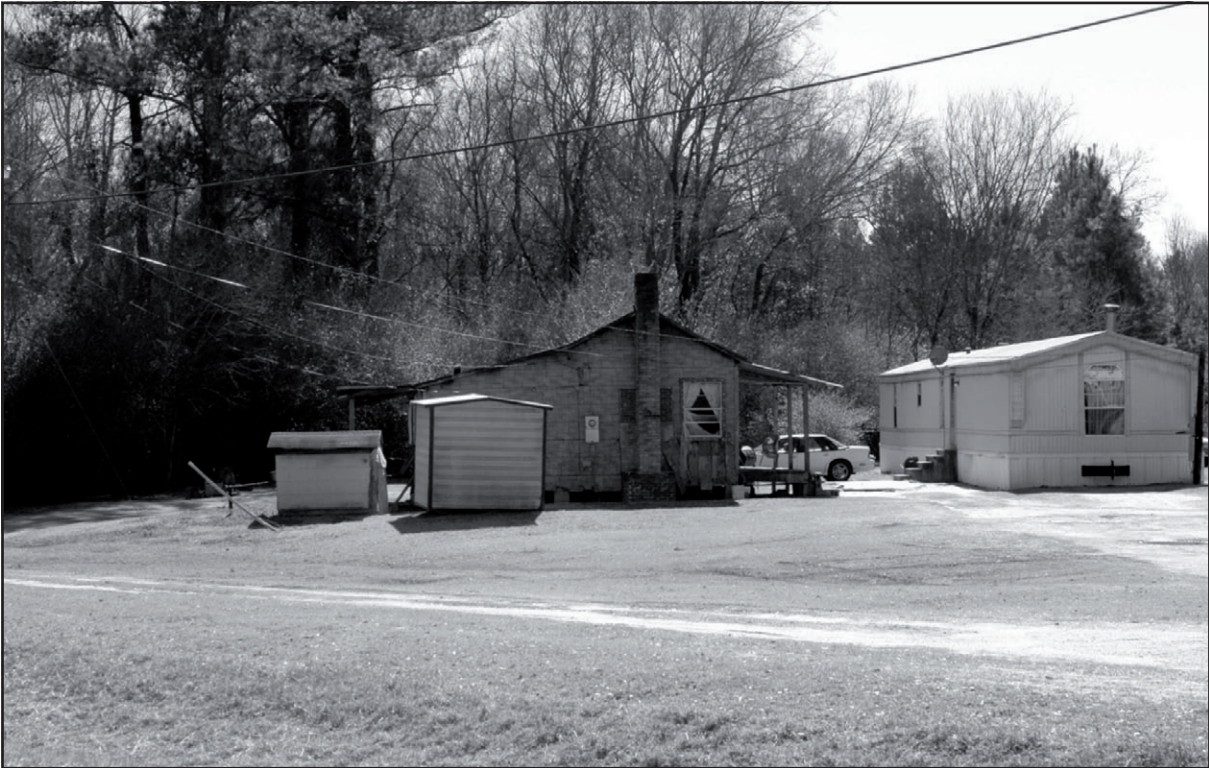
AL\_PerryCo\_Suttle\_0032. Resource #16, camera facing southwest

AL 14, W side, 400 yds. S of CR 6. The subject is a one-story frame dwelling with a side gable V-crimped metal roof with one exterior brick chimney. The house faces north and has a two by one bay rectangular core with a full-width rear gable extension. A modern replacement less full-facade shed porch is supported by wood posts (circa 1985). The facade has entrances in each of its bays and modern aluminum replacement windows are found at the side elevations (circa 1965). Exterior walls are clad with composition shingle siding siding (circa 1965). Modern manufactured house in yard.

Construction and design details indicate that this house was constructed circa 1910 and that it was remodeled circa 1965 and circa 1985.

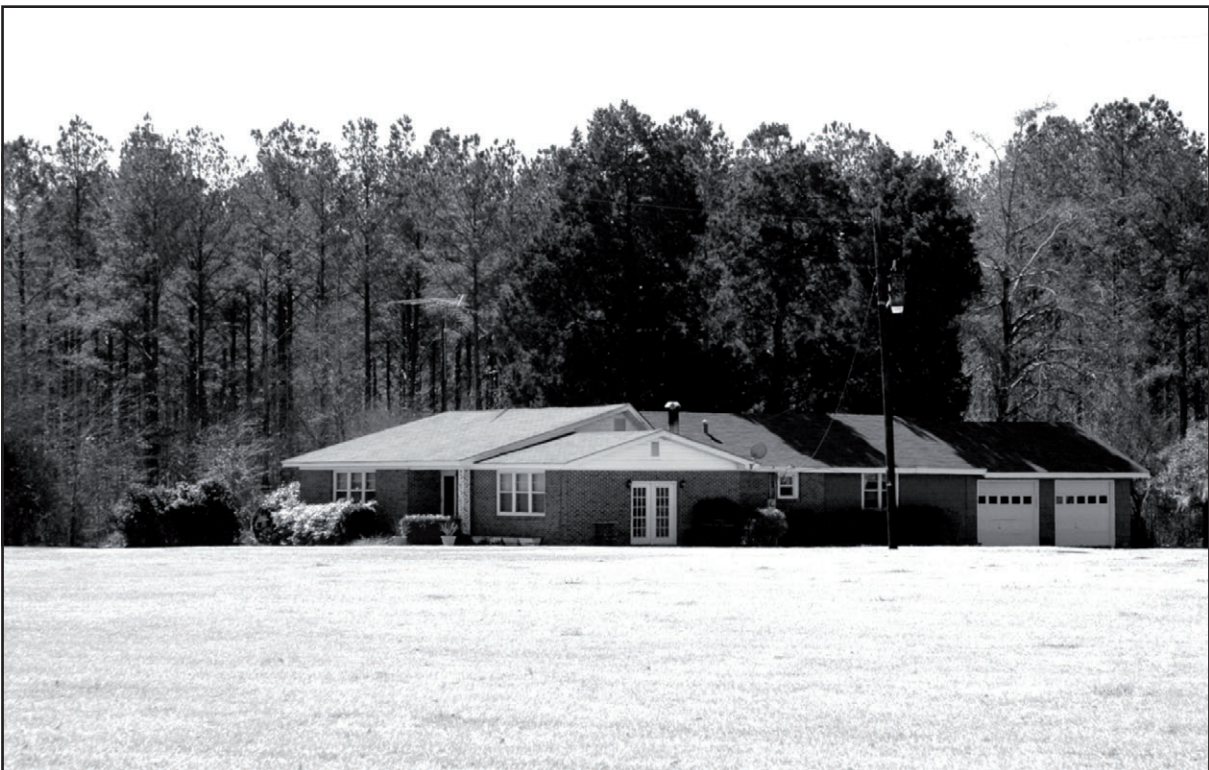
AL\_PerryCo\_Suttle\_0033. Resource #17, camera facing southwest

228 Hwy. 14. Modern one-story brick veneer Ranch style dwelling with a hipped composition shingle roof.

Construction and design details indicate that this house was constructed circa 1975.
