# Suttle, Alabama

Written Historical and Descriptive Data, Photographs, Drawings  
8 April 2010

SUTTLE, ALABAMA  
Perry County, Alabama

## Historic Resource Survey

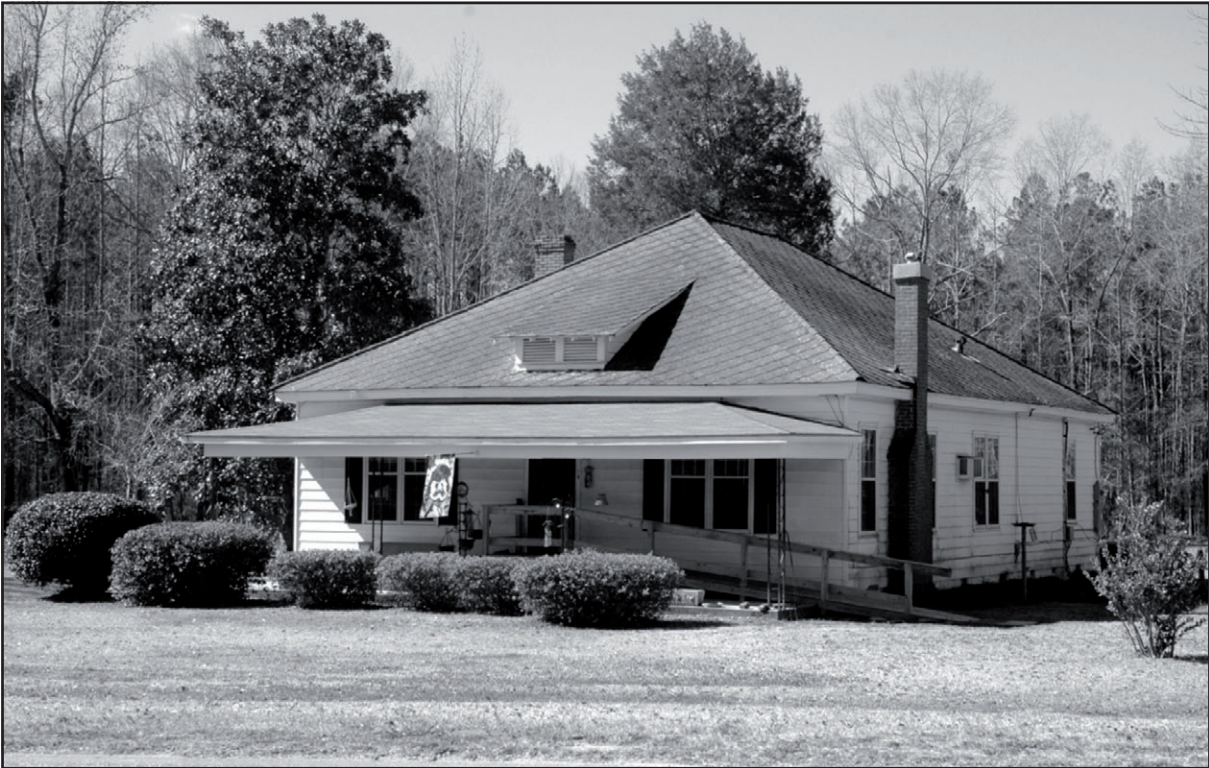
AL\_PerryCo\_Suttle\_0034. Resource #18, camera facing southwest

230 AL 14. The subject is a one-story frame pyramidal form dwelling with a hipped patterned composition tile roof with a central decorative shed dormer with exposed rafter ends and a paired attic louver, a simple boxed cornice, one interior brick chimney, and one exterior brick chimney. The house faces east and has a three by four bay rectangular core. A full-facade hipped porch is supported by replacement decorative metal supports (circa 1965). A single central entrance at the facade is flanked to either side by double Craftsman geometric double hung sash windows. Similar single and double windows are located at the side and rear elevations. Exterior walls are clad with replacement aluminum siding (circa 1965) and modern synthetic shutters have been added at the front windows (circa 1965).

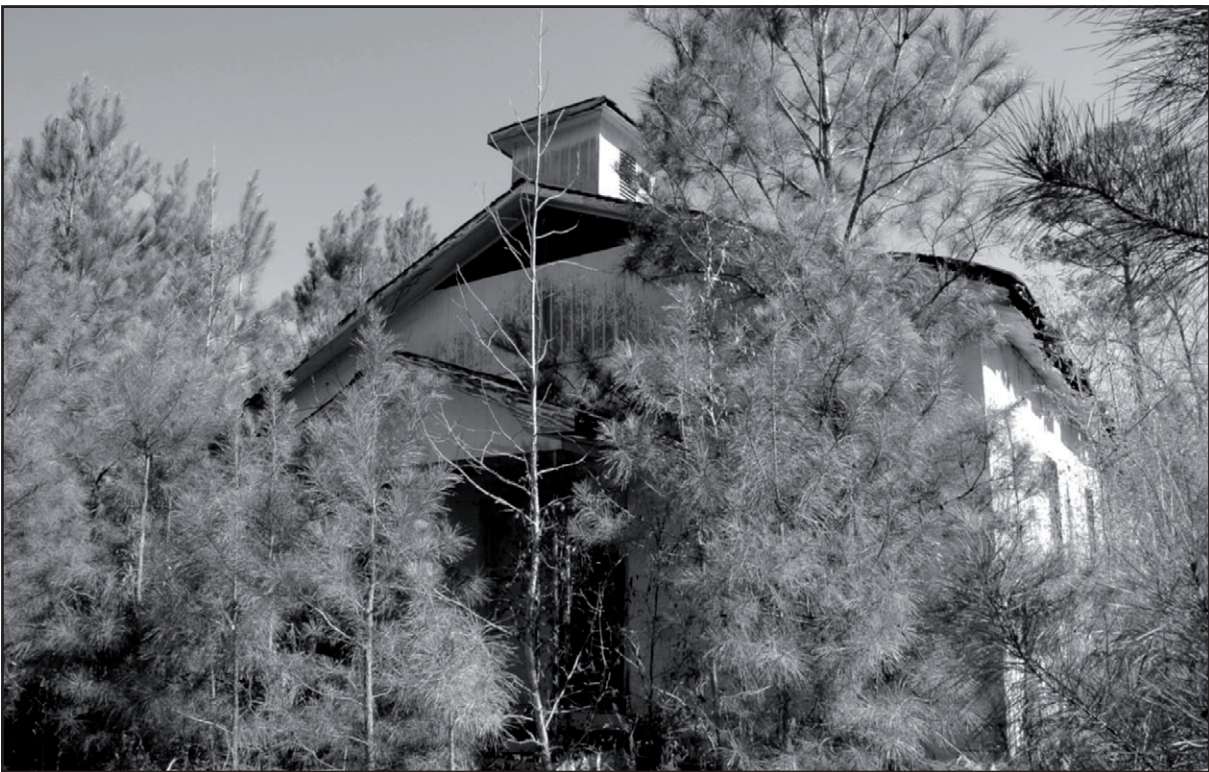
AL\_PerryCo\_Suttle\_0035. Resource #19, camera facing northeast

AL 14, E side, 0.9 mi. N of CR 6. The subject is a one-story concrete block church building with a front-facing gable V-crimped metal roof with a simple frame bell tower. The building faces southwest and is three bays wide and three bays deep. The central entrance is flanked to either side by single horizontal two-over-two windows. Similar windows are found at each side elevation. An entrance bay only gable portico is supported by wood posts. The building has painted concrete block exterior walls.
